Used Sale Safety & Compliance Check

MHE-000127 / 124196 / David Armor / 24/12/2025 / Jungheinrich /
EFG 218ki

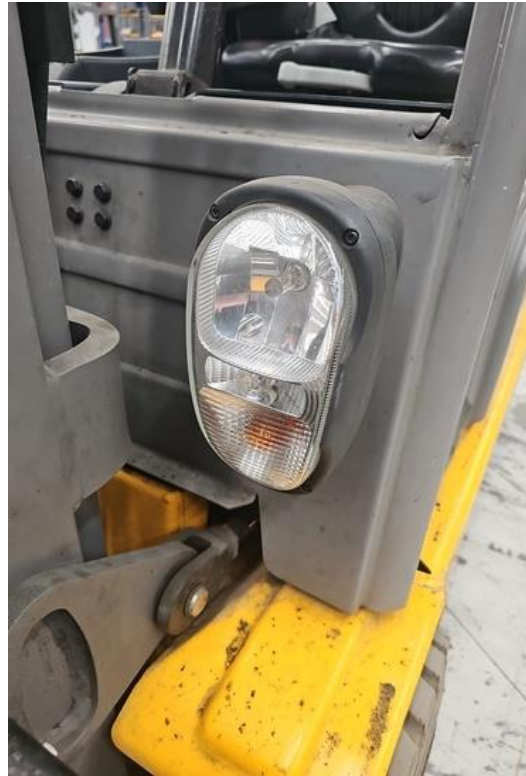
Photo 6

Emergency Stop, Horn/Warning device, lights, reverse alarm and flashing lights operational

No

Left headlight inoperative. Indicator ok

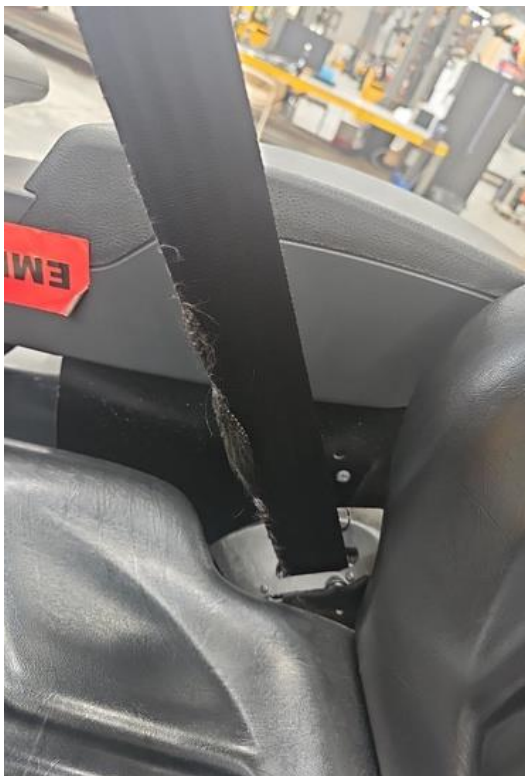
Photo 7

Seat is secure and seat belt is in serviceable condition?

No

Seat belt fraying - visible when pulled out all the way

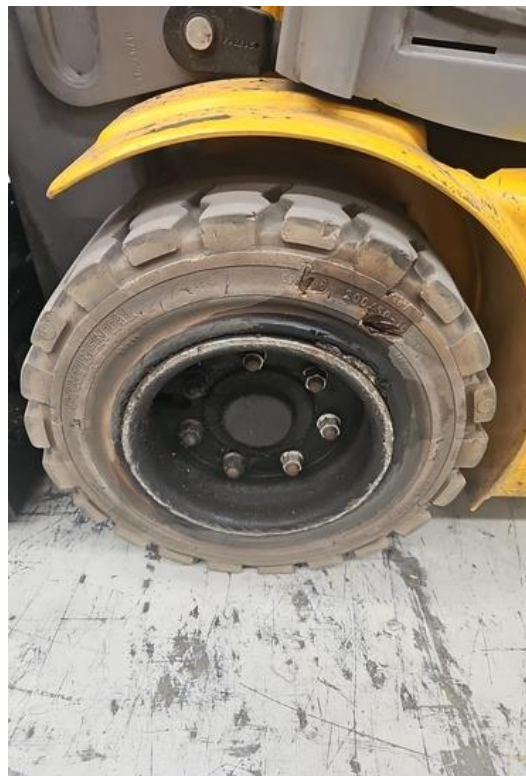
Photo 8

Are tyre treads within limits and/or free from damage?

No

Cracks and chunks missing from steer and drive tyres. Tread wear is within specification. Slightly bumpy when driving.

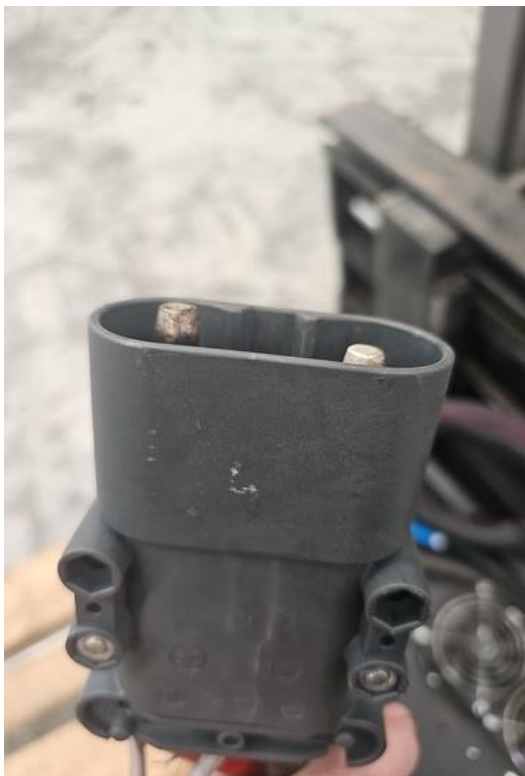
Photo 11

Charger not tested, Fitted with euro plug.

Forklift fitted with aftermarket battery

Pins bent/melted in charger plug.
