Boat Condition Overview

Boat Condition Overview - GRAYS

Chapperal196

04.02.2026

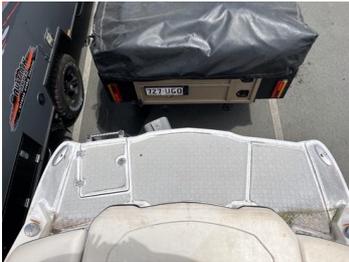
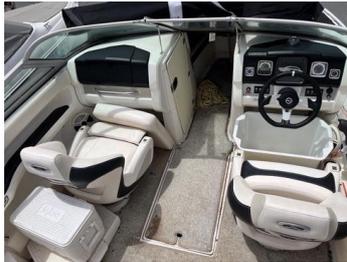
Main Floor/Deck

Poor

Duckboard deck grip has failed due to the elements and had lifted away from the fibreglass. Interior carpet is stained heavily signs of water ingress

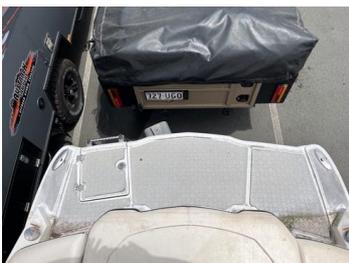
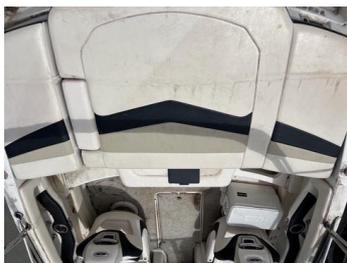
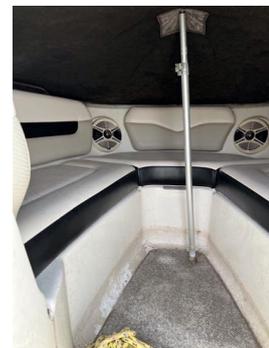
Seating and Trimming

Fair

Seats and trimmings have mould growth Nil cracks or splits present

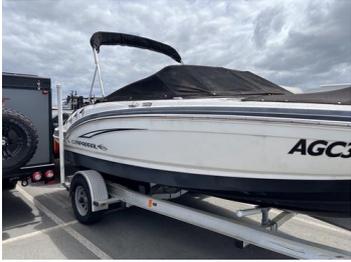
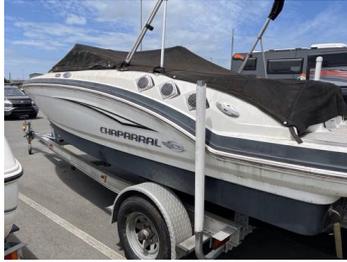
Bimini and Clears

Poor

Bimini bag excessive mould, vessel covers are heavily soiled and mould growth

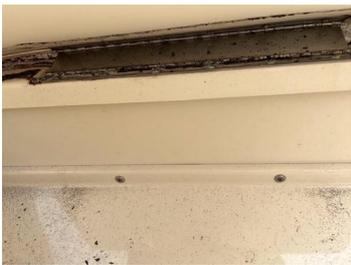
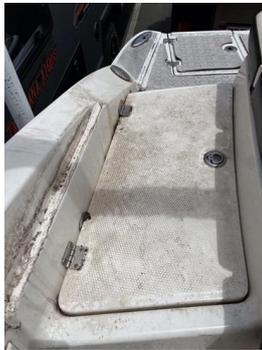
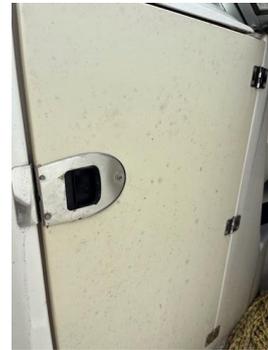
Doors, Windows, Lockers and Hatches

Fair

Corrosion present on the door latches and heavily corroded on the main rear seat

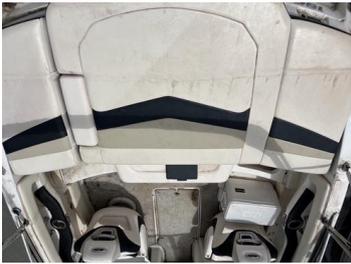
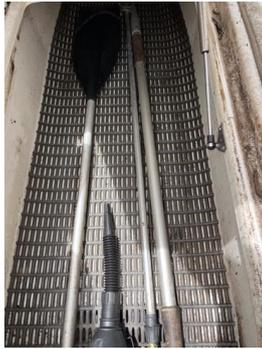
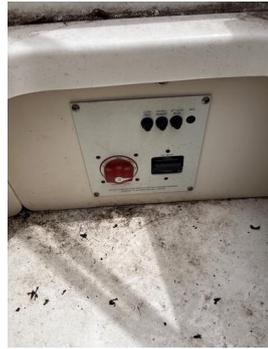
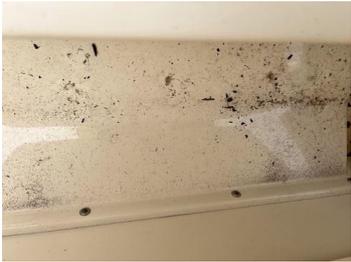
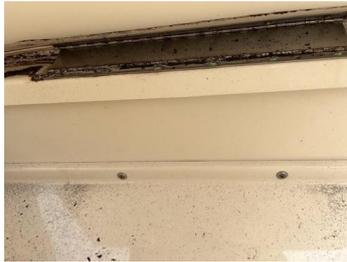
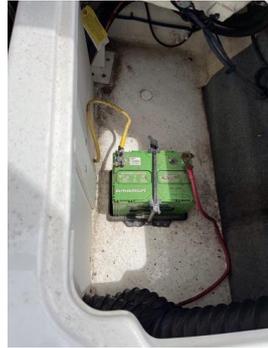
Hull Accessible Interior

Fair

Signs of water ingress inside stowage areas

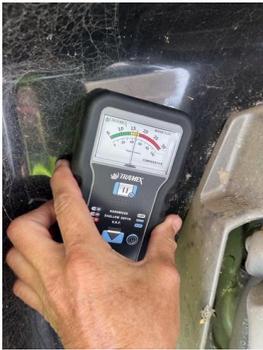
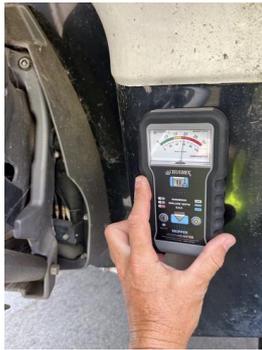
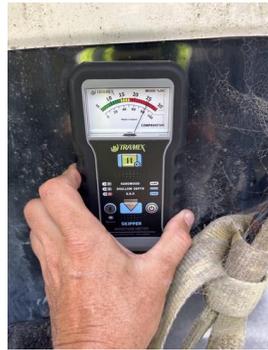
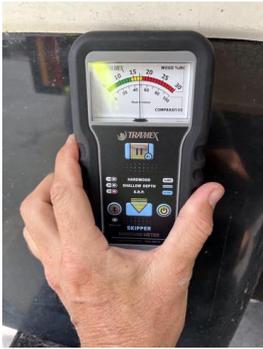
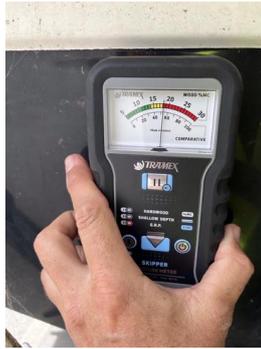
Transom Condition

Poor

High levels of moisture in transom area detected

Moisture test to transom has high reading of water moisture in the laminate

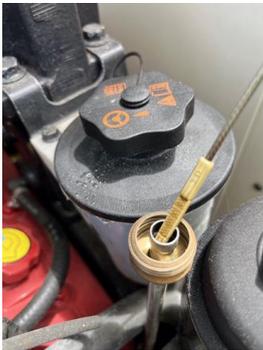
Photo 30

Engine Oil Visual Inspection

Satisfactory

Oil Level is within min max range and of used colour

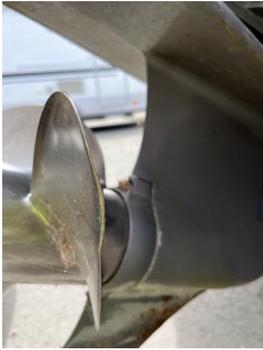
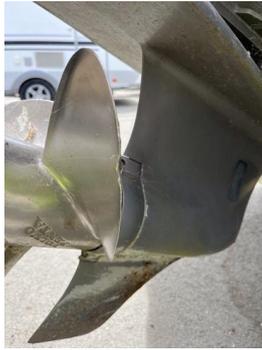
Propeller

Poor

Impact damage to blades

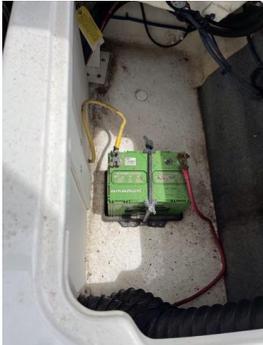
Photo 34

Batteries Tested

Reject

Battery Has failed

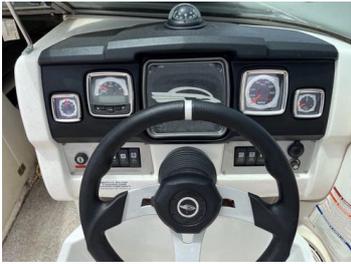
Photo 36

Other Boat System Instruments

Visual inspection only, all screens appear acceptable for age wear and tear

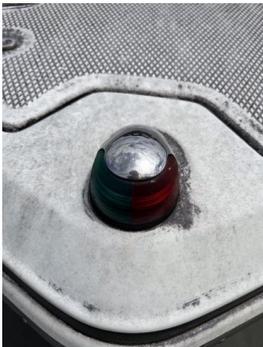
Photo 37

Navigation Lights

Navigation lights bow of vessel faded
