Used Sale Safety & Compliance Check

MHE-000296 / 131825 / Melbourne Service / 27/04/2026 /
Jungheinrich / EFG320

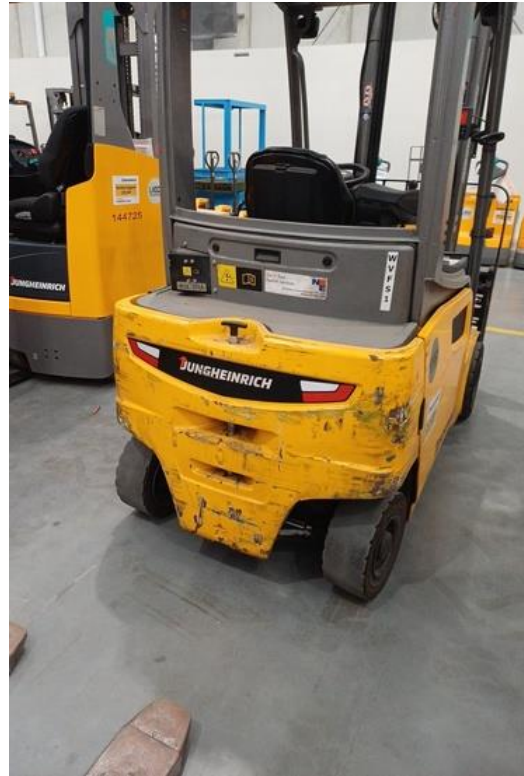
Photo 10

Emergency Stop, Horn/Warning device, lights, reverse alarm and flashing lights operational

Yes

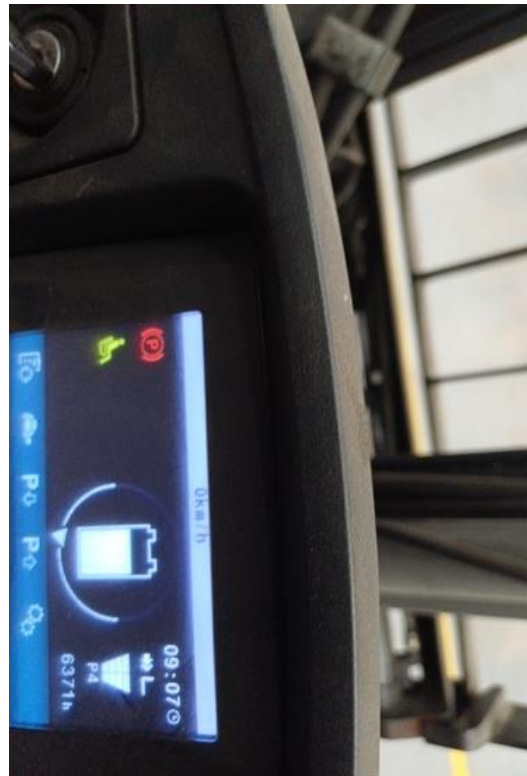
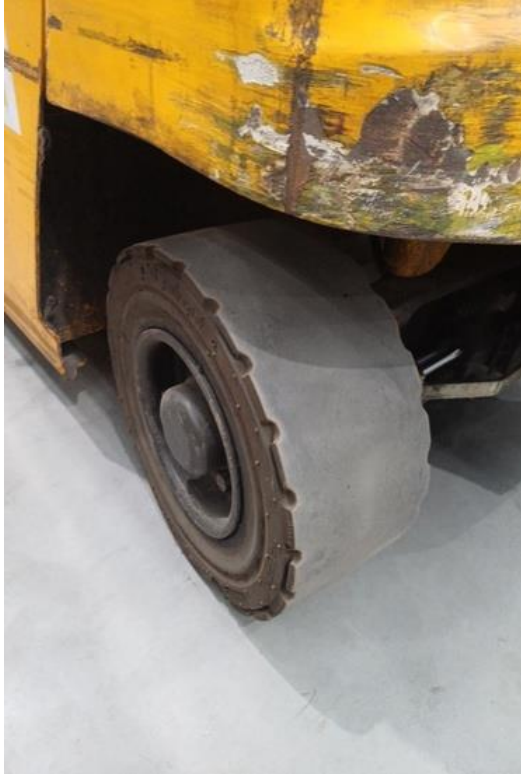
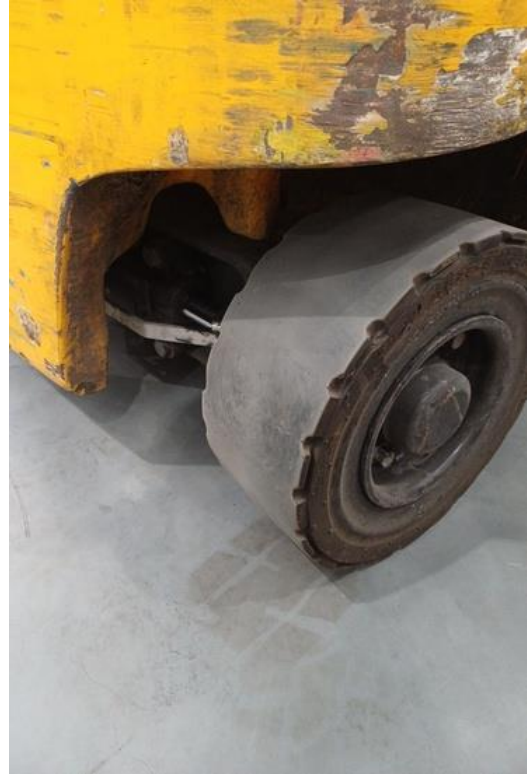
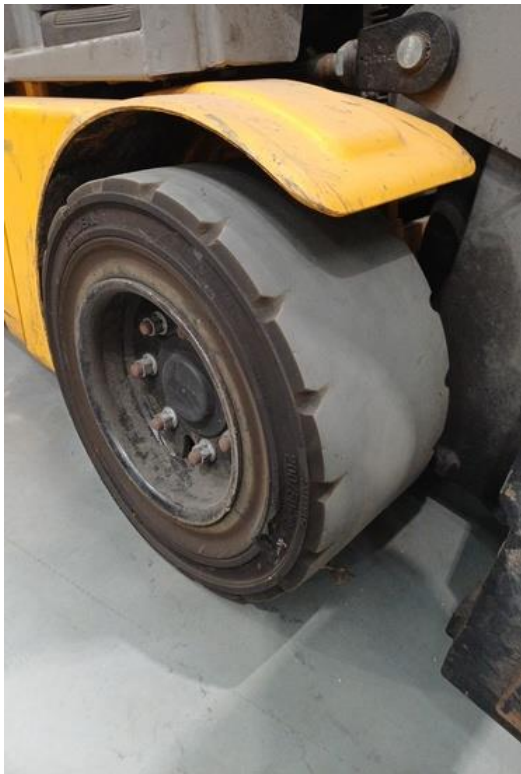
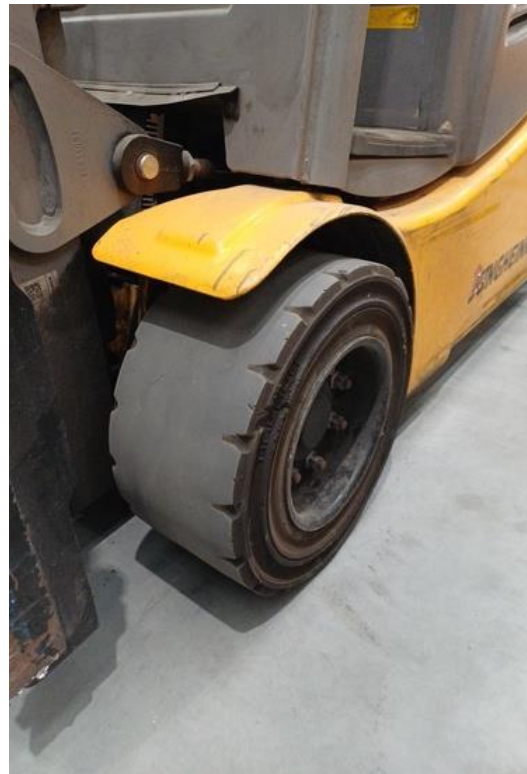
Are tyre treads within limits and/or free from damage?

Yes

Are fork tyres in good condition and within specification?

No

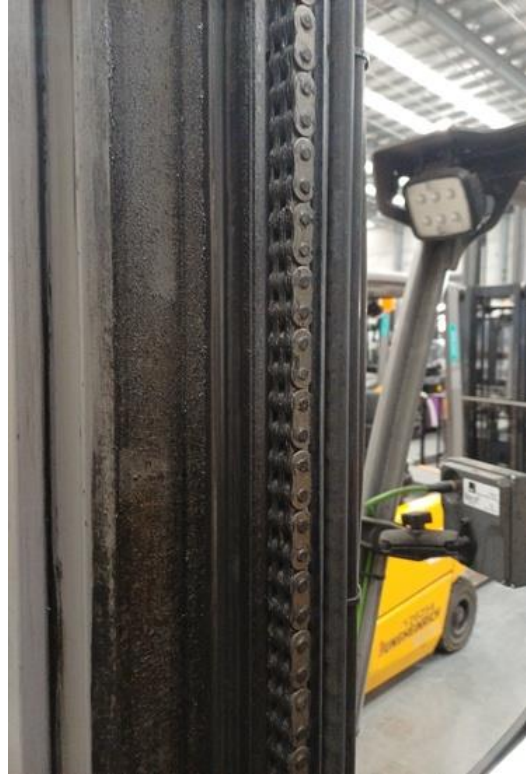
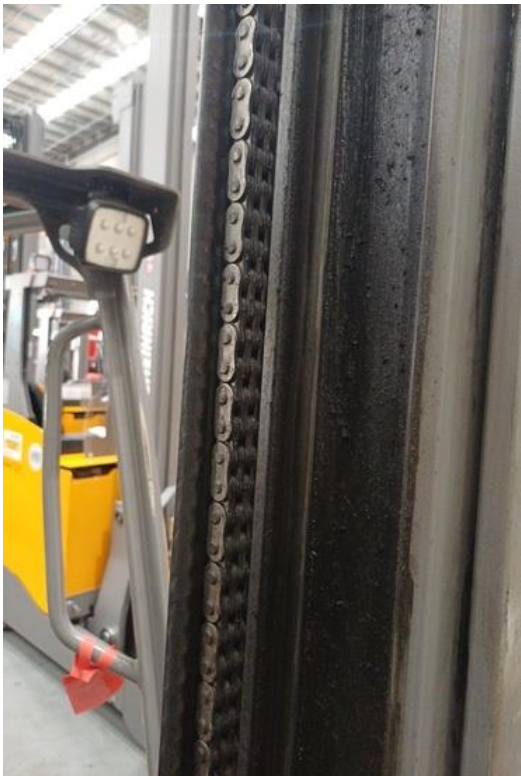
Are all controls inc. lift, tilt & sideshift/auxilliary functions working correctly

Yes

Confirm safety systems not bypassed or malfunctioning?

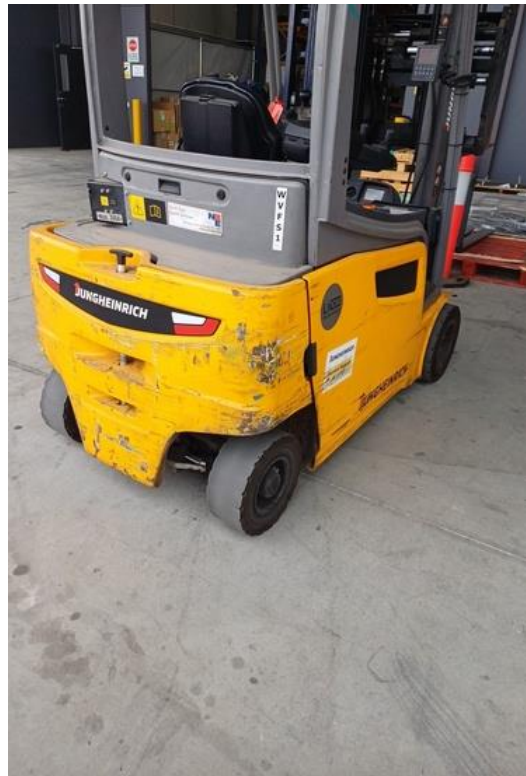
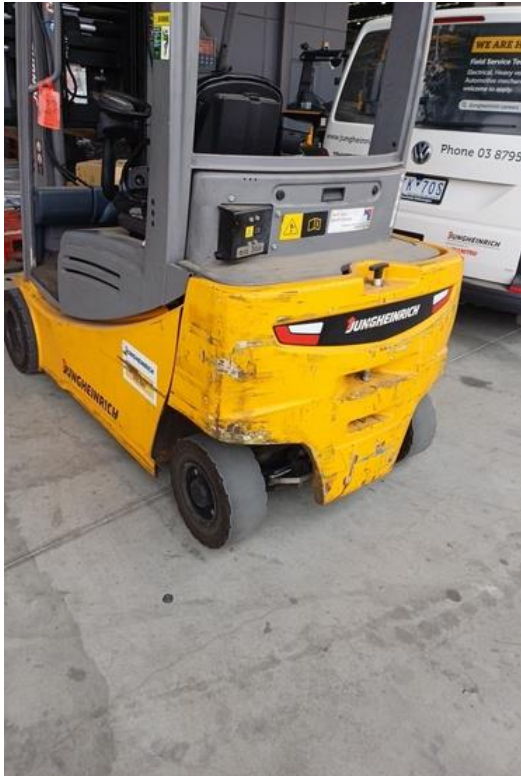
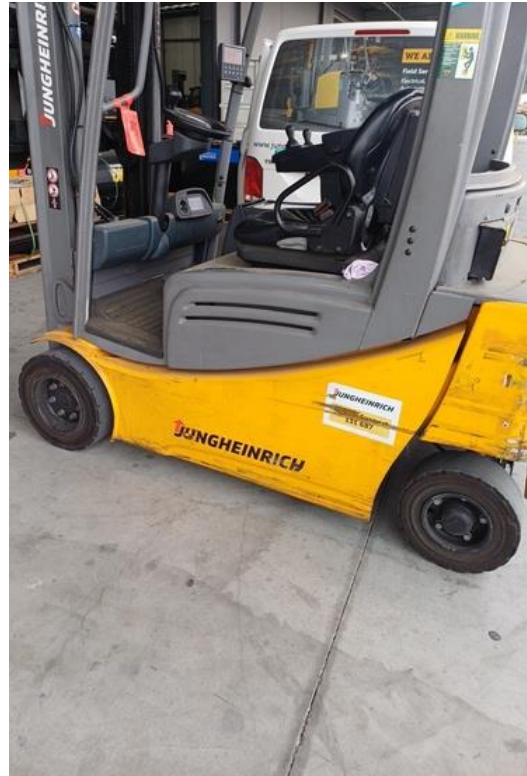
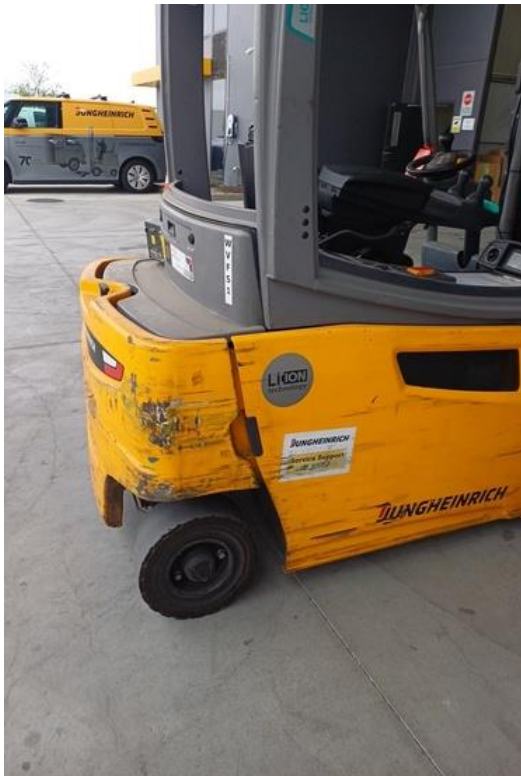
Tynes just under limit, carriage play, steer end bit play.
