## De-Hire Inspection Check

31/05/2025 / 383030 / Sydney / UE / Battery Electric / FN500192 /  
Artemio Drio

| Serial Number | FN500192 |

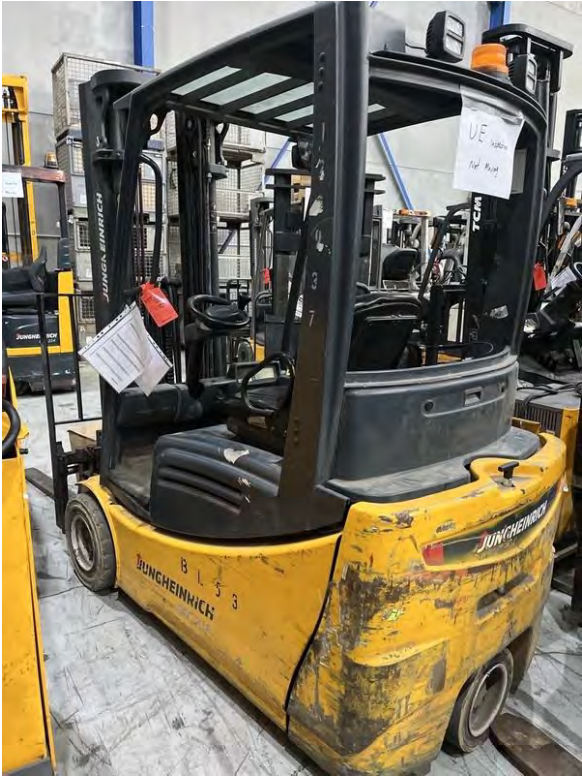
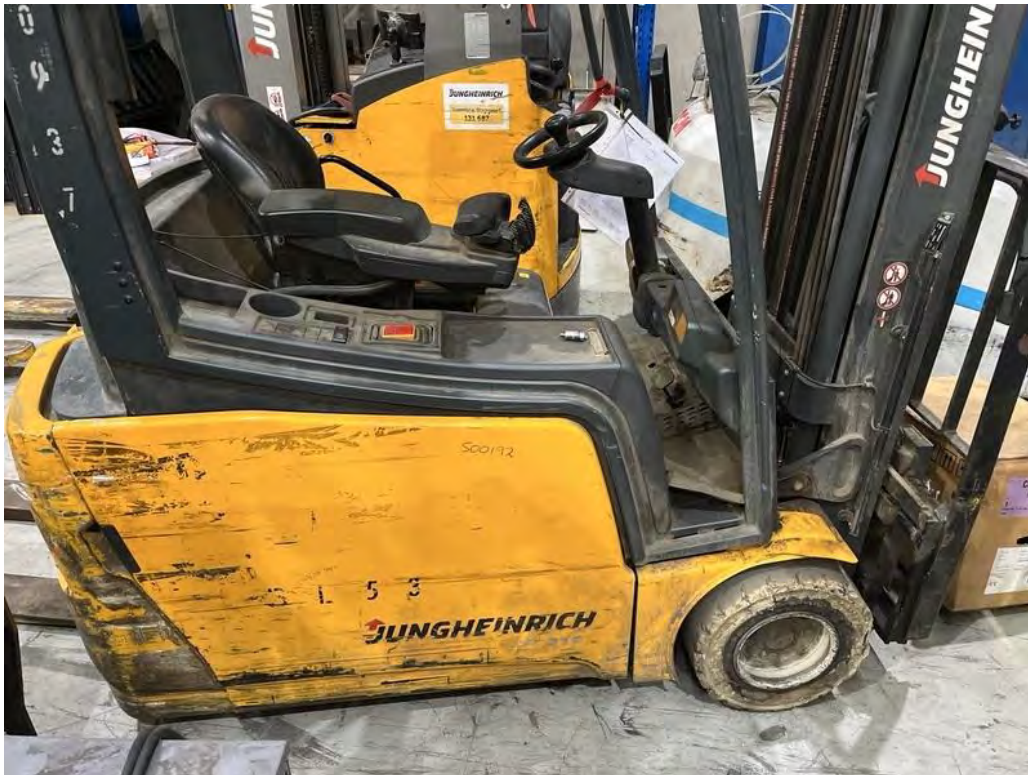
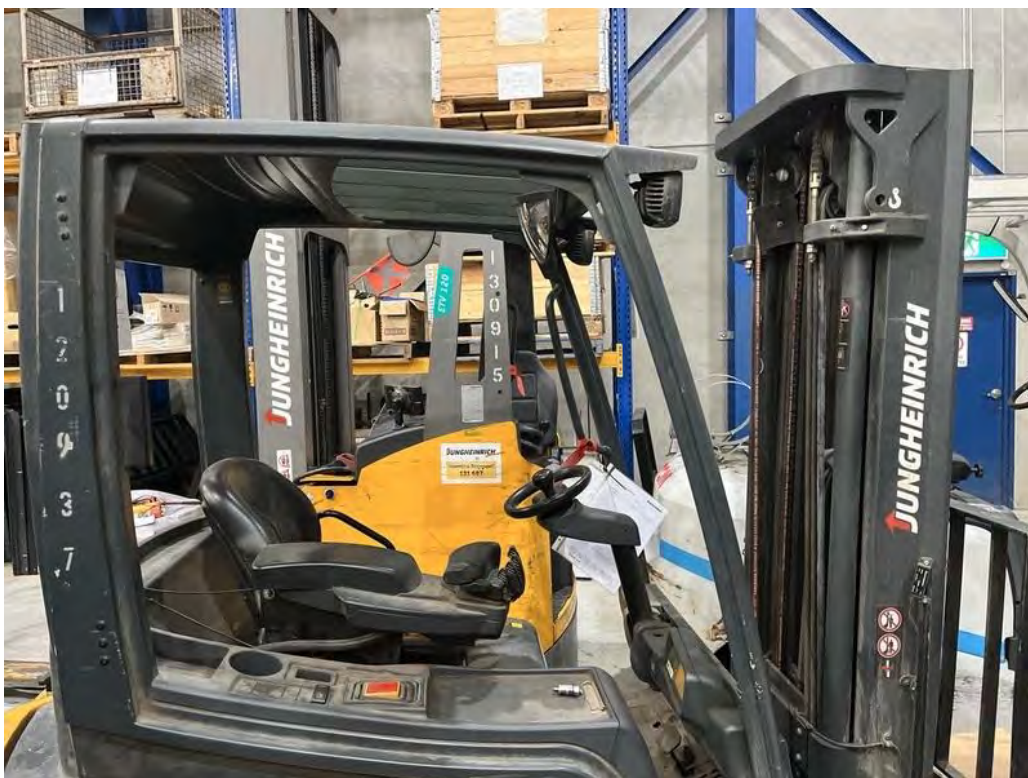
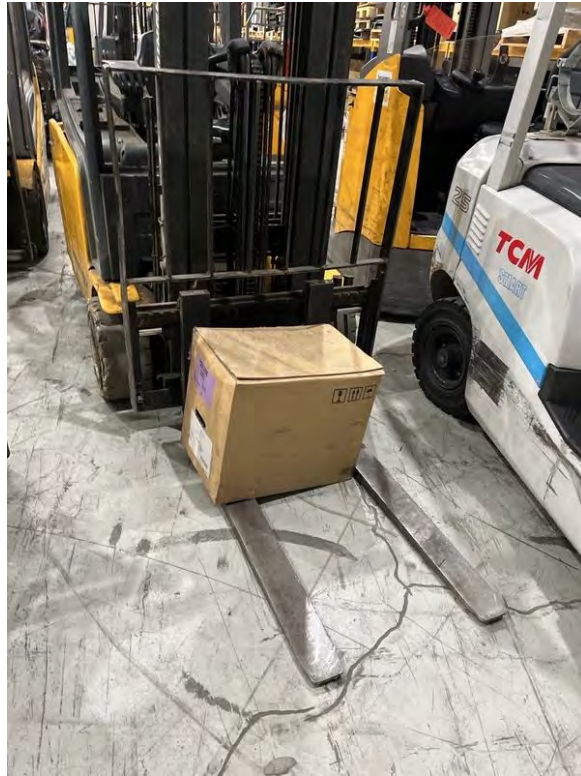
WEAR & TEAR

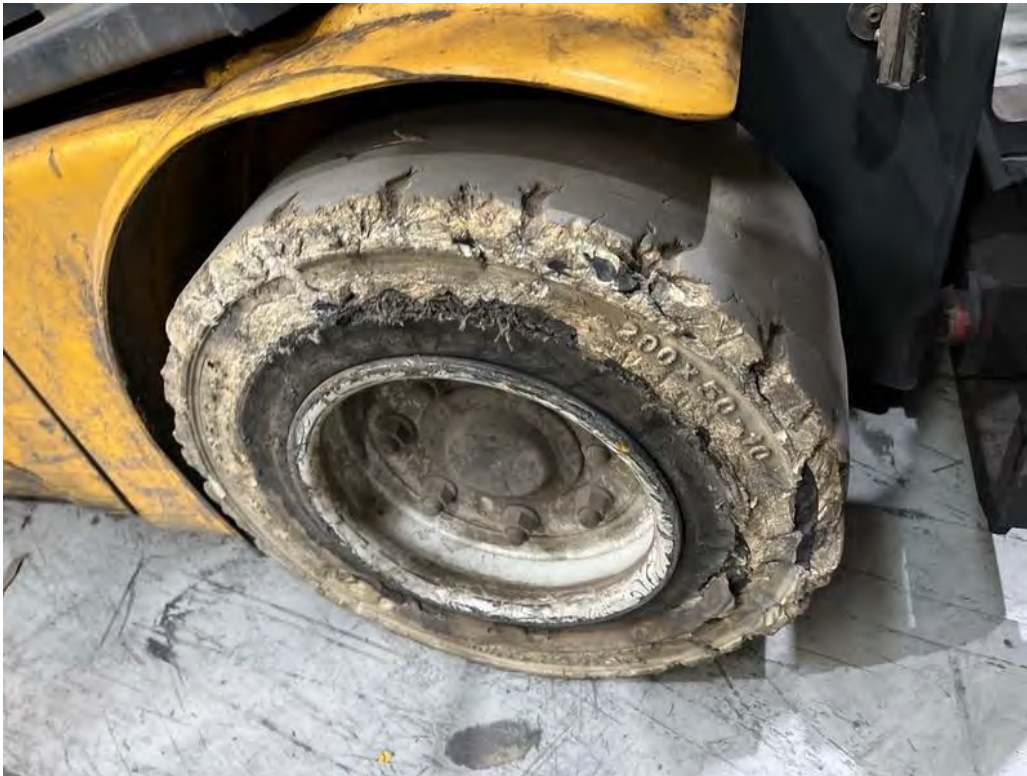
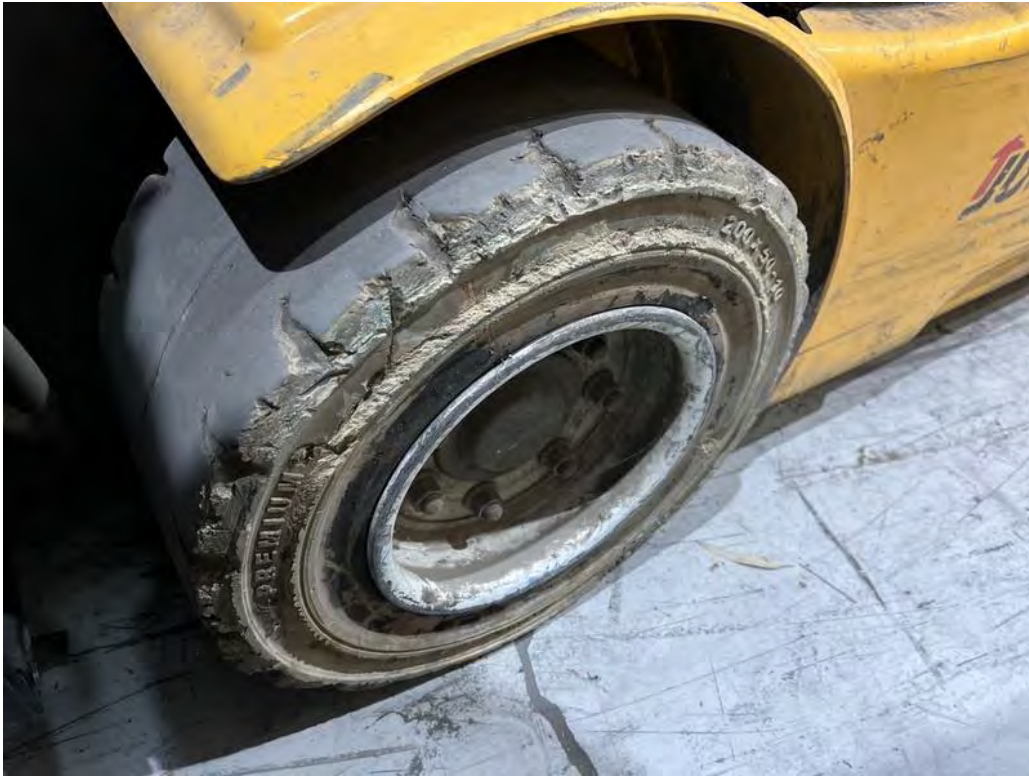
WEAR & TEAR

Chassis paint bad  
Front tyres worn  
Rear tyres worn  
Load guard bent  
Battery door lock defective  
Mast switch broken

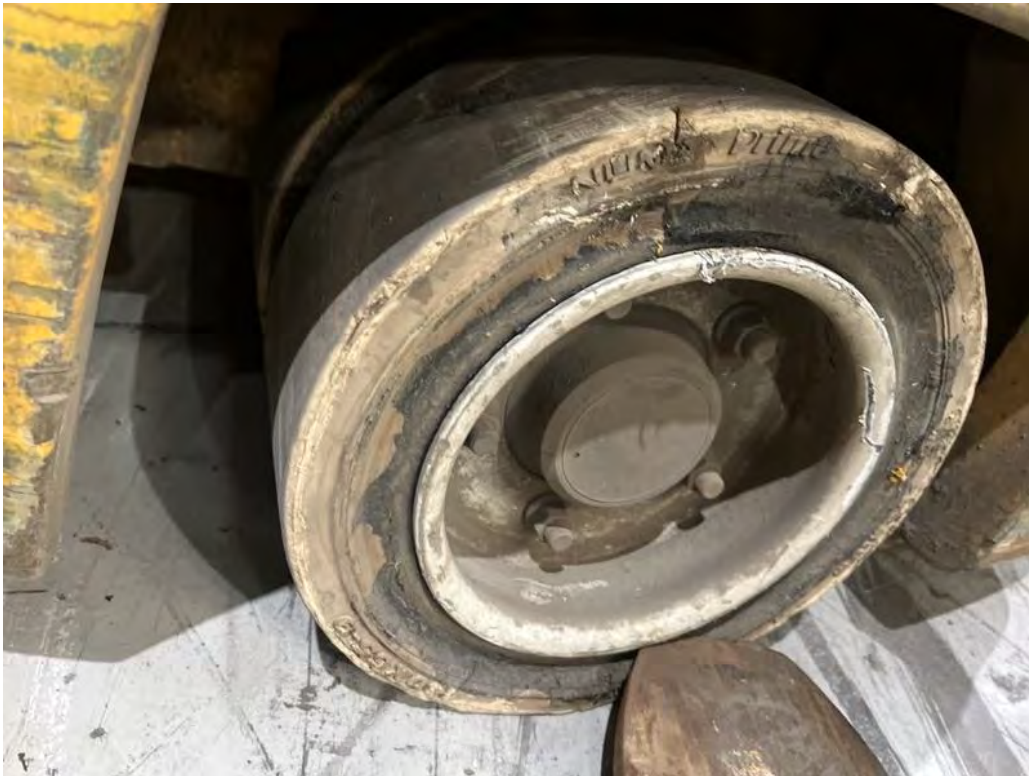
Photo 10

WEAR & TEAR

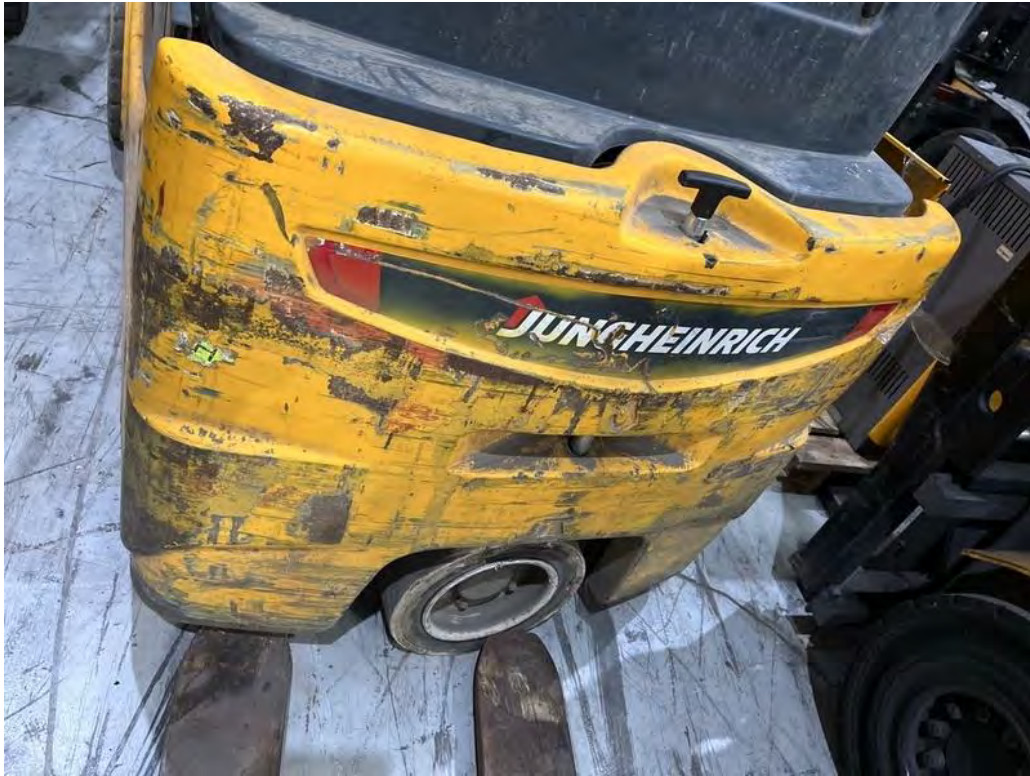
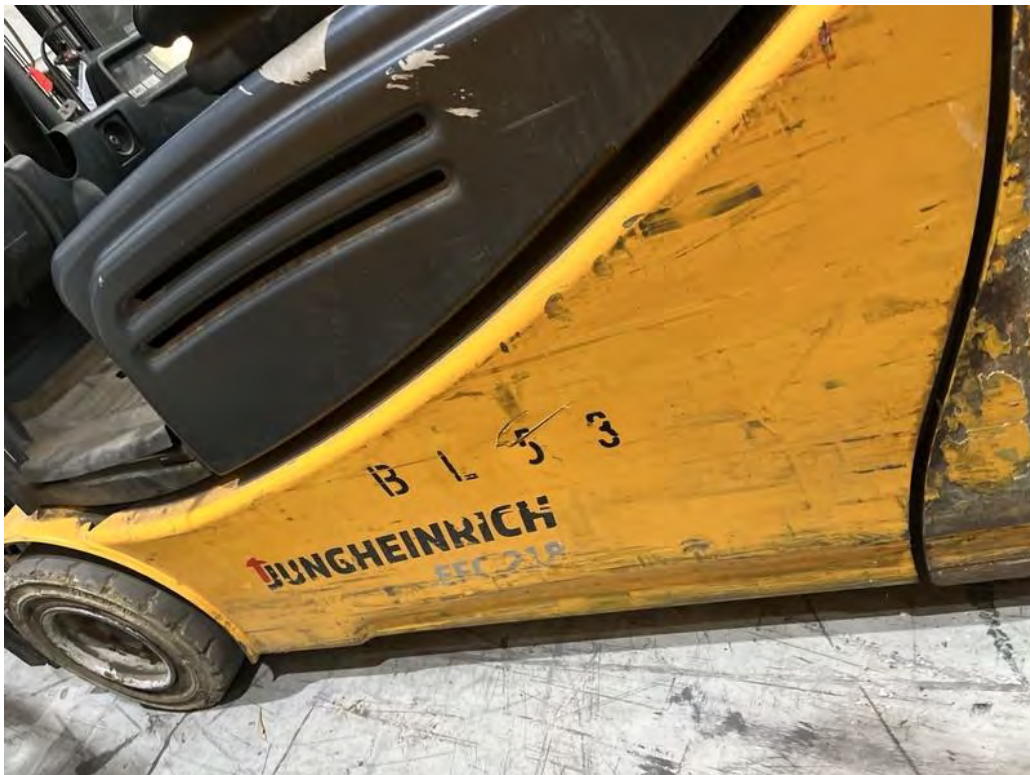
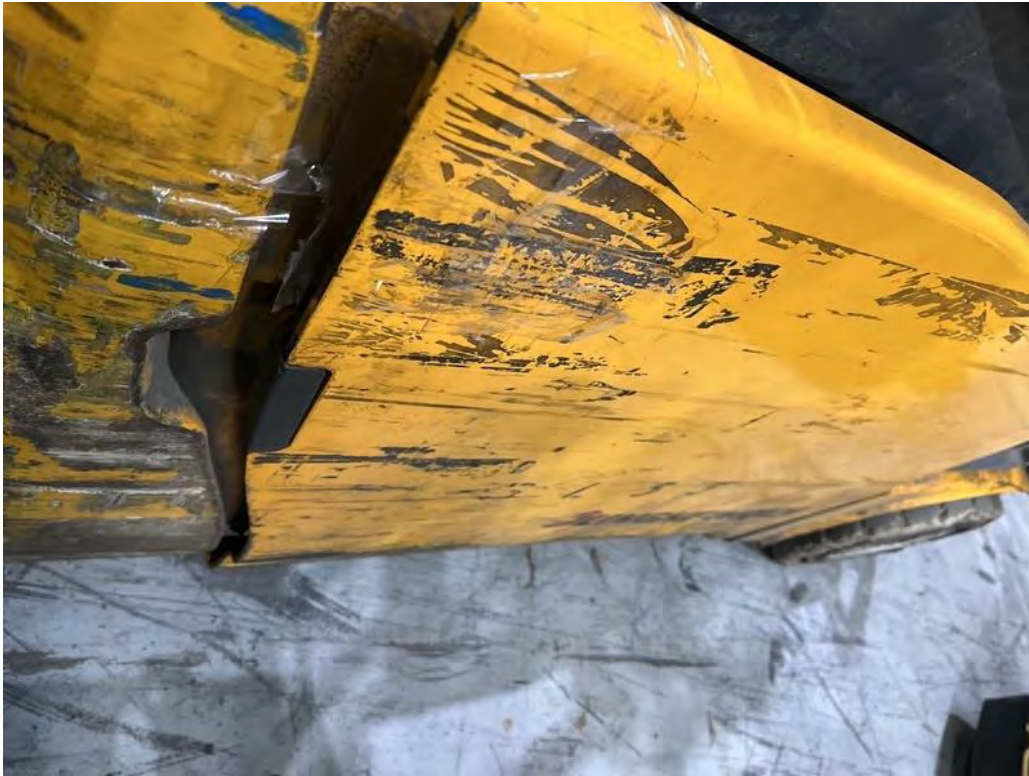
Rust every where on the counter weight . Scratches around truck .

WEAR & TEAR

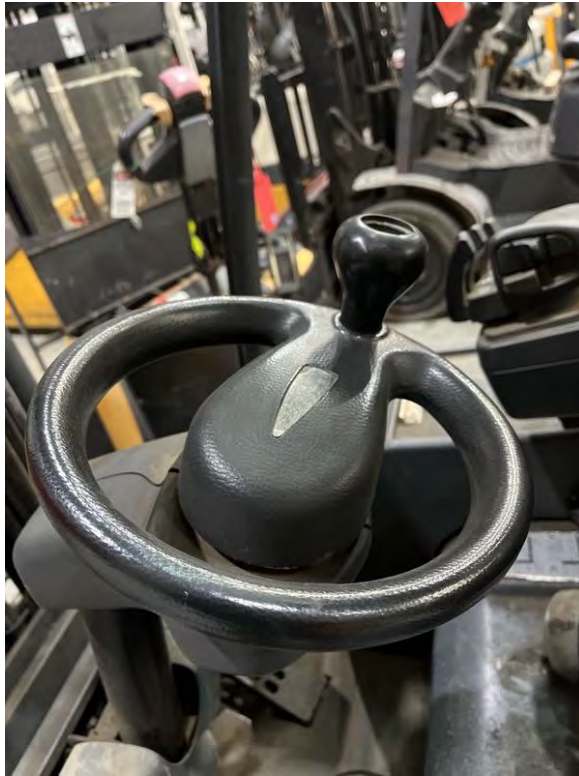
Photo 19

Machine inoperational . Squeaking noise when wheel turned .

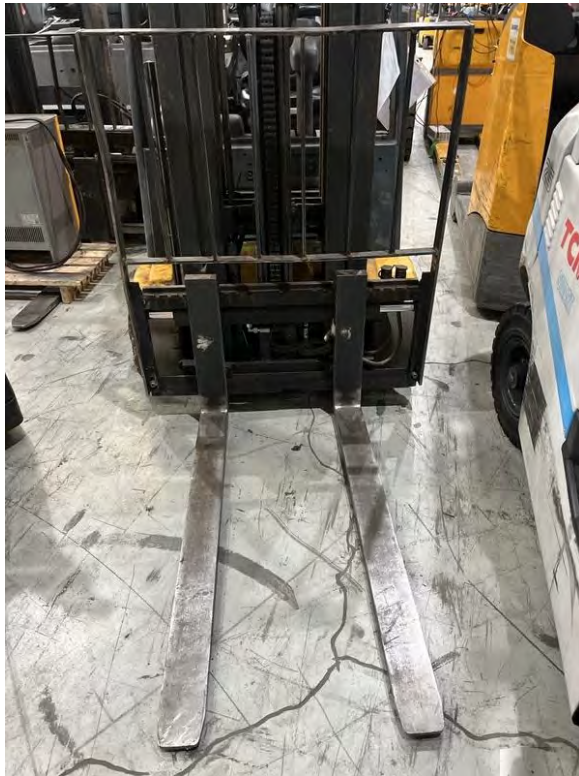
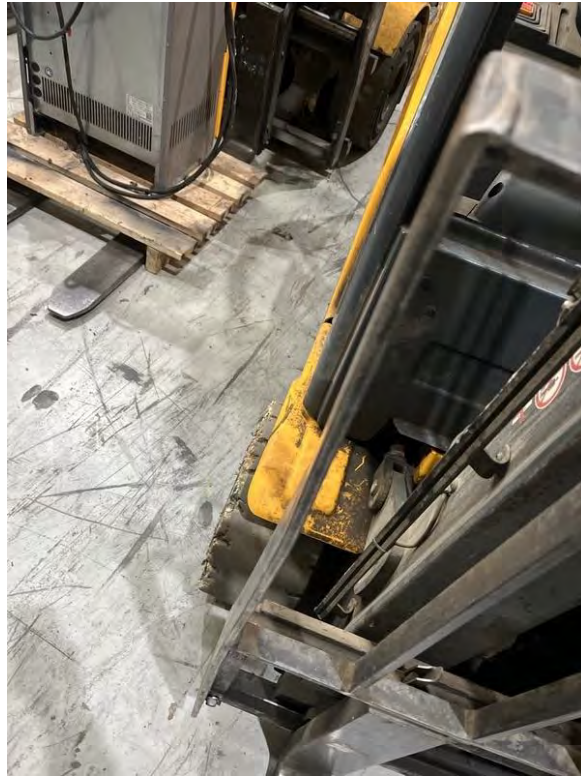
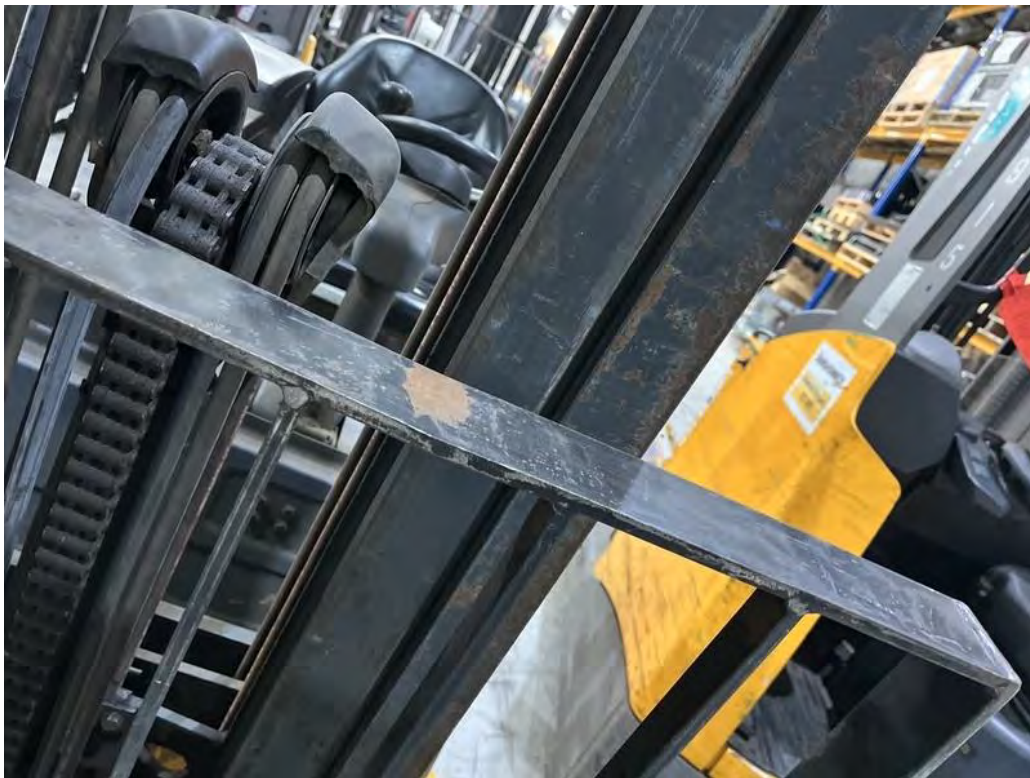
Slight bent on loadguard.

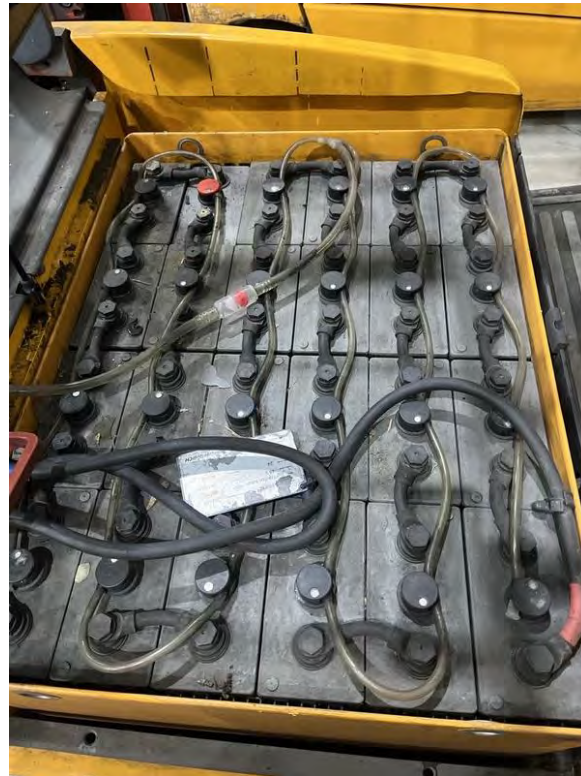
Photo 40

WEAR & TEAR

Initially found unit and 40v charge and unit inoperational . Put it on charge for an hour, battery indication still flat but most functions already working .

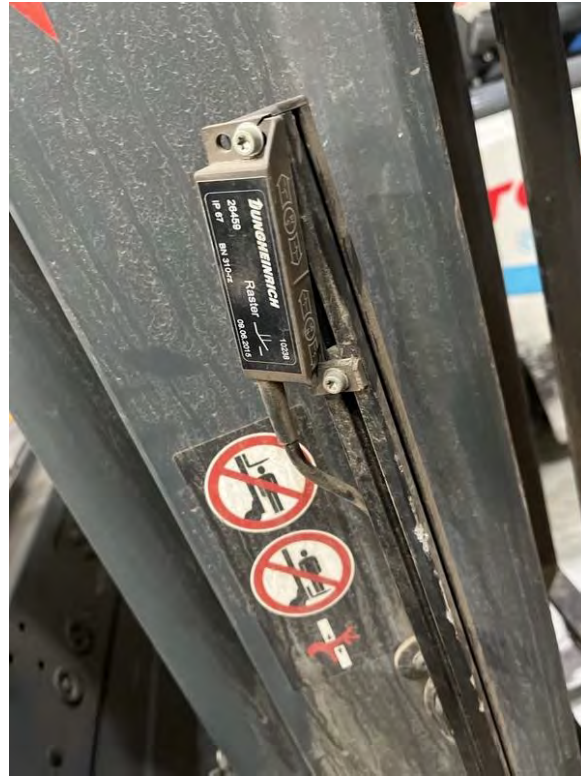
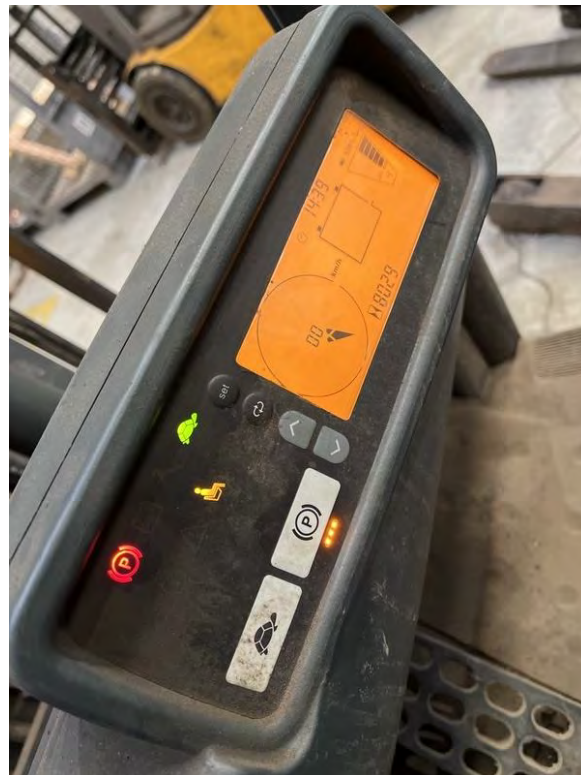
Battery extremely flat . Broken mast switch . Door lock not latching in. Found unit with 40v charge, put it on charge for an hour , bdi still shows flat battery.
