Pre-Purchase Inspection

Hattarass, 64 Pilothouse, 1984

PPS230510

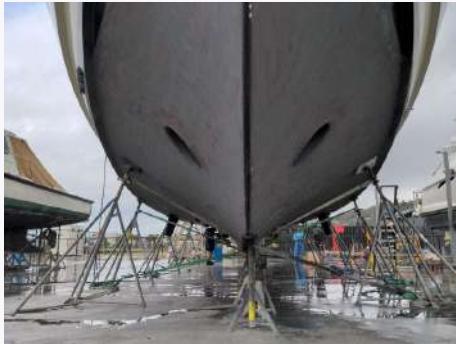
Ref # 2.1

Ref	Item	Material / Construction	Condition	Comments
2.1	Hull Bottom	FRP Composite	Sound	<p>Semi displacement hull, no signs of previous repair, stress or defect was sighted.</p> <p>The antifouling had just been sanded back giving us a good chance to inspect the hull substrate.</p> <p>We did notice some sporadic hull blisters most being around 3-5cm in size, we estimate approximately 20 or so across the hull bottom were sighted.;</p> <p>These blisters appear minor and considered cosmetic shallow blisters only.</p>
2.2	Hard chine	FRP Composite	Sound	Clean and fair edge running along hull, no damage or defects sighted.

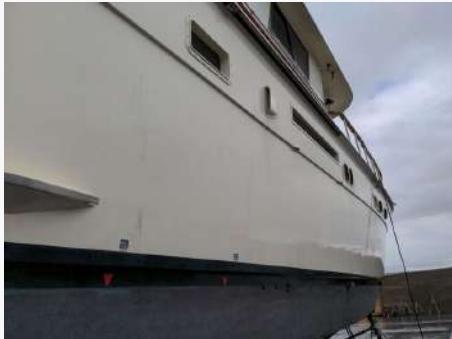
Ref # 3.1

Ref	Item	Material / Construction	Condition	Comments
3.1	Hull side / Topsides	Two Part Polyurethane	Sound	<p>The entire hull topsides appear to have been painted with cream two Part Polyurethane paint or similar.</p> <p>The hull sides displayed a reasonably good gloss and shine, there are some scuffing marks and minor wear and tear in areas to commensurate with age.</p>
3.2	Gunnel	FRP Molding with Stainless Insert	Fair	<p>Hull integral gunnel moulding with stainless steel belting strip, there is a small section missing on the port side midships.</p> <p>C: Low Priority (Cosmetic or Superficial)</p>
3.3	Bow Stem	FRP Composite	Sound	No damage

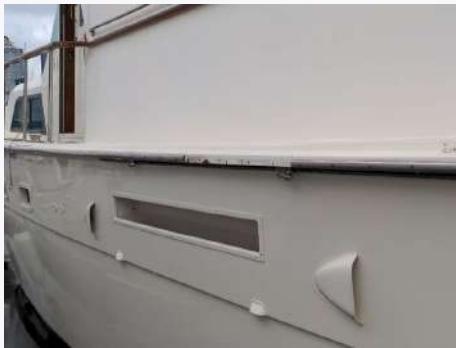
Ref # 3.2 - Section of gunnel strip missing

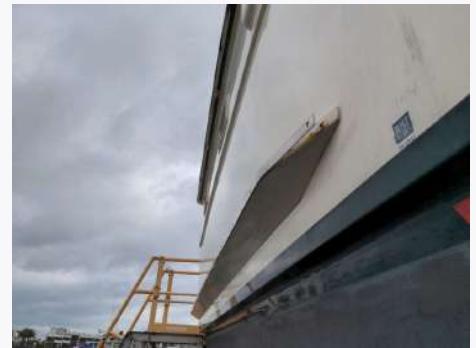
3.4	Sponson	Timber	Sound	Hardwood painted timber sponson with belting strip, a section the belting strip has come away on the starboard side.
3.5	Skin Fittings	Bronze	Sound	Suitably installed, many near the waterline have covers fitted.
3.6	Boot stripe	Painted Green	Sound	Painted green bootstripe, no notable wear sighted.
3.7	Swim platform	FRP Composite	Fair	FRP composite cored platform affixed to the stern with 6 stainless steel support struts, finished with non-skid gelcoat. There is damage to the centre of swim platform consistent with docking contact damage. B: Medium Priority (Service or Maintenance Item)

Ref # 3.4 - Sponson strip loose.

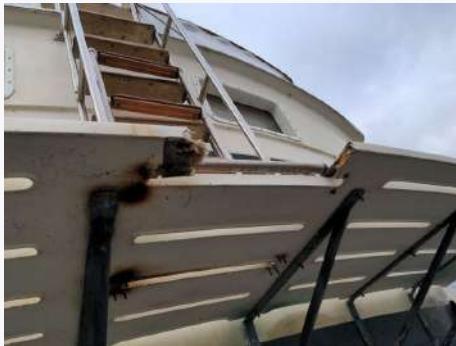
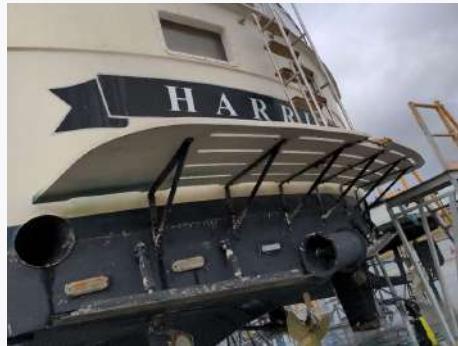
Ref # 3.7 - Swim platform condition

B: Medium Priority (Service or Maintenance Item)		
Ref	Responsibility	Comments
3.7 Hull Condition (Above Waterline) » Swim platform	N/A	<p>There is damage to the centre of swim platform consistent with docking contact damage.</p>

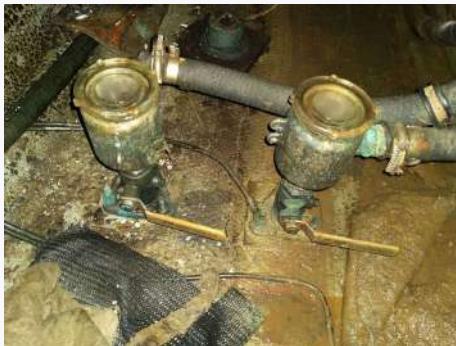
Ref # 4.1

Ref	Item	Material / Construction	Condition	Comments
4.1	Seacocks	Bronze or similar	Sound	<p>All were exercised, however some were quite stiff.;</p> <p>Most display signs of minor surface patina to some valves, however due to the dirty condition of the bilge and most valves and fittings were partially covered in debris.;</p> <p>It is recommended all seacocks be regularly inspected and excised monthly.</p>
4.2	Intake Grills	Bronze or similar on	Sound	Appeared clear and unobstructed.

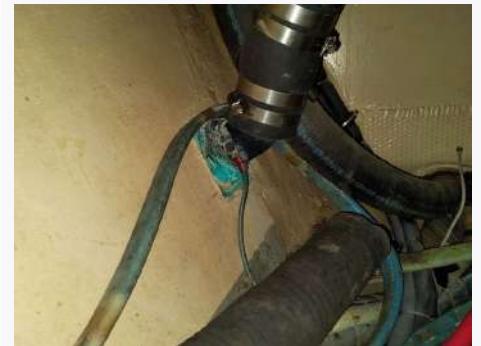
Ref # 4.3

4.3	Skin Fittings	Bronze or similar	Fair	Some skin fittings, particularly above the waterline shows signs of Patina corrosion. Any skin fittings displaying signs of corrosion should be scheduled for replacement. B: Medium Priority (Service or Maintenance Item)
4.4	Transducers / Speed Logs	Thru-Hull Type	Sound	Appeared to be suitably installed.
4.5	Sea Strainers	Perko Type	Poor	The sea strainers under the floor just aft of the utility space (laundry) display signs of build-up, all sea strainers aboard appear due for service. The hoses running's from these strainers are also in poor condition and due for replacement A: High Priority (Rectification Required)

4.3 Seacocks / Thru-hulls » Skin Fittings	N/A	<p>Some skin fittings, particularly above the waterline shows signs of Patina corrosion.</p> <p>Any skin fittings displaying signs of corrosion should be scheduled for replacement.;</p>

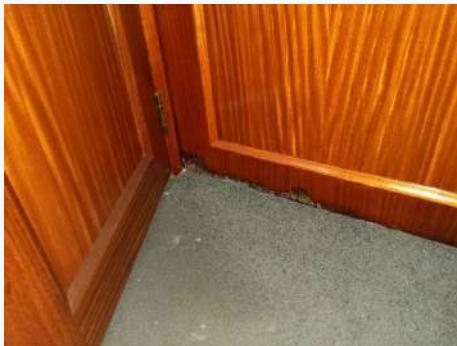
Ref # 6.4 - water stain rear cabin near head

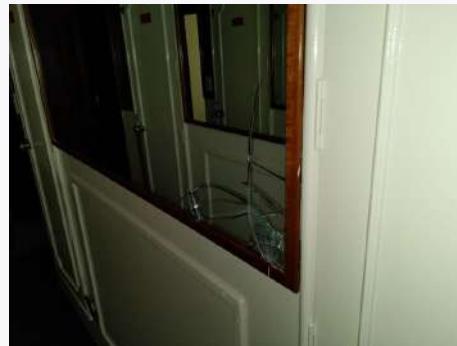
Ref # 6.4 - Broken mirror between engine spaces

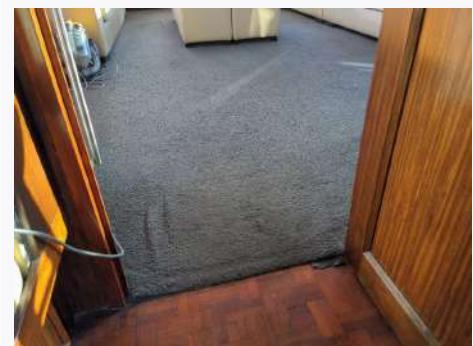
6.7	Cabin Sole	Career / Parquetry	Sound	Parquetry flooring in galley and helm, appear reasonably solid and sound with some wear and tear. A section appears to be sanded back as test piece.
6.8	Doors & Handles	Stainless Steel	Sound	Blue carpet in cabins and saloon, mostly clean with some stains and wear present in some areas, particularly the rear cabin which would benefit from a clean.
6.9	Galley Fitout	Laminated Veneer	Good	In good usable condition, appears to have been upgraded at some stage.
6.10	Benchtops	Stone or similar	Good	No notable wear.
6.11	Seating & Upholstery	Leather	Sound	Cream leather U-shaped dinette with two cream lounges in saloon, no notable wear sighted.
6.12	Bedding	Foam Base	Sound	Appear in reasonable condition.; Port side cabin is used for storage, we inspected this cabin as best of possible without removing all contents.

Ref # 6.7 - Carpet condition

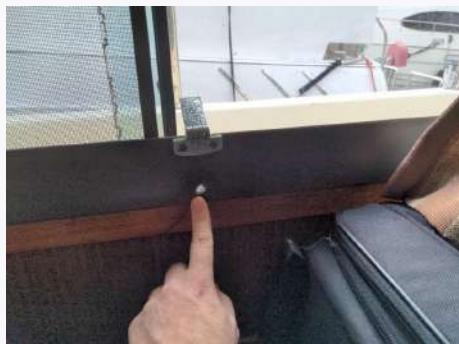
Ref # 7.7 - Corrosion hole in port side window bezel.

7.7 Deck, Hardware & Fittings » Windows	N/A	<p>Multiple sectional tempered glass helm windows surround the helm with acrylic curved side panels which have some crazing present.</p> <p>The sealant around the helm windows are showing signs of deterioration with signs of slight weeping in some areas.</p> <p>Window wipers powered-up, blades appear worn.</p> <p>Small corrosive hole to window frame in port forward cabin.;</p> <p>There is a crack to one window pane on the port side saloon.;</p> <p>The windows do appear to require sealing in some areas and maintenance.</p>

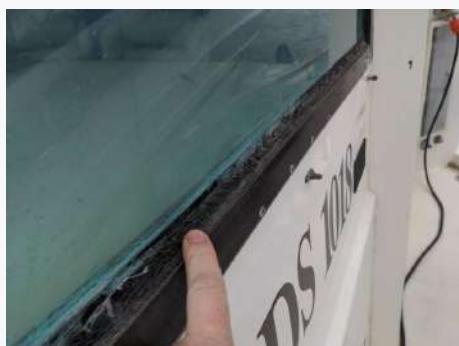
Ref # 7.7 - Sealant worn on some windows

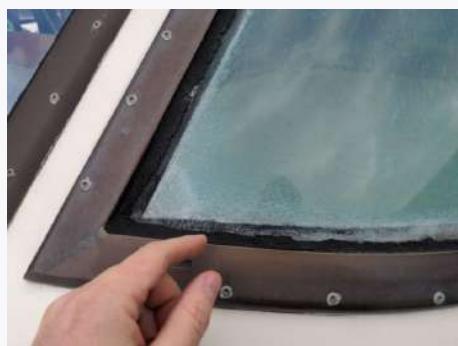
Ref # 7.7 - Crazing to curved window.

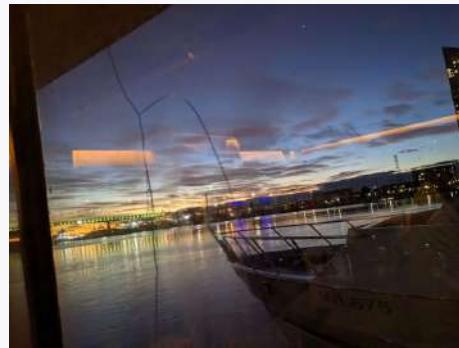
Ref # 7.7 - Crack in saloon window.

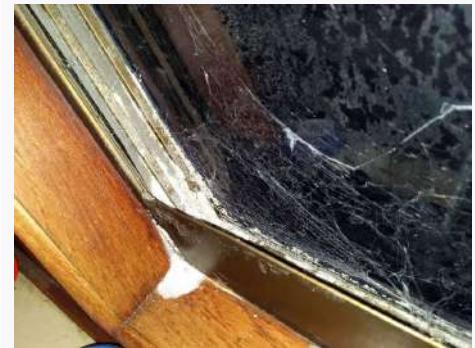
Ref # 7.7 - Build-up around saloon widow.

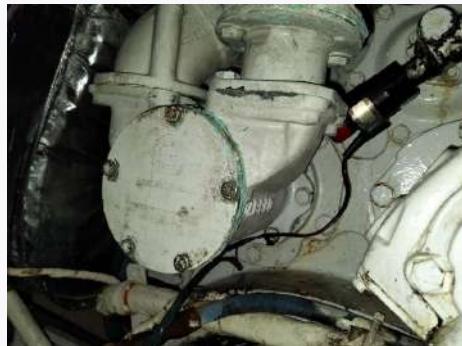
8.15	Blowers / Ventilation	12-volt	Sound	12-volt bilge blowers fitted.
8.16	Engine Oil	Oil	Sound	Appeared at normal levels and colour.
8.17	Raw water pump	Impeller Pump	Sound	Appear serviceable, no notable leaks.

Ref # 8.17 - Water pump condition

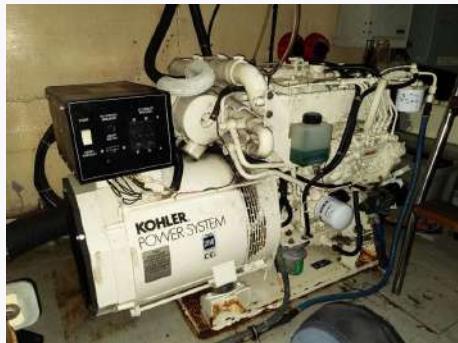
Ref	Item	Type / Make	Condition	Comments
12.1	Type	Onan 4KVA	Sound	<p>There are two Gensets aboard, however only one is said to be operational.</p> <p>We did not test the older 20kw Kohler Genset as it has not been started in sometime and not required for ships supply.</p> <p>The tested Genset was a Kohler 21kw fresh water cooled diesel genset.</p>
12.1.1	- Genset Hours	Analogue Gauge	Sound	Genset gauge is reading 2436 hours
12.2	External Case / Bottom Tray	Steel	Sound	No external case, only minor corrosion to bottom tray.
12.3	Cooling System	Closed / Fresh water	Fair	Some hoses showing signs of wear, the raw water intake feed hose was unconventional but functional.
12.4	Heat Exchanger	Metal	Sound	Some minor build-up around end caps.
12.5	Hoses and Fittings	Reinforced Marine Hose	Fair	Appeared sound.
12.6	Exhaust	Reinforced Marine Hose	Sound	Exits hull on port side.

Ref # 12.1 - Tested genset

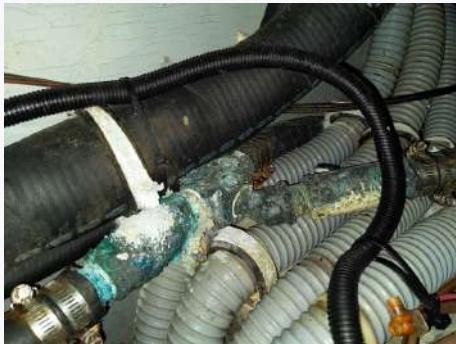
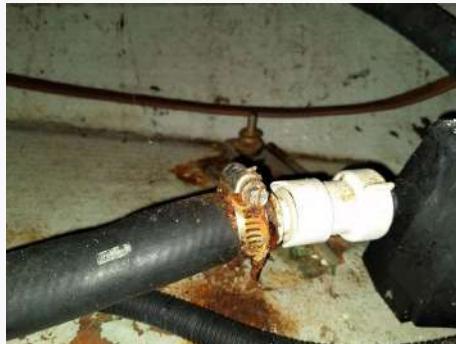
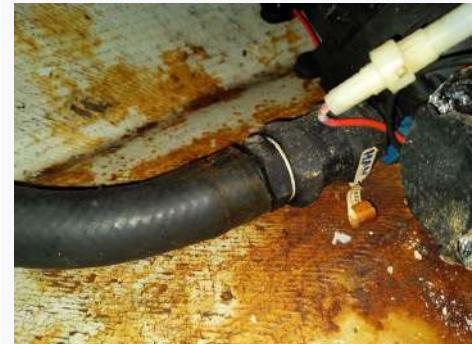
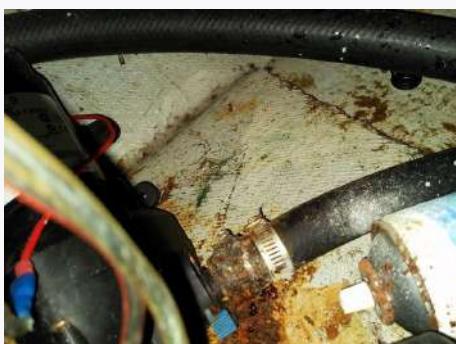
13.3	Accumulator	5 litre	Sound	No leaks sighted.
13.4	Plumbing / Hose	Various	Fair	<p>Combination of copper piper and reinforced hose.</p> <p>The plumbing systems and hoses are showing signs of wear and deterioration.</p> <p>There are hose clamps corroding or missing along with corrosion to joiners in areas.</p> <p>The entire onboard plumbing system appears to have been repaired and "band-aided" over the years.</p> <p>Ideally, the entire onboard plumbing system appears due for service by a suitably qualified marine plumber or similarly competent person.</p> <p>B: Medium Priority (Service or Maintenance Item)</p>

Ref # 13.4 - Plumbing system condition

Ref # 13.4 - Plumbing system condition (no hose clamp)

13.4 Plumbing Systems » Plumbing / Hose	N/A	<p>Combination of copper pipe and reinforced hose.</p> <p>The plumbing systems and hoses are showing signs of wear and deterioration.</p> <p>There are hose clamps corroding or missing along with corrosion to joiners in areas.</p> <p>The entire onboard plumbing system appears to have been repaired and "band-aided" over the years.</p> <p>Ideally, the entire onboard plumbing system appears due for service by a suitably qualified marine plumber or similarly competent person.;</p>

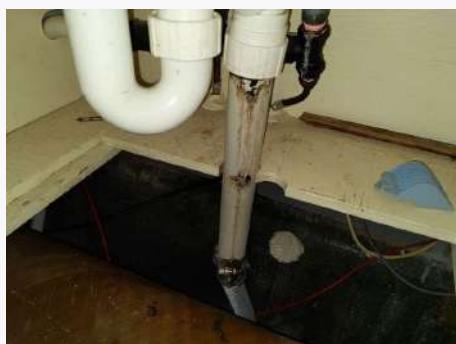
13. Plumbing Systems (Cont.)				
13.8	Sinks	Stainless Steel	Sound	<p>Sink drain in rear head linking, needs to be rectified.</p> <p>Forward starboard head sink plumbing leaking</p> <p>B: Medium Priority (Service or Maintenance item)</p>

Ref # 13.8 - Leaking rear head sink

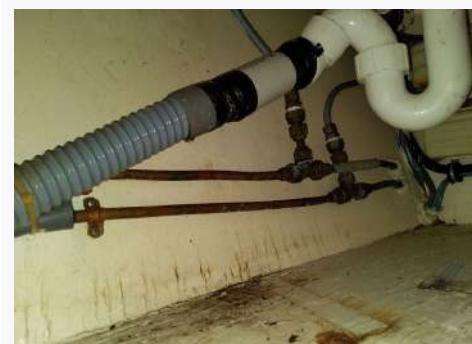
Ref # 13.8 - Leaking starboard head sink

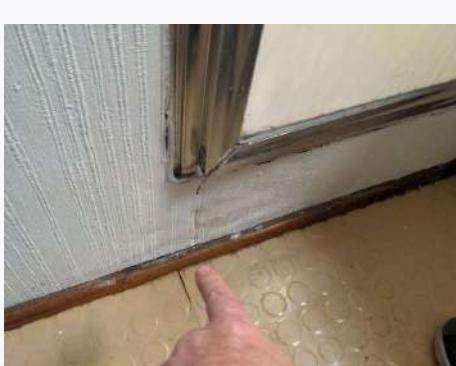
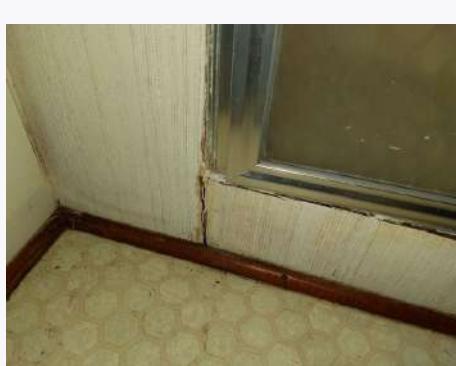
13.9	Showers	Head Shower	Fair	<p>Showers fitted in each head, functional</p> <p>There is some water damage to shower surrounds below shower doors</p> <p>C: Low Priority (Cosmetic or Superficial)</p>

Ref # 13.9 - Shower frame

13.9 Plumbing Systems » Showers	N/A	There is some water damage to shower surrounds below shower doors;

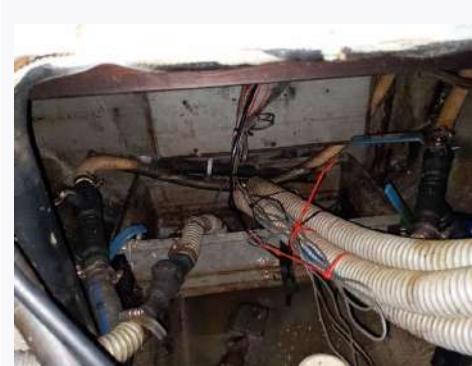
13.10	Shower Drainage	32-volt	Poor	<p>Shower drains into sump box, discharging overboard via 32-volt pump.</p> <p>Sump box are in poor condition, pumps do not work, hoses are deteriorated, lids for sumps missing.</p> <p>Recommend they are all repaired and/replaced.</p> <p>B: Medium Priority (Service or Maintenance item)</p>

Ref # 13.10 - Shower sump condition

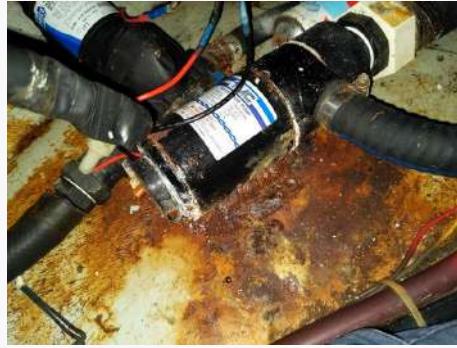
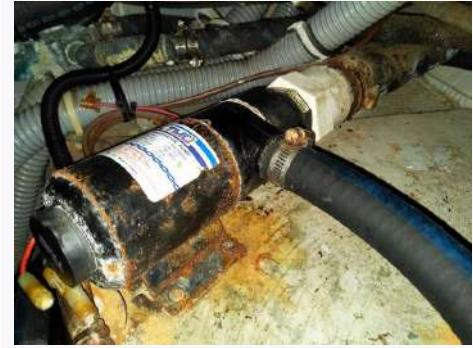
13.12	Toilet Plumbing	Sanitation Hose	Fair	<p>Hose with hose clamps draining into holding tank.</p> <p>Hoses, pumps and hose clamps all showing signs of wear.;</p> <p>Head plumbing and pumps require service.</p> <p>B: Medium Priority (Service or Maintenance item)</p>

Ref # 13.12 - Macerator pump condition

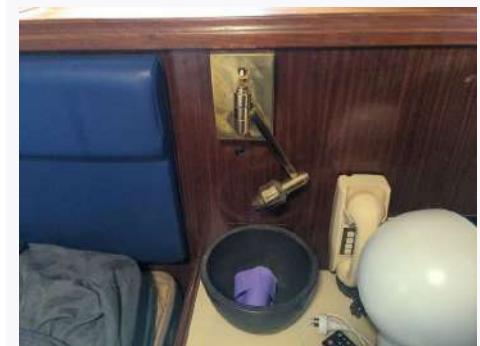
14.4	Interior Lighting	110-volt and 32-volt lighting	Fair	Most powered-up. Rear cabin port side reading light broken.
14.5	Transformers	240 to 120 Transformers	Sound	2 X Step down transformer fitted.

Ref # 14.4 - Reading light broken

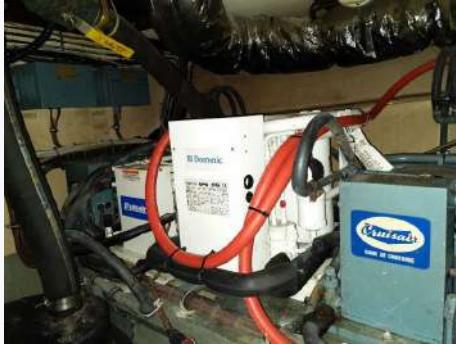
Ref # 15.1

Ref	Item	Type / Make	Condition	Comments
15.1	Type	Cruise Air	Sound	<p>There are seven Air Conditioner condensers fitted, there are 3 Cruiser Air units which appear original and did not power up.</p> <p>There are also two newer Cruise Air units which also did not power up.</p> <p>There is a Dometic and a Marine Air unit, which both powered up and appeared connected to the 2 Dometic digital touch screen displays</p> <p>One services the main saloon and the other serving the rear master cabin.</p>

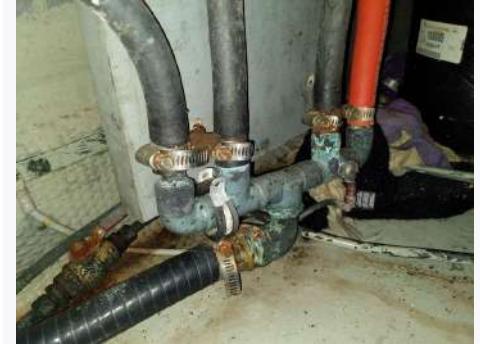
15.2	Ducting	Insulated Ducting	Fair	Appeared servicable, showing signs of wear.
15.3	Hoses	Reinforced Marine Hose	Fair	No leaks sighted, however hoses, connections and clamps are showing signs of wear.

Ref # 15.3 - Air Conditioner intake manifold

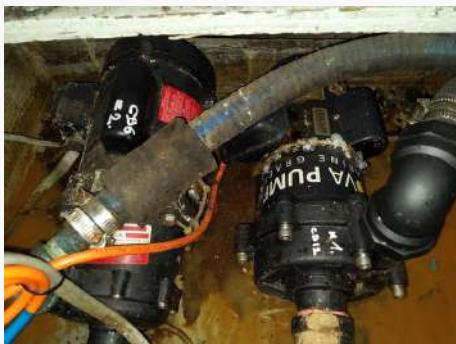
15.6	Cooling Water Flow	Port Side	Poor	<p>No water flow sighted, there appears to be 2 x 240-volt raw water cooling pumps forward of the port engine. Both trip the circuit breakers when powered-up.</p> <p>Plumbing hose on pumps are in poor condition and should be replaced.</p> <p>Pumps are mounted low in the bilge, possibly water affected. ;</p> <p>Further investigation and repair required by technician.</p> <p>B: Medium Priority (Service or Maintenance Item)</p>
------	--------------------	-----------	------	---

Ref # 15.6 - Air Con Pumps

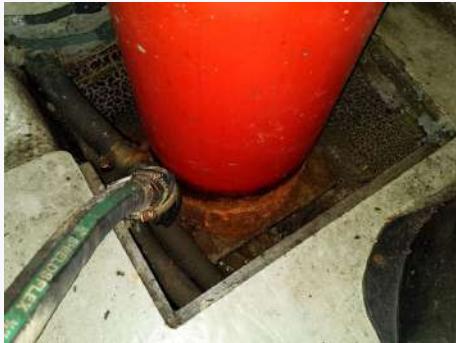
Ref	Safety Gear	Type	Comments
19.1	Life Jackets	Foam PFD type	2 x Inflatable & 18 x Foam sighted.
19.2	Extinguishers	Dry Chemical Type	3 x 4kg, 3 x 1kg, 1 X 2kg
19.3	Fire Suppression	Wormald	Heavy corrosion on cylinder in Genset space, recommend replacement; Update - being replaced with a 9pk handheld Dry chemical by Miller Marine - 28/8/2023, 2 X 45kg Carbon Dioxide cylinder in engine bays. A: High Priority (Rectification Required)
19.4	EPIRB	Safety Alert	Battery Expires: May 2029
19.5	Flares	One set	One set in grab bag, expired.
19.6	Fire Blankets	One Blanket	Found in galley

Ref # 19.3 - Gen Set bay cylinder.
(Corroded)
