# INSURANCE SURVEY FOR GRAHAM ROSE

26/3/2021

**VESSEL:** Halcyon Quest **DESIGN:** Roberts 38 **REGISTRATION:** WE562Q

**LOA:** 11.66 meters **BEAM:** 3.43 meters **DRAFT:** 1.7 meters **BUILT:** 1978

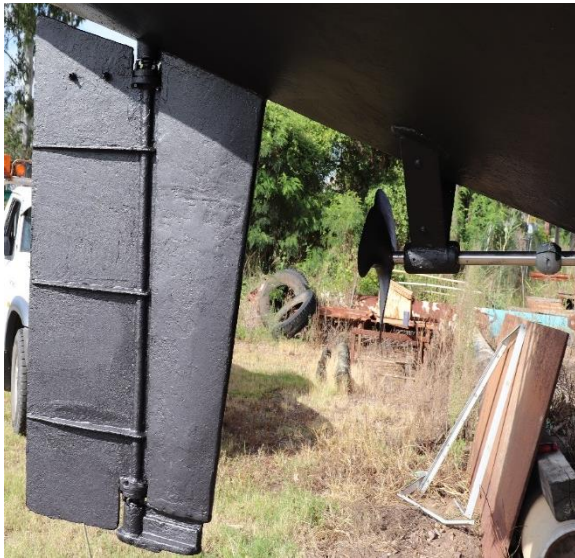
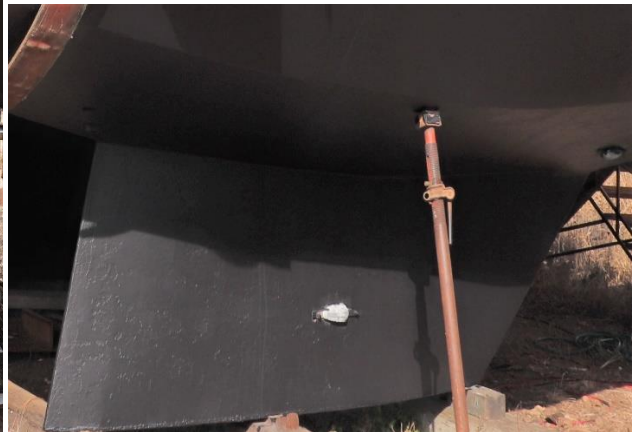
The rudder is well mounted on the skeg. The rudder bearings felt firm when I moved the rudder by hand. The Hydrive hydraulic steering looked in good condition.

There is a three blade bronze propeller mounted on a 1 ¼ inch stainless steel shaft. The cutlass bearing felt firm when I rotated the shaft by hand.

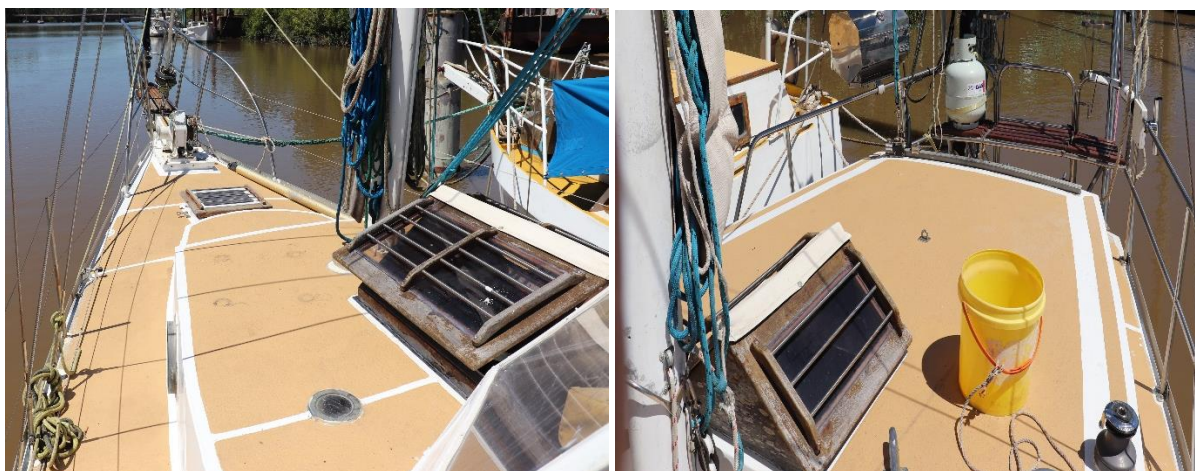
The deck is constructed of steel and is in good condition for its age.

There is a good condition stainless steel toe rail that encompasses the whole yacht.

The cabin windows are bronze portholes and are in good condition.

There are three custom made timber hatches on the deck. All the hatches could do with a new coat of varnish.

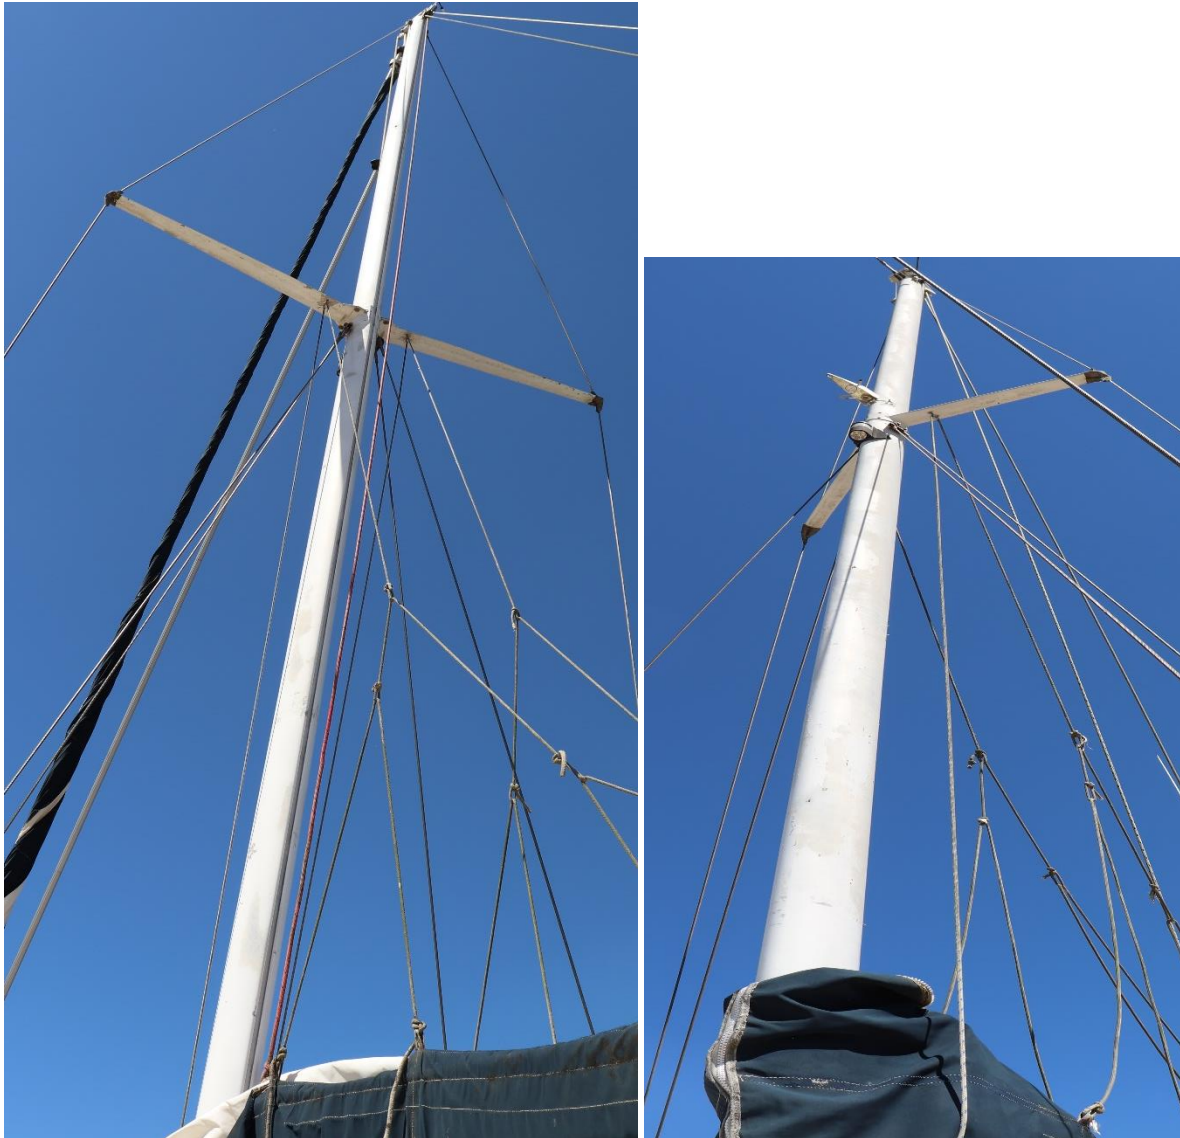
Halcyon Quest is ketch rigged with two aluminium masts that both have aluminium booms and solid boom vang. The masts are deck stepped into aluminium mast step brackets. There is a Profurl furler on the forestay and inner stay. The rigging was replaced in 2015. The chainplates are well welded to the hull structure.

There are two Barlow 25 winches, one Barlow 23 winch, one Barlow 20 winch and one Lewmar self-tailing winch. All sun freely when turned by hand.

There is a mainsail, mizzen sail and two furling headsails. I did not inspect the sails on the day off the survey. The mainsail cover needs repairing.

1. Repair mainsail cover.

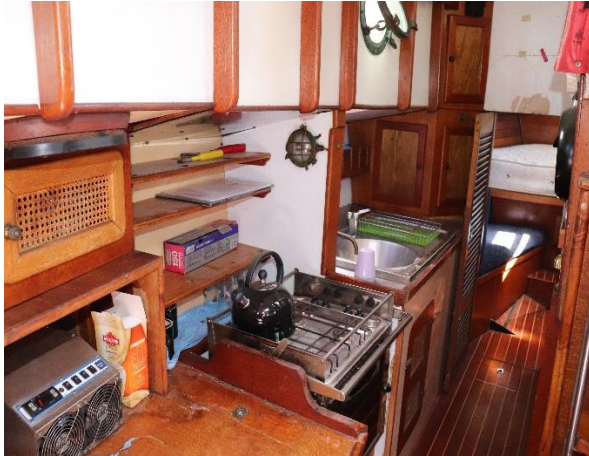
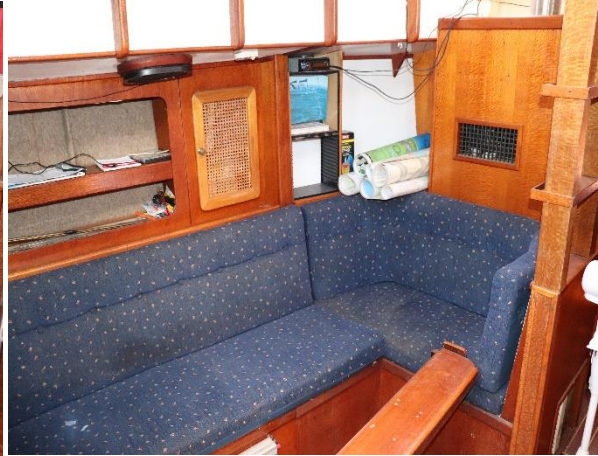
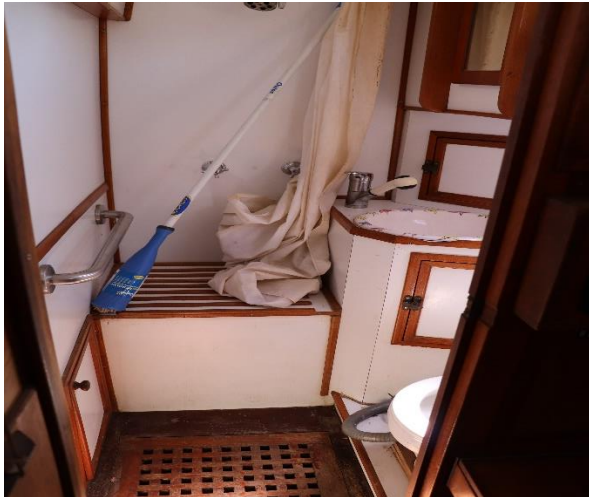
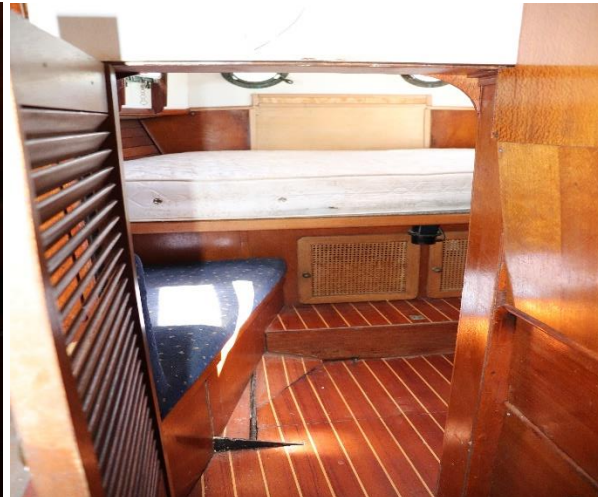
The interior is finished in white paint, varnished trim and panels and blue upholstery. The interior is in good condition for a 43-year-old yacht.

The photos starting from the left-hand side and going clockwise are galley, dinette, aft cabin, and toilet/shower area.

The 25mm x 6mm stringers, 5mm x 4mm frames and bulkheads all look like the day Halcyon Quest was built.

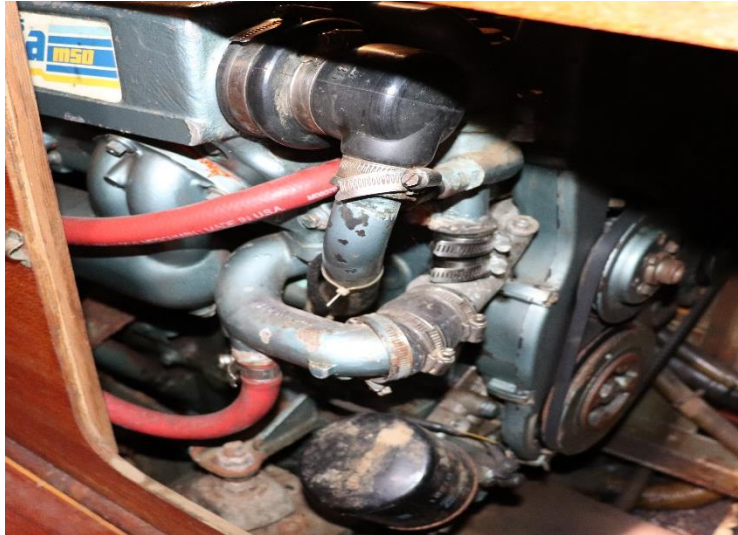
The engine inspection was a visual one, so I am unable to comment on the condition of the internal parts or the correct operation of the engines. There is a four-cylinder 50hp Perkins Prima diesel engine under the cockpit floor. There is 2,226 hours on the clock. There is a PSS seal on the shaft and new flexible coupling.

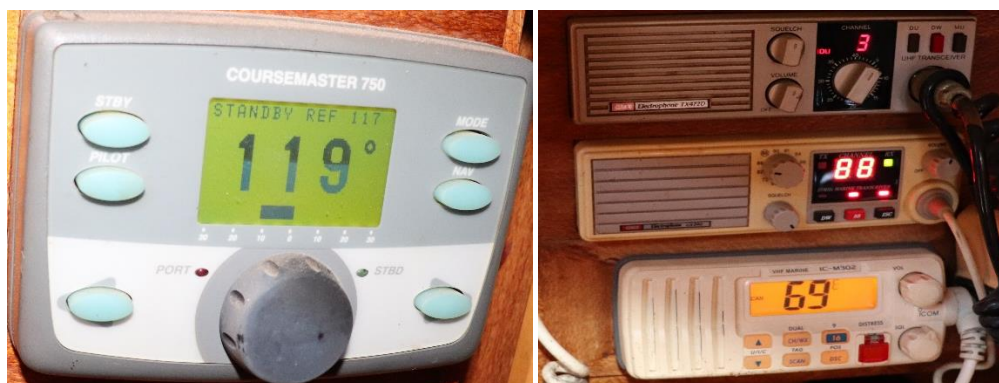
The 12-volt electrical installations are all fitted with fuses which appear to be functioning correctly.

There are two well secured deep cycle house batteries under the dinette seat and two start batteries under the companionway step.

There is a Course Master 750 autopilot. ICOM VHF, two GME 27 meg radios, two solar panels and solar regulator.
