## Insurance Survey- Cruiser

Inspected by: James Brooks  
On 28 October 2023  
Cammeray Marina NSW  
Australia

Builder	Model	LOA
Sea Ray	Fly Bridge Sedan	30' – 9.15M

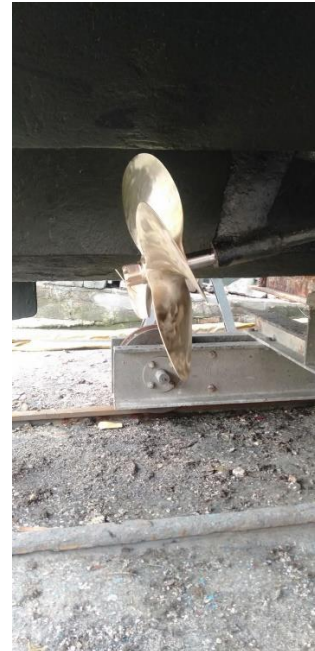
Note: 1. Starboard engine inlet new 25/10/23  
2. Rudders and propellers were replaced.

New propellers

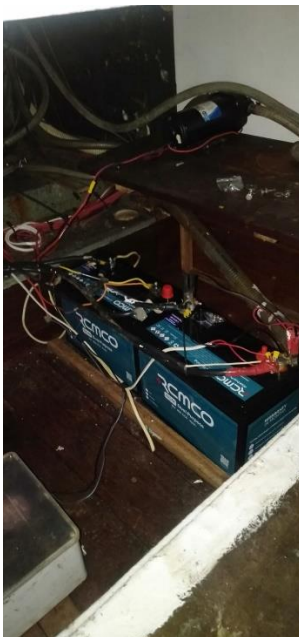
Batteries need strapping down

*RECOMMENDATIONS: Batteries should be strapped down.*

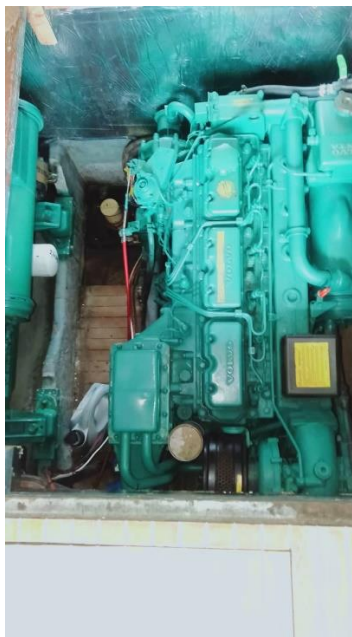
Engines

Components	Accept	Decline	N/A	Comments
Visual condition of engine	✓			Good
Venting and blowers	✓			Operational
Fuel tanks	✓			Stainless steel, good condition
Fuel lines	✓			Good condition
Signs of oil leaks	✓			No fluid leaks
