De-Hire Inspection Check

30/01/2026 / 406479 / Sydney / STR / Yes / Yes / 1x Seat cushion
Painting / 2.5 / Yes / 1xfloor spot bracket
1xcharger cable
1x320amp plug / 0.5 / FN500193 / Artemio Drio

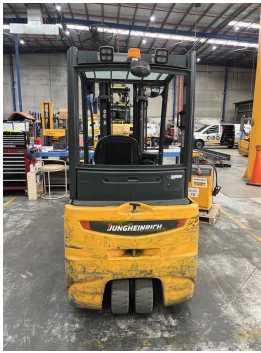
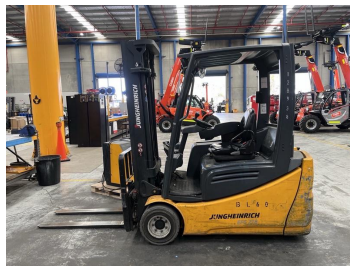
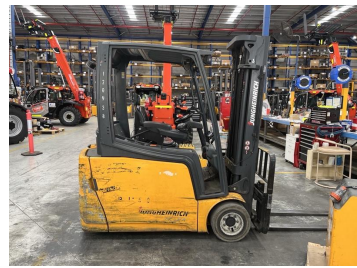
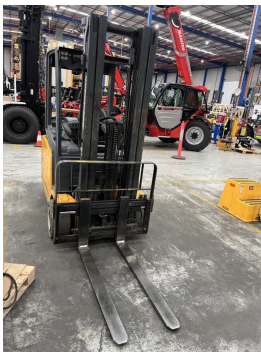
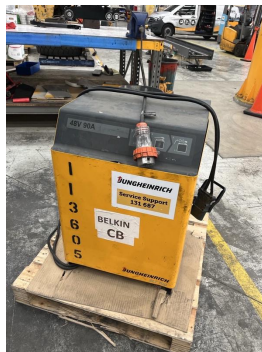
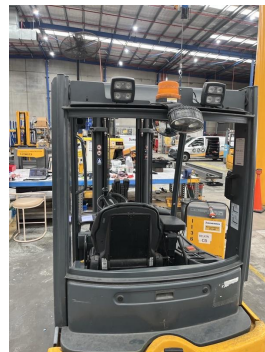
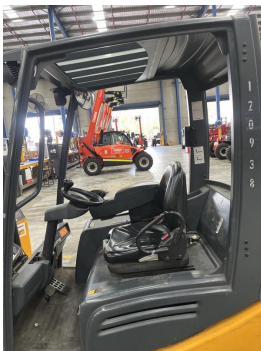
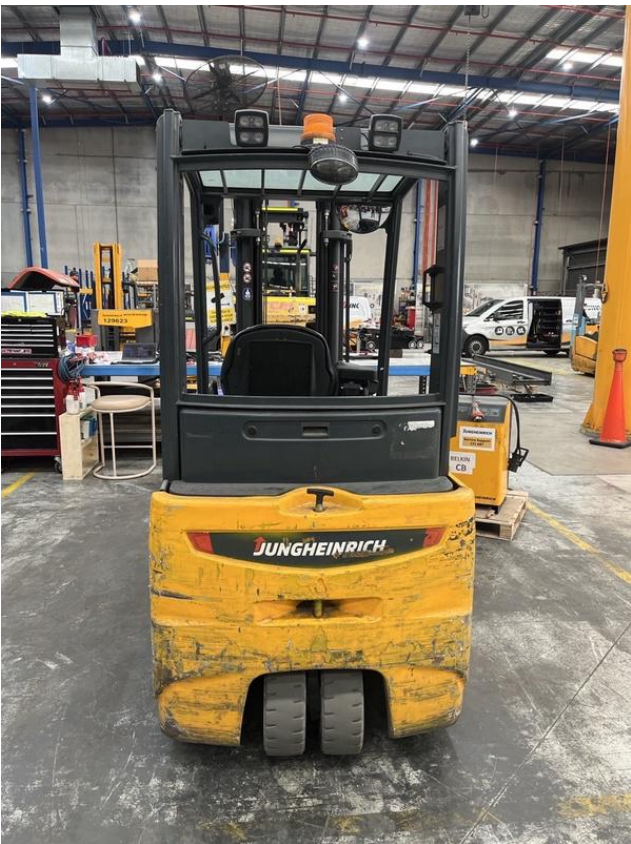
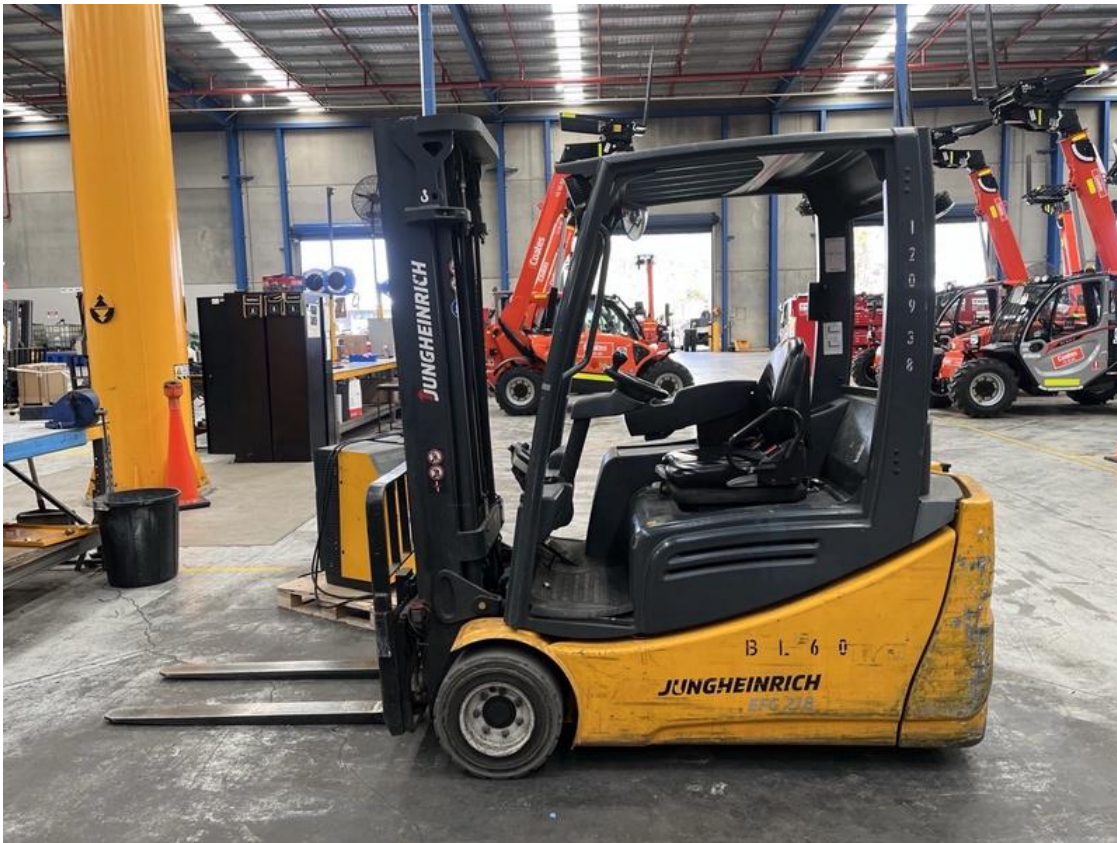
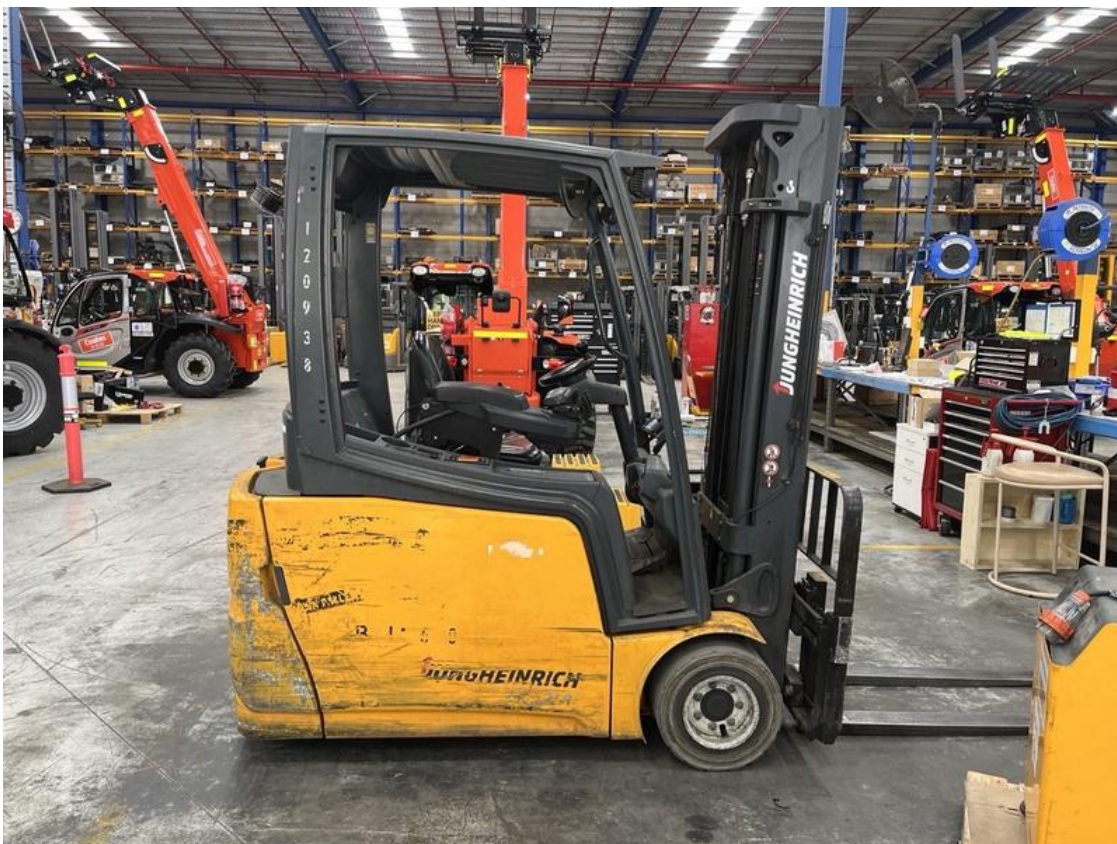
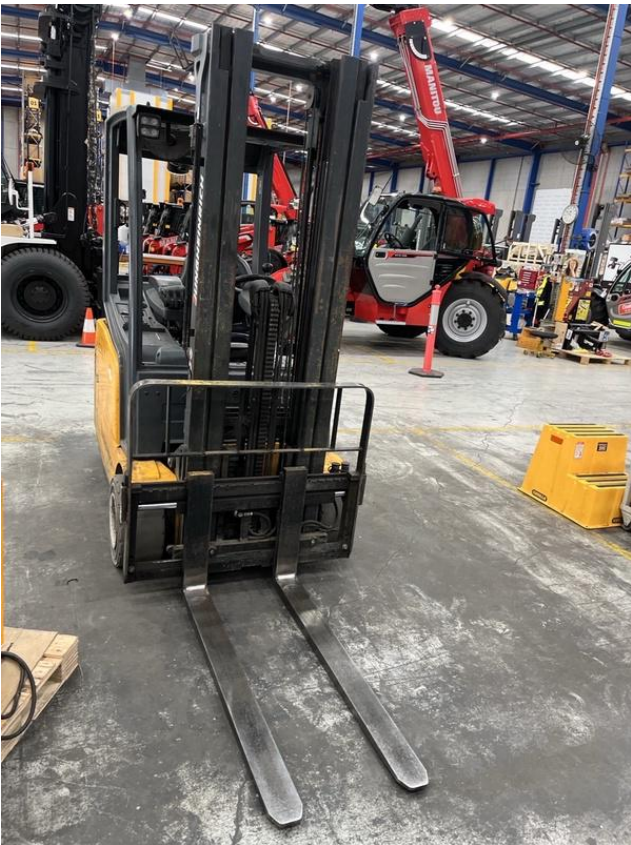
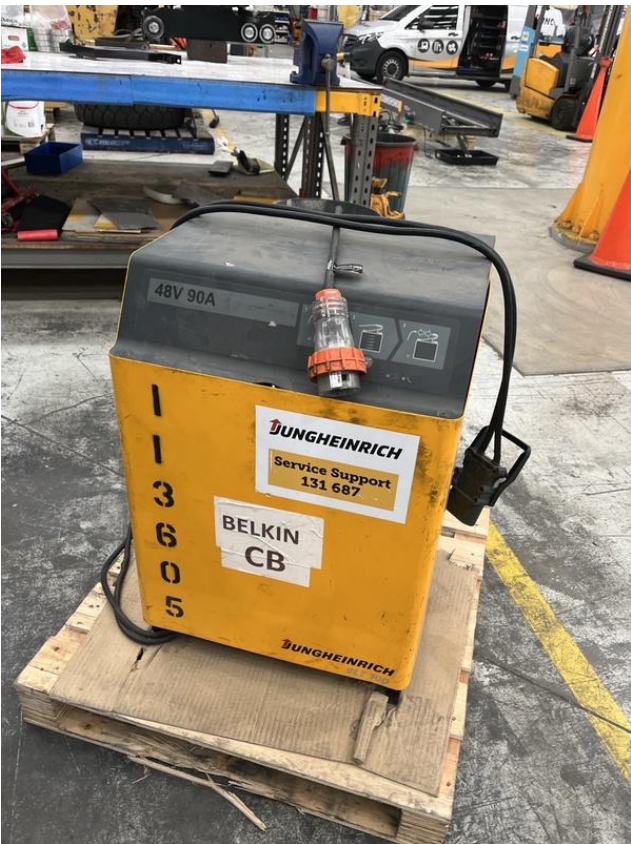
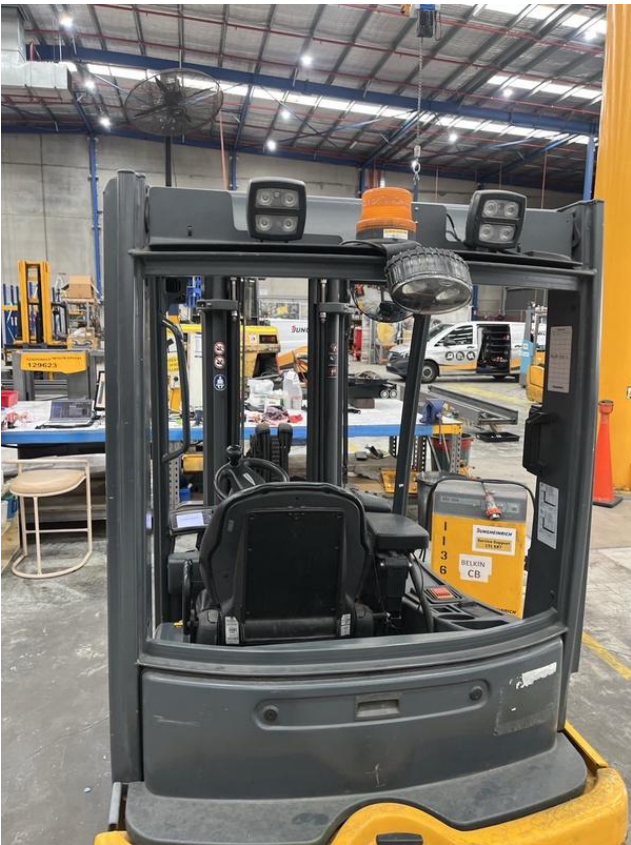
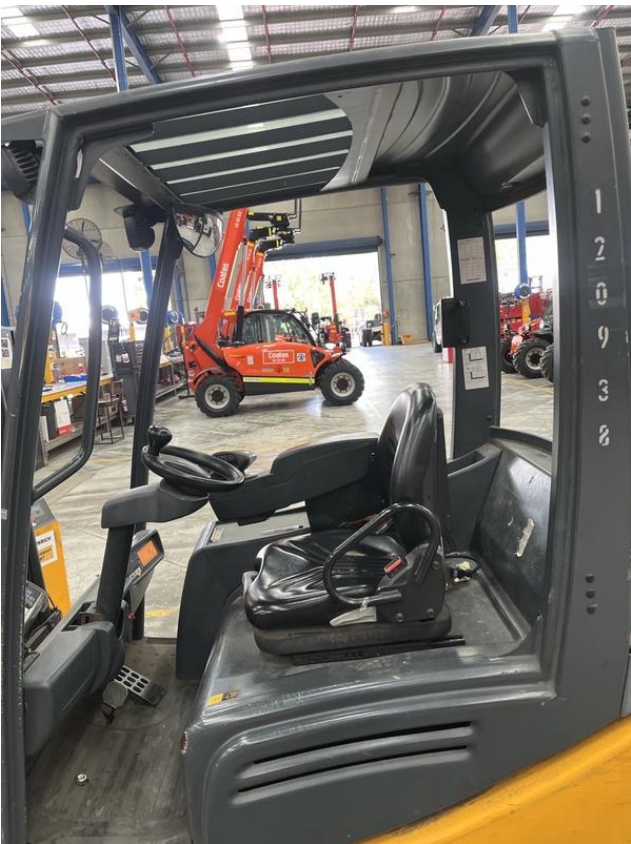
Fair

Charger with the truck belongs to another unit .

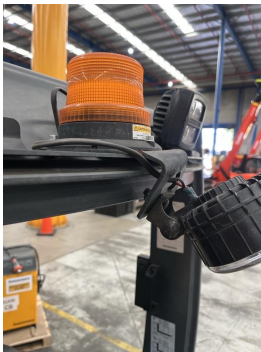
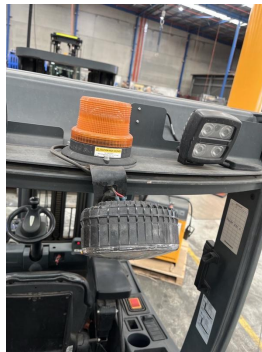
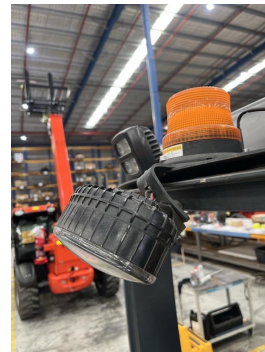
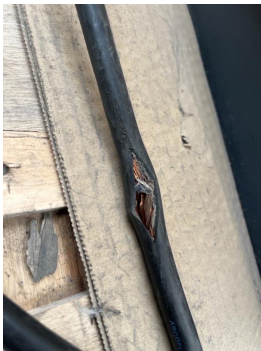
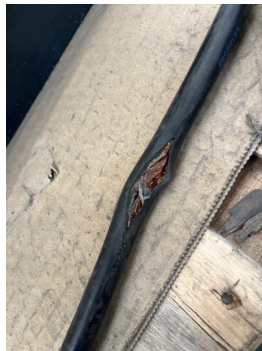
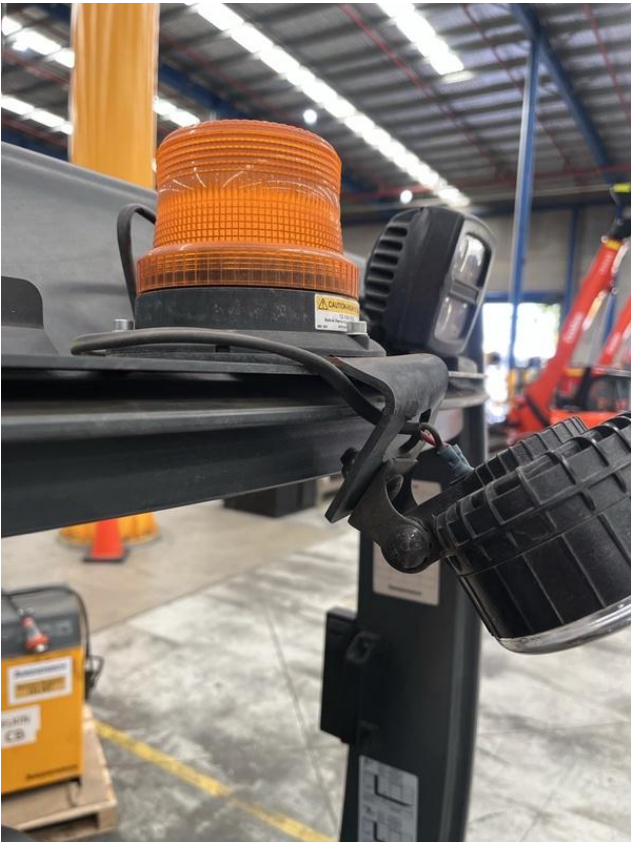
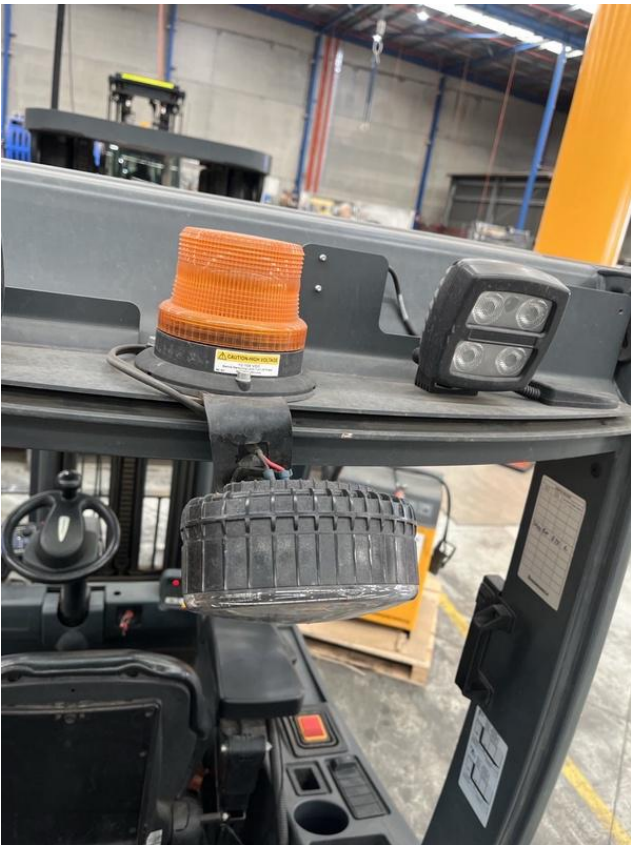
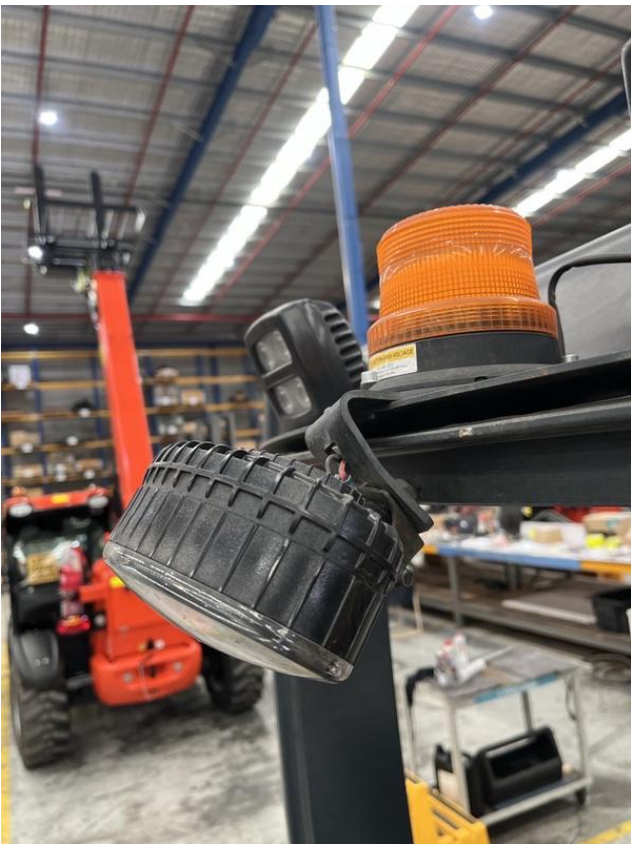
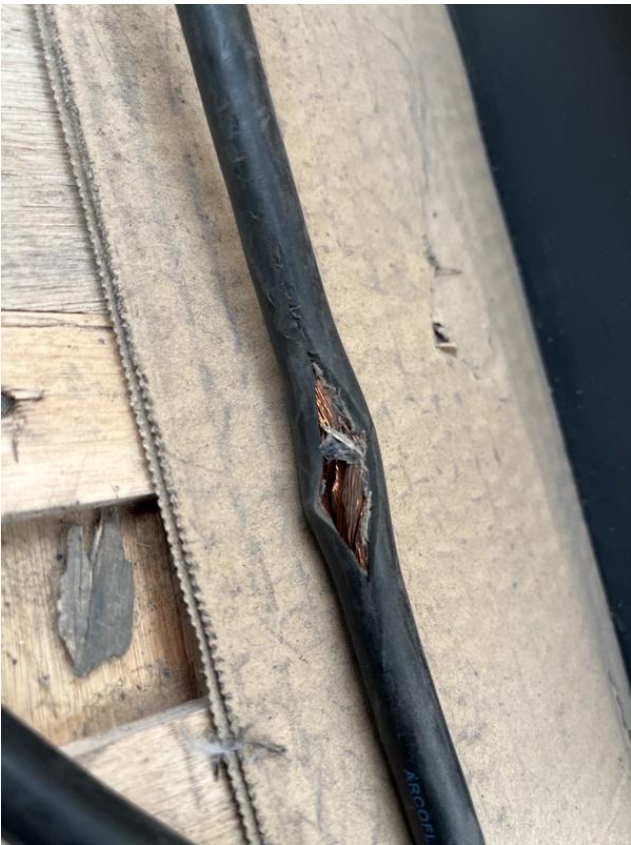
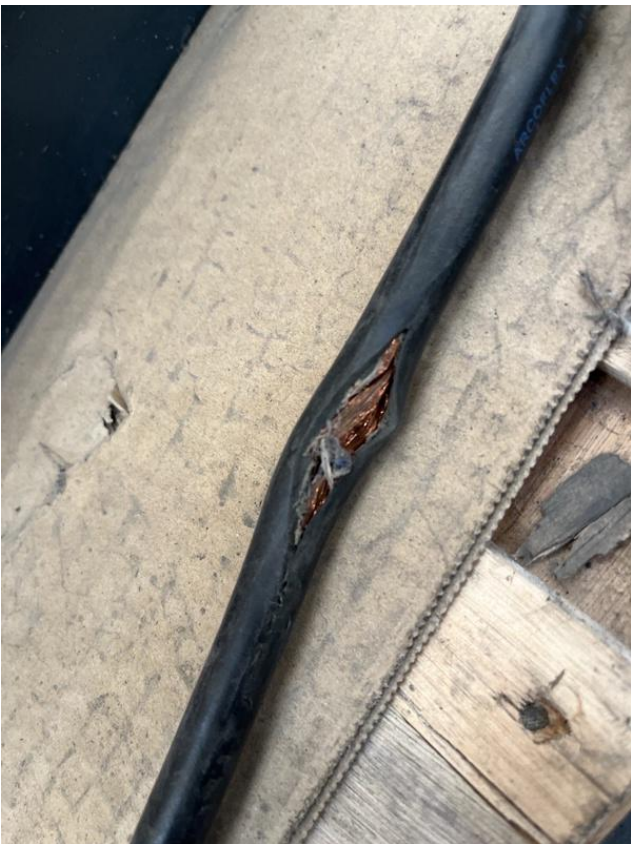
Bent floor spot bracket and charger cable cut open .

1xfloor spot bracket
1xcharger cable
1x320amp plug

0.5

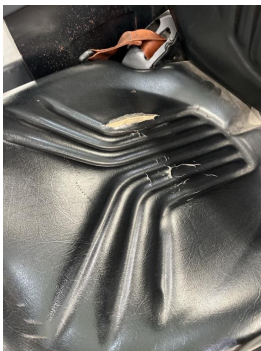
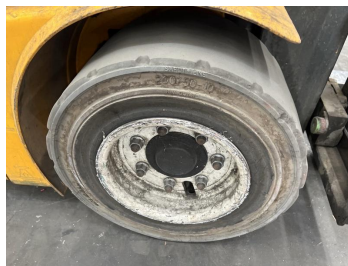
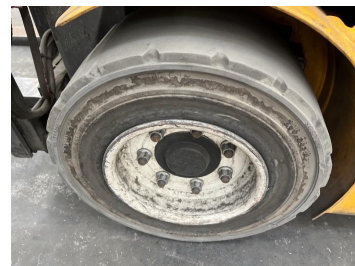
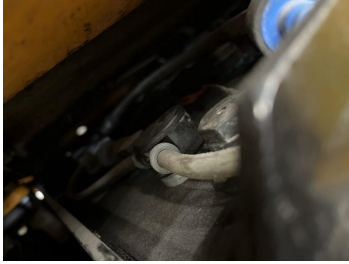
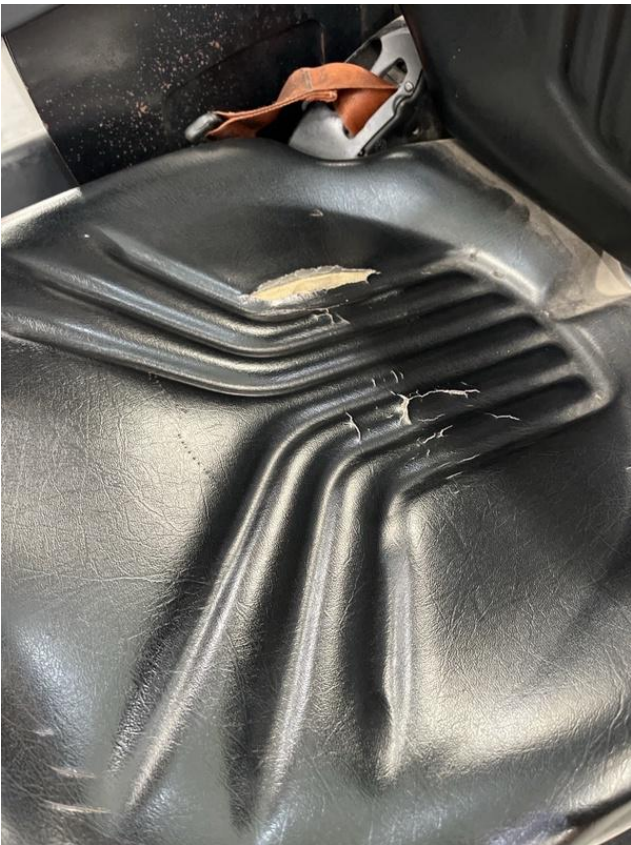
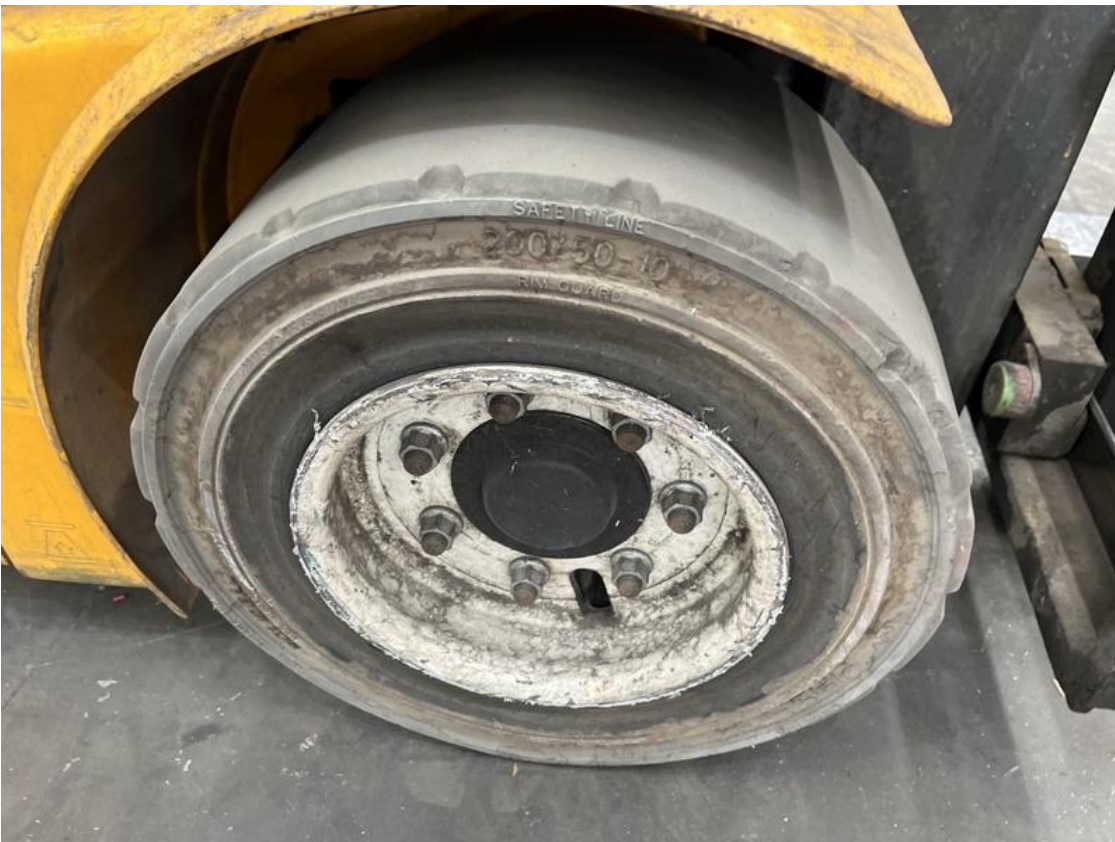
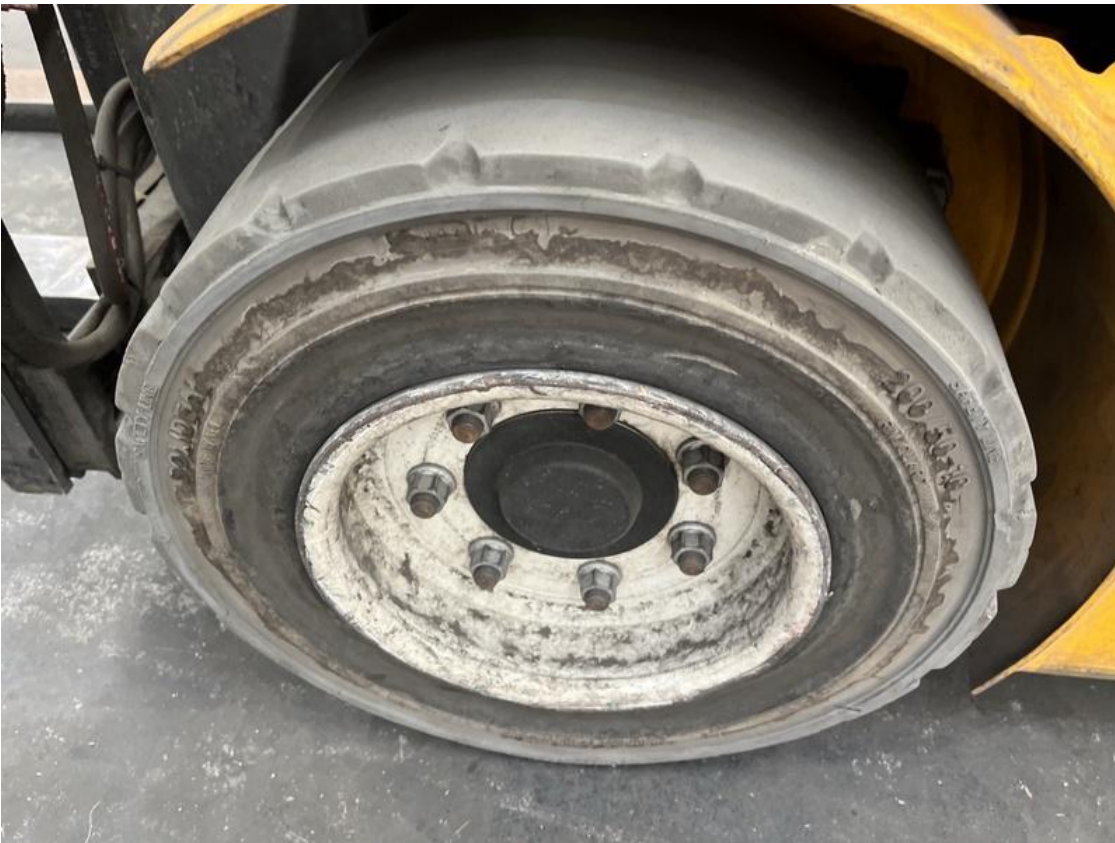
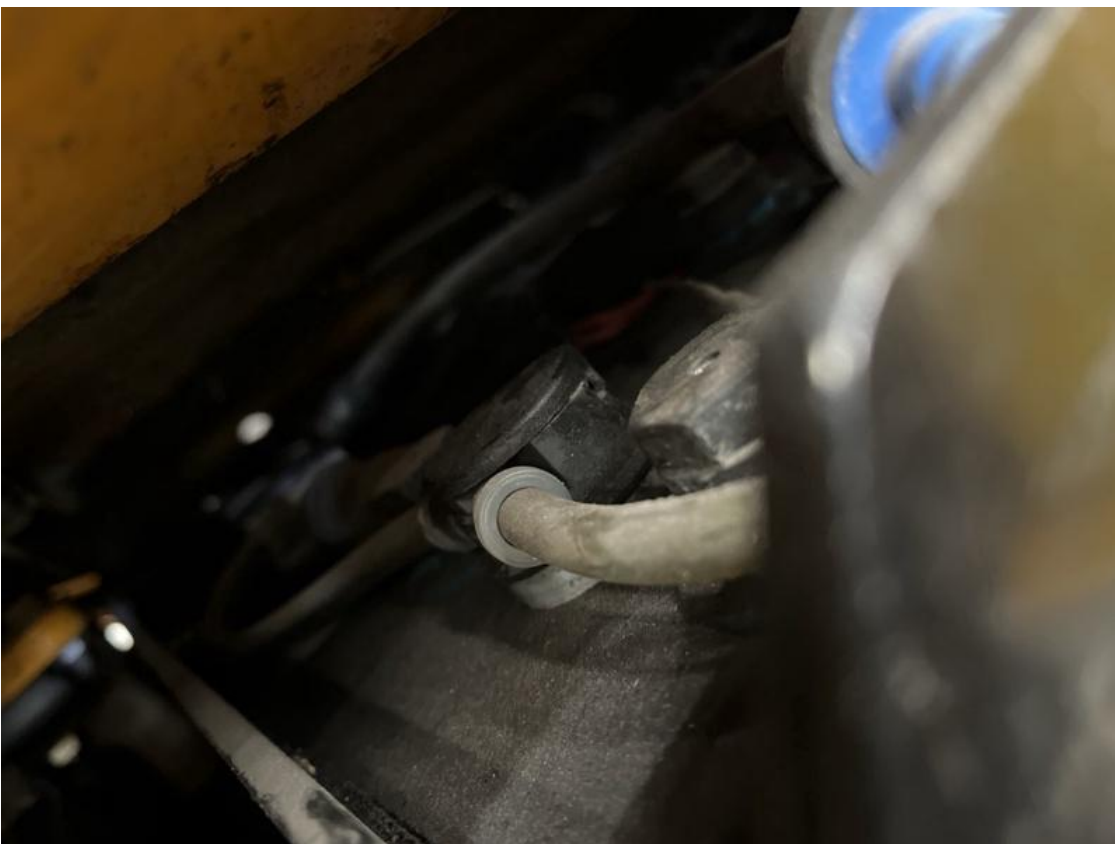
Seat cushion tear. Front tires near wear limit . Paint chips and scratches around truck . Battery dusty.

1x Seat cushion
Painting

2.5 hr
