## Pre-Purchase Inspection

Angelone, 490, 2018 Model

### Survey Details

Survey type:	Pre-Purchase Inspection
Survey No#:	PPS210913
Client:	[REDACTED]
Email:	spayne@dalboramarine.com.au
Inspection date:	12th September 2021
In-Water location:	The Boatyard, Mount Martha, Victoria
Out-Water location:	Martha Cove Marina, Mount Martha, Victoria

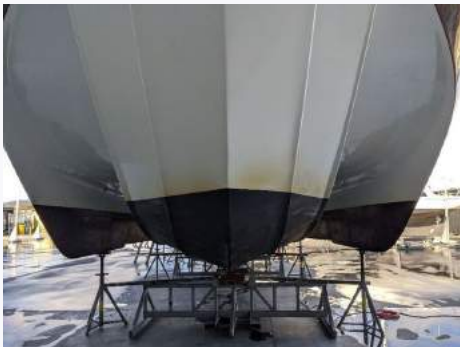
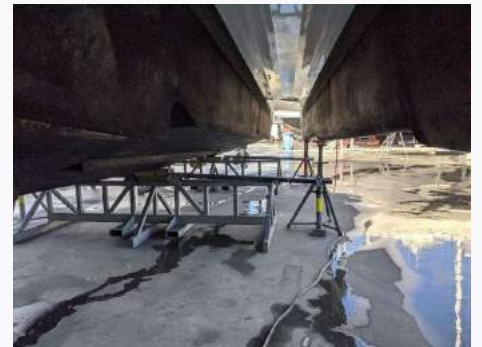
Ref # 2.1

Ref	Item	Material / Construction	Condition	Comments
2.1	Hull Bottom	FRP Composite	Sound	<p>Trimaran semi-planning hull, hulls are stepped. No signs of previous repair, stress or defect was sighted.</p> <p>The hull bottom was moisture tested using a moisture meter (Tramex Skipper +) the hulls were mostly found to be within normal ranges, however we did detect slightly elevated reading on each bow around the waterline. We did notice some minor cosmetic blisters in these areas.</p> <p><b>C: Low Priority (Cosmetic or Superficial)</b></p>

Ref	Responsibility	Comments
<a href="#">2.1</a> Hull Condition (Below Waterline) » Hull Bottom	N/A	The hull bottom was moisture tested using a moisture meter (Tramex Skipper +) the hulls were mostly found to be within normal ranges, however we did detect slightly elevated reading on each bow around the waterline. We did notice some minor cosmetic blisters in these areas.
<a href="#">3.7</a> Hull Condition (Above Waterline) » Swim platform	N/A	Minor damage to teak on starboard swim step.

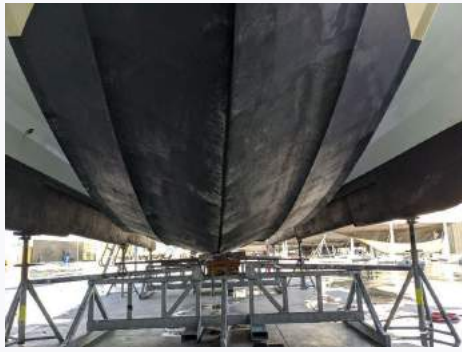
Ref # 2.3

2.2	Hard chine	FRP Composite	Good	Hard chine is clean and fair edge running along hull, no damage or defects sighted.
2.3	Hull Strakes	FRP Composite	Good	Two integrated hull strakes, running parallel to hull, no damage or defect sighted.

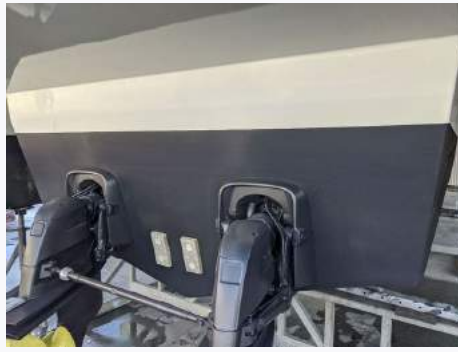
Ref # 2.5

2.4	Keel	FRP Composite	Good	Planning keel running along centreline, no damage.
2.5	Transom	FRP / Timber Composite	Good	The transom was percussion sounded in areas with no notable anomalies detected.

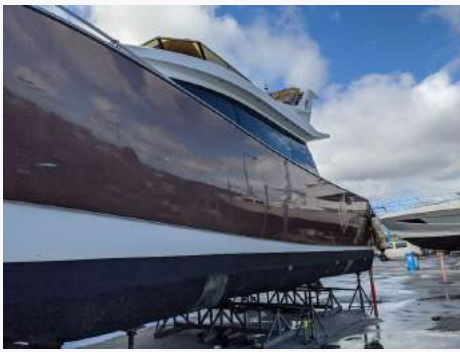
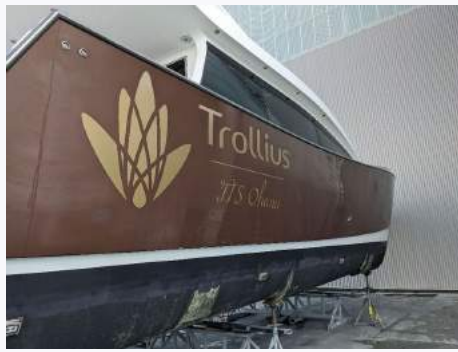
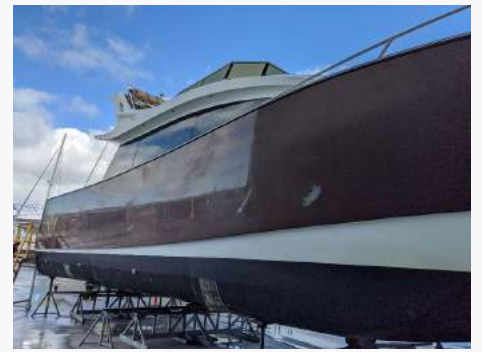
Ref # 3.1

Ref	Item	Material / Construction	Condition	Comments
3.1	Hull side / Topsides	Paint / FRP Composite	Sound	Pearl Two-part polyurethane finish with some cosmetic wear and tear in areas consistent with fender rub and hull scuffing marks.
3.2	Gunnel	Rubber with stainless Steel	Good	Appears to run true, no notable indentation or damage.
3.3	Bow Stem	FRP Composite	Good	No damage sighted
3.4	Skin Fittings	Stainless Steel	Sound	Some tea staining present, suitably installed.
3.5	Foredeck	FRP Sandwich Core	Good	Percussion sounded and moisture tested appearing rigid and structurally sound.
3.6	Superstructure	Gelcoat / FRP Composite	Good	The superstructure and bridge deck was found to be structurally sound.
3.7	Swim platform	FRP Composite	Good	Hull integrated swim platform laid with solid teak.; Minor damage to starboard teak step. <b>C: Low Priority (Cosmetic or Superficial)</b>

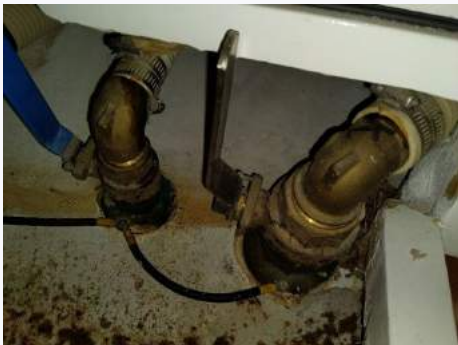
Ref # 4.2

Ref	Item	Material / Construction	Condition	Comments
4.1	Seacocks (Port Side)	Bronze or similar	Sound	1 on Port side, exercised.
4.2	Seacocks (Stbd Side)	Bronze or similar	Sound	3 on Starboard side, all were exercised.
4.3	Intake Grills	Bronze or similar	Sound	Appeared clear and unobstructed.

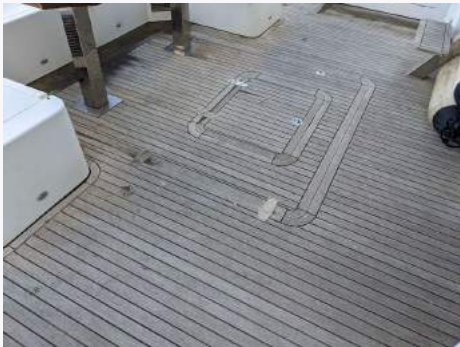
Ref # 5.1

Ref	Item	Material / Construction	Condition	Comments
5.1	Cockpit Sole	FRP Composite	Sound	Overlaid with natural laid teak.
5.2	Combing / Bulwarks	FRP Composite	Good	Full height bulkwarks around cockpit and side decks with gelocat finish
5.3	Seating & Upholstery	Material	Good	Cockpit table could benefit from a sand and varnish.  Seating cushions stored in rear cabin.
5.4	Covers & Awnings	Hardtop Awning	Good	Hardtop awning over cockpit
5.5	Bimini Frame / Targa	FRP Composite	Good	Bimini on bridge deck with Targa arch, both found suitably secure.
5.6	Cockpit doors	Stainless Steel	Good	Glass sliding entrance door opens and closes with locking mechanism.

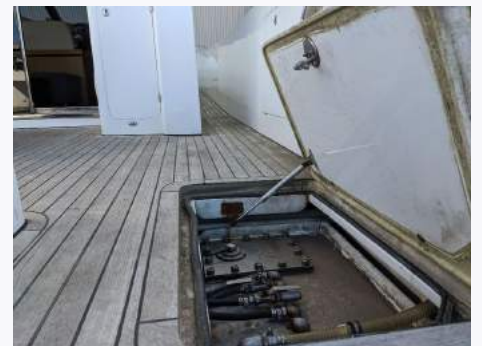
Ref # 5.8

5.7	Lockers and storage	FRP Composite	Sound	Storage lockers are clean and free from water and moisture.
5.8	Cockpit Drainage	Self draining	Fair	<p>Cockpit is somewhat self draining, however water can collect around seating area and run-off from side decks leads into side deck hatches. Drainage could be improved in these areas.</p> <p><b>B: Medium Priority (Service or Maintenance Item)</b></p>
5.9	Cockpit lighting	12-volt	Fair	<p>Cockpit lighted powered-up.;</p> <p>Courtesy and underwater lighting did not power-up. Kept tripping breaker.</p> <p><b>B: Medium Priority (Service or Maintenance Item)</b></p>

Ref	Responsibility	Comments
<a href="#">5.8</a> Cockpit » Cockpit Drainage	N/A	Cockpit is somewhat self draining, however water can collect around seating area and run-off from side decks leads into side deck hatches. Drainage could be improved in these areas by fitting additional drains.
<a href="#">5.9</a> Cockpit » Cockpit lighting	N/A	Courtesy lighting and underwater lighting did not power-up, the breaker was tripping for these services. As such did not power-up.
<a href="#">8.12</a> Main Engines & Propulsion » Hoses	N/A	Some minor deterioration to raw water intake hose between drive and engine on both sides.
<a href="#">14.5</a> Heating & Cooling » Heating Mode	N/A	The two forward units did not go into heating mode, however did have cooling mode.

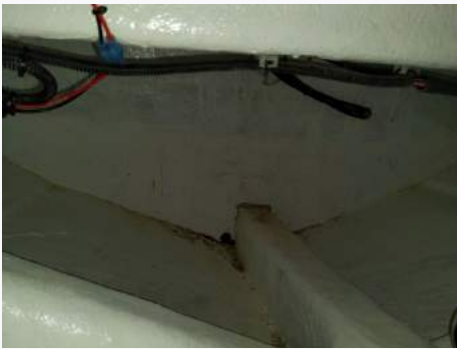
Ref # 6.1

Ref	Item	Material / Construction	Condition	Comments
6.1	Interior Frames & Bulkheads	FRP Composite	Sound	Timber veneer plywood panels bonded to hull.
6.2	Hull stringers	FRP Composite	Sound	FRP longitudinal and transverse frames all found in sound structural condition. Not all hull frames could be inspected due to permanently fitted panels.;  Please note, the internal areas of both side hulls were not inspected. Access was restricted by fixed panels.

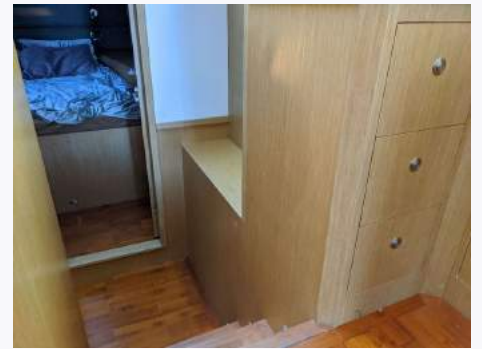
Ref # 6.4

6.4	Cabinetry & Fitout	Timber Veneer	Good	Normal wear and tear in areas.
6.5	Brightwork	Low sheen	Good	Little signs of wear or tear present
6.6	Headlining	Material Panels	Good	Reasonably clean, no sagging or staining sighted.

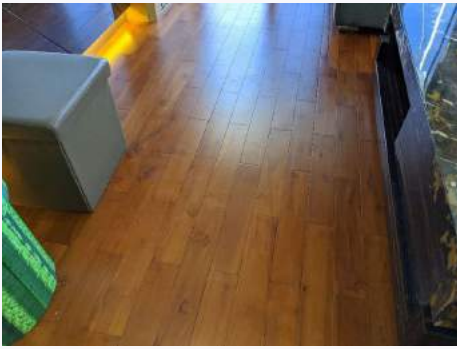
Ref # 6.7

6.7	Cabin Sole	Timber	Sound	Laid timber 10mm, some minor wear.
6.8	Doors & Handles	Aluminium	Good	All found functional
6.9	Galley Fitout	Timber Veneer	Good	In good usable condition.

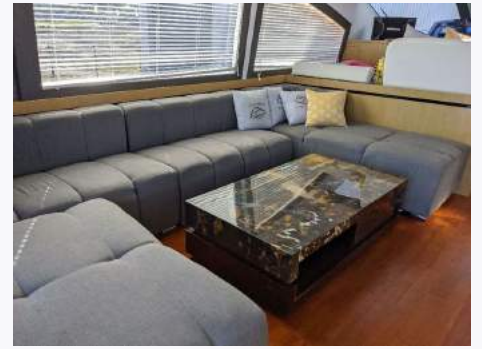
Ref # 6.12

6.10	Benchtops	Solid marble or similar	Good	No notable wear.
6.11	Cupboards and closers	Push Button Type	Good	All found functional.
6.12	Seating & Upholstery	Leather	Sound	Some minor wear sighted.

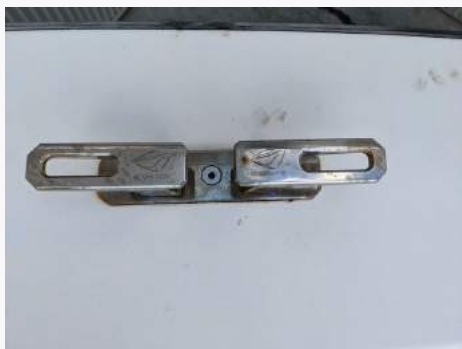
Ref # 7.3

7.3	Cleats	Stainless Steel	Good	Custom cleats, appeared secure providing multiple mooring configurations.
7.4	Hatches	Acrylic or similar	Good	All deck hatches appeared free from leak, minimal wear too lenses. Closers fitted.
7.5	Windows	Acrylic or similar	Good	Multiple sectional tempered glass helm windows surround the main cabin and helm.
7.6	Portholes	Acrylic or similar	Good	Porthole windows are installed around hulls sides appearing leak free.
7.7	Anchor Winch	12-Volt Electric	Good	Maxwell anchor winch fitted to bow, no notable corrosion to under deck mounted motor. The anchor was raised and lower using helm controls.
7.8	Anchor	Stainless Steel	Good	Suitably sized plough type anchor mounted at the bow.
7.9	Anchor chain, warp and fittings	Stainless Steel	Good	Stainless chain sighted in anchor locker; length unknown.
7.10	Bow roller / Stem head	Stainless Steel	Good	Securely mounted

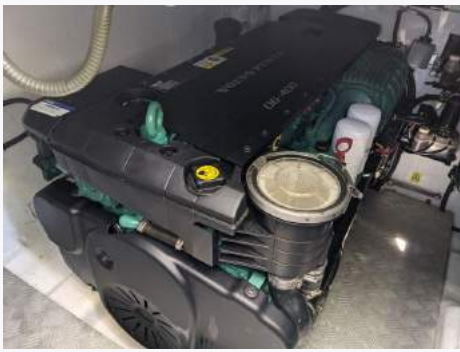
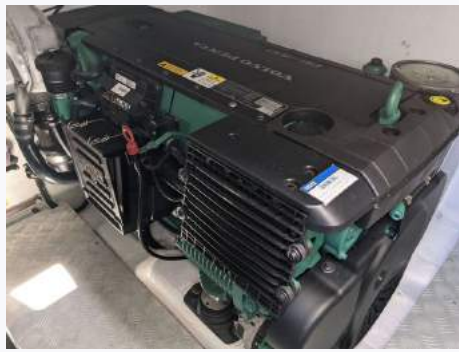
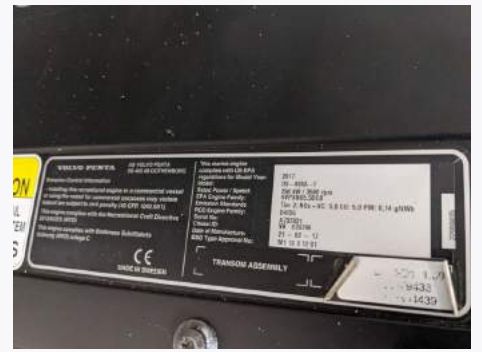
Ref # 8.1

Ref	Item	Type / Make	Condition	Comments
8.1	Engine Block	Inline 6 Cylinder	Good	5.8 litre turbo diesel, no oil leaks or corrosion sighted.
8.2	Sump	Pressed Steel	Good	No oil staining or corrosion on sump.

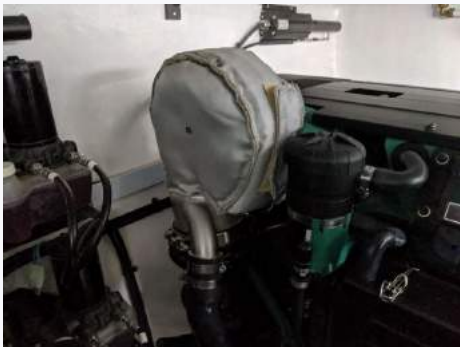
Ref # 8.4

8.3	Manifolds	Cast Aluminium	Good	No corrosion or deterioration evident.
8.4	Exhaust System	Single horn	Good	Single cast horn connected with hose clamps and rubber joiners, exiting transom assembly.

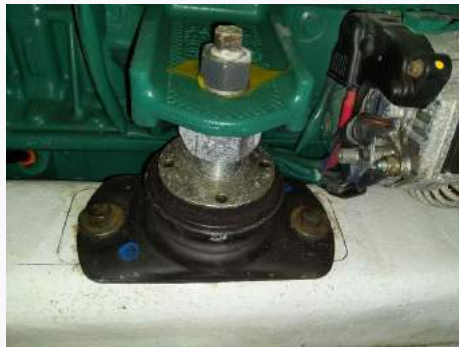
Ref # 8.9

8.9	Engine Mounts	Flexible Mounts	Good	Volvo Penta flexible mounts, no corrosion sighted.
8.10	Cooling System	Closed / Fresh water	Good	Fresh water cooling system via drive pick-up.

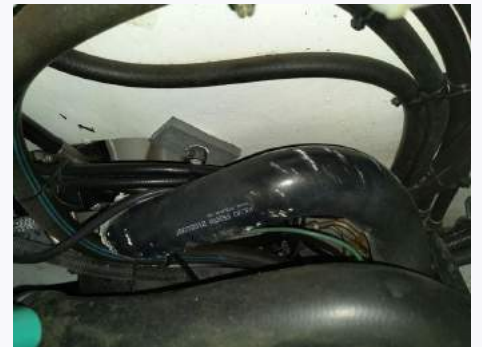
Ref # 8.12

8.11	Coolant	Green	Good	Appeared at normal levels and colour.
8.12	Hoses	Reinforced Rubber	Sound	No notable deterioration, splitting or bulging cooling system hoses, except some minor deterioration to raw water intake hose between drive and engine on both engines. B: Medium Priority (Service or Maintenance Item)

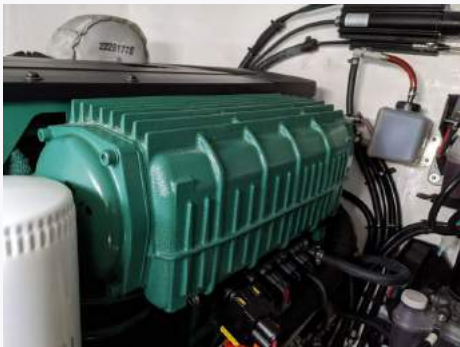
Ref # 8.13

8.13	Heat Exchanger / Intercooler	Metal	Good	No weeping from end caps, appear serviceable.
8.14	Water Pump	Impeller Type	Good	No notable leak sighted.
8.15	Turbocharger	Cast Metal	Good	No oil leaks or deterioration sighted.

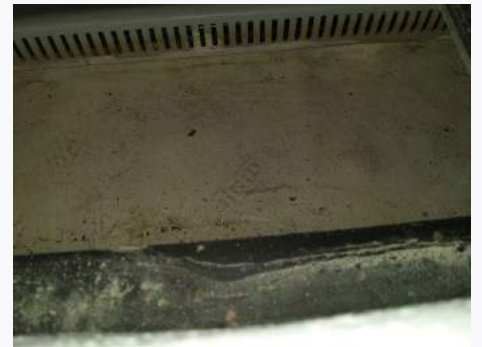
Ref # 8.23

8.22	Throttle levers	Electronic Type	Good	Top mount controls, smooth to engage.
8.23	Engine bilge	Flow coat	Good	Reasonably clean.

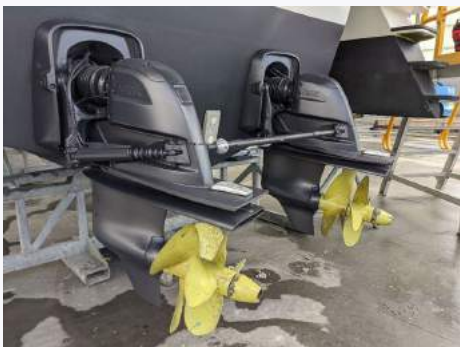
Ref # 9.1

Ref	Item	Type / Make	Condition	Comments
9.1	Type	Stern Drives	Good	Twin Volvo Penta DPH-D1 drives
9.2	Gear Box	Volvo penta	Good	No damage or abrasion to lower units.
9.3	Transom Shields	Cast Aluminium	Good	No corrosion or pitting sighted.

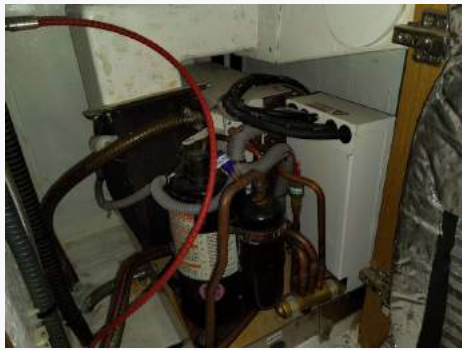
Ref # 14.1

Ref	Item	Type / Make	Condition	Comments
14.1	Type	Dometic	Sound	Four Air Conditioner/Heaters fitted, not all units could be inspected due to access restrictions.
14.2	Ducting	Insulated Ducting	Good	Appeared servicable.
14.3	Hoses	Reinforced Marine Hose	Good	No leaks sighted.
