MARITIME ENGINEERS PTY LTD

CONDITION, LOSS PREVENTION AND VALUATION SURVEY

FILE REF. NO.	JP1042/20
CLIENT	HAMILTON MURPHY
VESSEL NAME	SON OF SAM
MAKE/ YEAR OF BUILD	X -YACHT, XP-50 / 2013
VESSEL TYPE	RECREATIONAL SAILING YACHT
WHERE SURVEYED	CULLEN BAY MARINA, DARWIN, NT
SURVEYOR	JUAN PAZO
INSPECTION DATE	04/03/2022

OUR REF. NO.: JP1042/20
DATE: 15 MARCH 2022

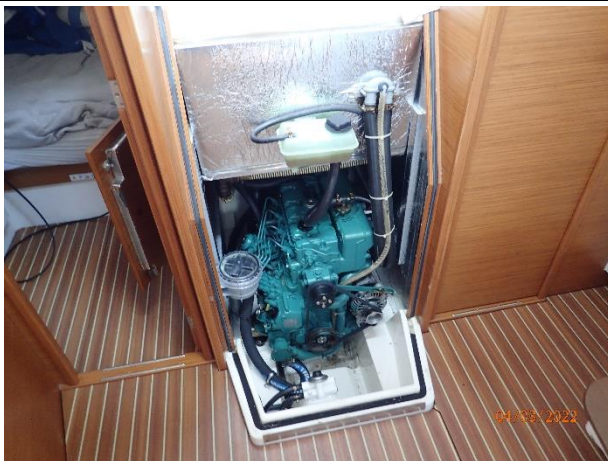
MAIN ENGINE

No.	Description	Check	Remark
8	Is the machinery in satisfactory condition?	SR	Visual inspection noted satisfactory. No operational check carried out. No records of recent used noted.

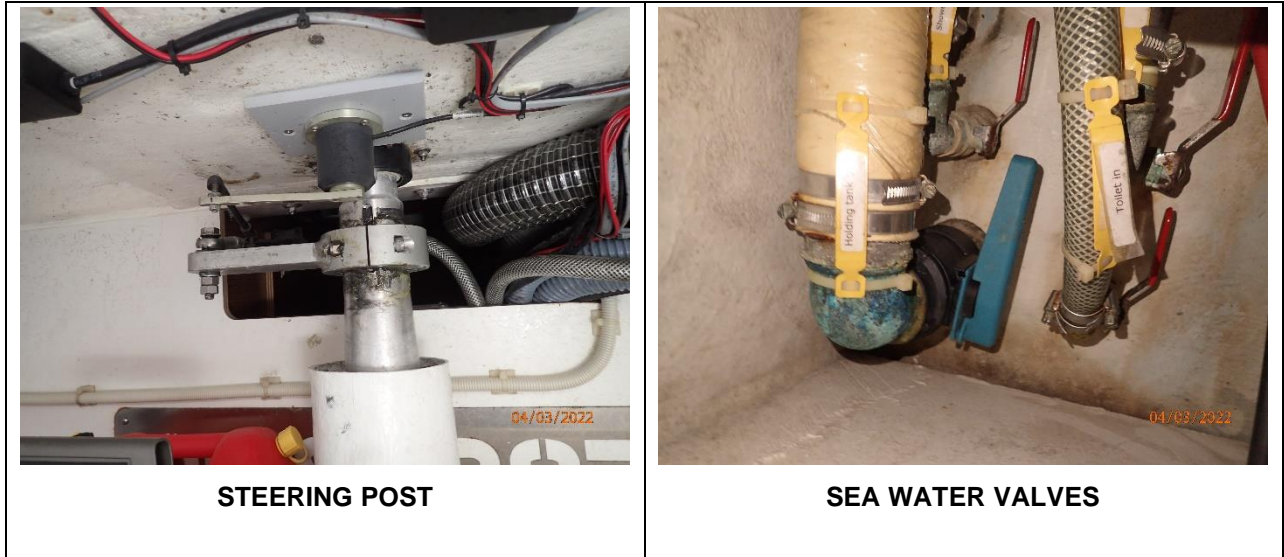
SEA WATER VALVES

7.3 COMPARTMENTS			
1	Are below deck compartments in satisfactory condition?	Yes	
2	List any compartments not inspected	SR	Some lower bilge sections and fore peak.
3	Condition of the internal coatings?	SR	Satisfactory
4	Condition of hull valves?	SR	Satisfactory. Early signs of superficial rust.

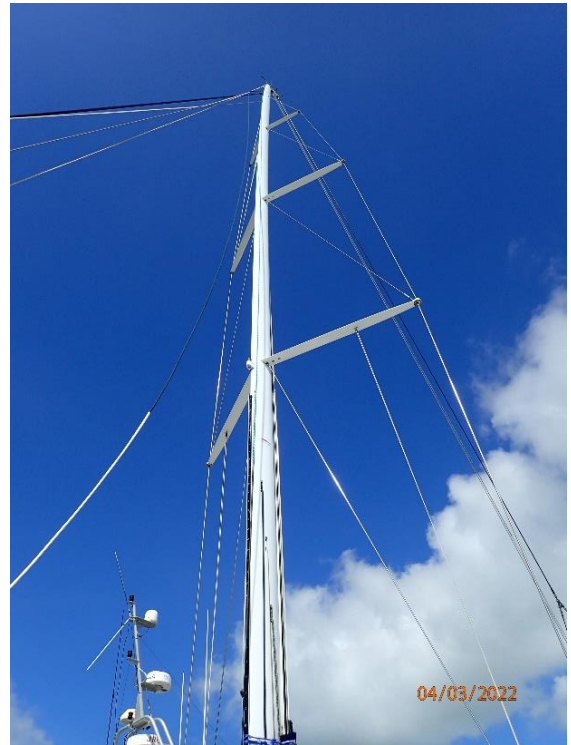
MAST AND RIGGING

Sail inventory not provided. Sails not inspected at the time of attendance. Overall rigging noted in satisfactory condition.
