## HAZELWOOD MARINE Pty Ltd

**Report Carried Out At:** Jones Island Manning Valley NSW

**Date:** 1<sup>st</sup> November 2016

**Vessel:** American built Trojan 4400 fibreglass sports cruiser.

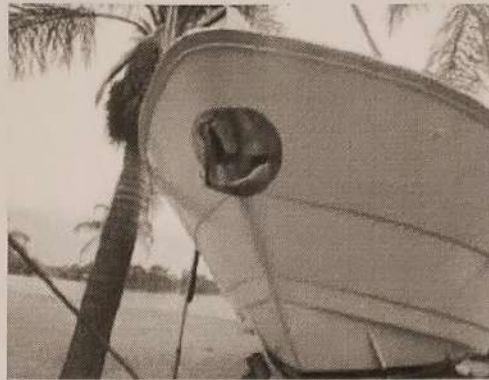
1.1	A	Hull, General	Fibreglass laid up in a female production mould using acceptable trade practises
1.2	NA	Frames	Bulkheads and furniture glassed in to help stiffen the hull with frames below the sole
1.3	A	Stringers	Part of grid patten below the sole.
1.4	NA	Floors,	
1.5	A	Bearers, Supports	Engine bearers are well glassed in
1.6	A	Sole	
1.7	A	Deck/Hull Join	Glassed
1.8	A	Bilges	The bilges are clean
1.9	A	Bulkheads	
1.10	A	Transom	
1.11	A	Skin Fittings	All skin fittings below the waterline are metal
1.12	A C	Sea Cocks	All seacocks below the waterline are metal ballvalves <ul style="list-style-type: none"> <li>• All seacocks were very stiff or did not move.</li> <li>• All seacocks on board must be eased and made to operate feely or replaced with new ones.</li> </ul>

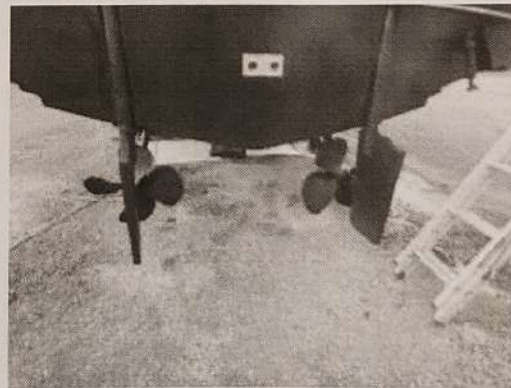
2.1	A	Topsides	Original gelcoat in fair condition. <ul style="list-style-type: none"> <li>There is some minor cosmetic damage on the starboard side from docking.</li> </ul>
2.2	A	Underwater	There is no evidence of grounding or collision below the waterline
2.3	NA	Docking Strip	
2.4	A	Sponsons	Alloy moulding at gunwale level
2.5	A	Anodes	The anodes are being replaced at this slipping.
2.6	NA	Bonding	
2.7	A	Hull Deck Join	Glassed
2.8	A	Trim Tabs	
2.9	A	Antifoul	The vessel is being antifouled at this time.
2.10	A	Keel

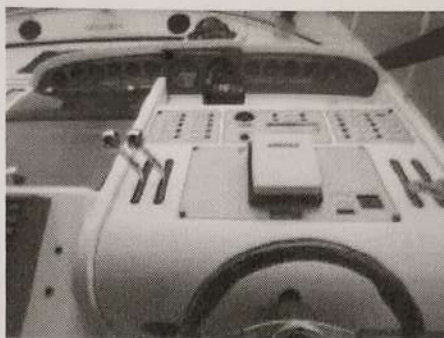
3.1	A	Steering General	Single station wheel power assisted
3.2	A	Rudder General	Twin spade hung metal profiles.
3.3	A	Shaft	
3.4	A	Bearings	
3.5	A	Tube/Support

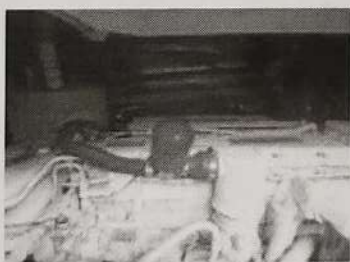
4.1	A	Motor/s Type	Twin turbo charged 6 cylinder 321Catapillar diesel engines
4.2	A	Appearance	The engines are well painted and do not exhibit any leaks
4.3	A	Belts	
4.4	A	Coupling	Coupled to Vee drive units.
4.5	A	Controls	
4.6	A	Stuffing Box	
4.7	A	Exhaust	
4.8	A	Sound Proofing	
4.9	A	Lines	
4.10	A	Elec.	
4.11	A	Blowers	
4.12	A	Inlet Filter	
4.13	A	Beds	
4.14	A	Mounts
