# VerifiInspect Report

24 / 01 / 2026

## 2014 Rolls-Royce Ghost

2014 Rolls-Royce Ghost Red MY09 || Automatic

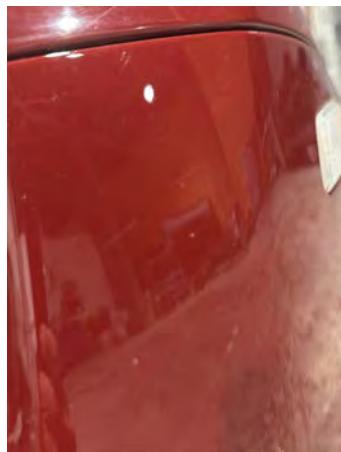
LOCATION  
full front  
TYPE  
Cosmetic Imperfection  
SUGGESTED REPAIR  
PRICE  
NOTES  
Small scuff marks on passenger side front bumper

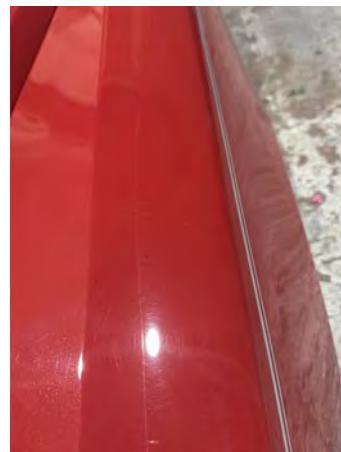
LOCATION  
full left  
TYPE  
Cosmetic Imperfection  
SUGGESTED REPAIR  
PRICE  
NOTES  
Scuff Mark across passenger side guard

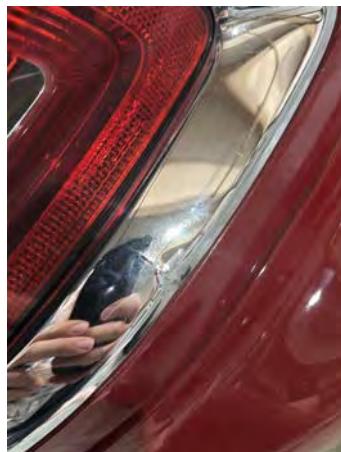
LOCATION  
full rear  
TYPE  
Cosmetic Imperfection  
SUGGESTED REPAIR  
PRICE  
NOTES  
Damage to passenger side tail light chrome moulding

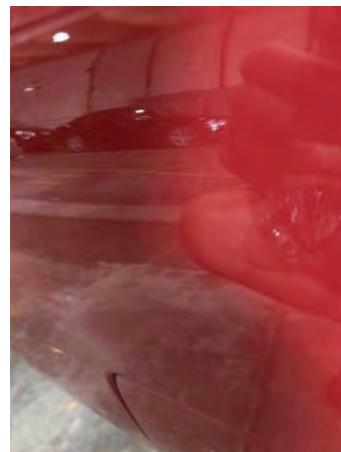
LOCATION  
full rear  
TYPE  
Cosmetic Imperfection  
SUGGESTED REPAIR  
PRICE  
NOTES  
Small scuff marks to driver side rear bumper

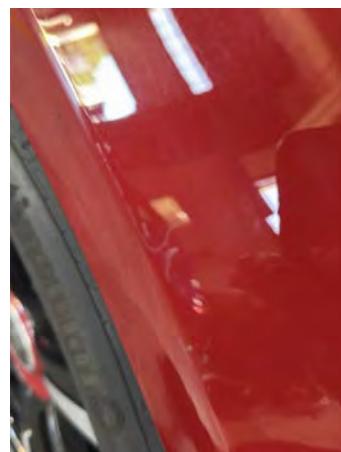
LOCATION  
full right  
TYPE  
Cosmetic Imperfection  
SUGGESTED REPAIR  
PRICE  
NOTES  
Scuff marks on driver side rear quarter panel

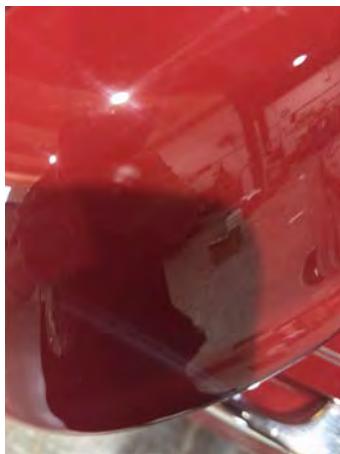
LOCATION  
full right

TYPE  
Cosmetic Imperfection

NOTES  
Scuff mark to driver side  
mirror cover

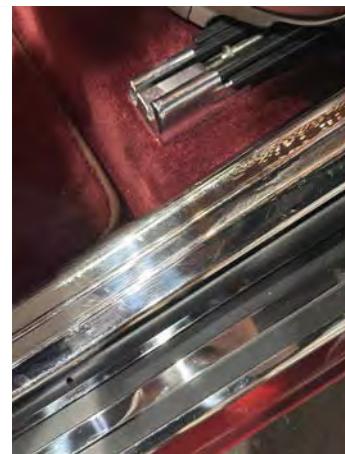
LOCATION  
full interior front left

TYPE  
Cosmetic Imperfection

NOTES  
Scuff marks to scuff plate

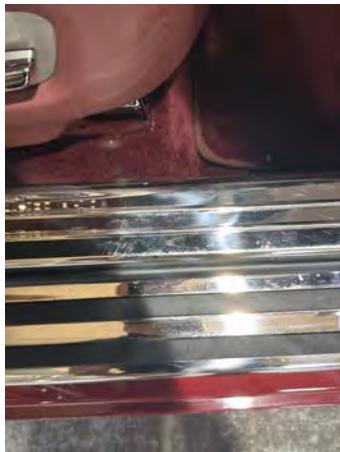
LOCATION  
full interior front right

TYPE  
Cosmetic Imperfection

NOTES  
Scuff marks to scuff plate

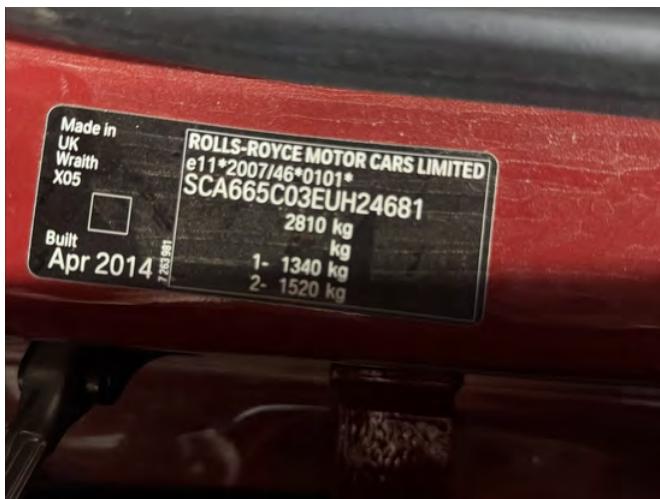
Compliance Plate

No service books available; online  
 Could not locate the comp plate  
 Minor oil spot under vehicle unsure if oil leak or not  
 Small scuff marks on passenger side front bumper  
 Scuff Mark across passenger side guard  
 Damage to passenger side tail light chrome molding at rear  
 Small scuff marks to driver side rear bumper  
 Small scuff mark on driver side rear quarter panel  
 Scuff marks on driver side rear quarter panel  
 Scuff mark to driver side mirror cover  
 Scuff marks to scuff plate at front left interior  
 Scuff marks to scuff plate at front right interior  
 Tyres have approximately 60-80% tread remaining  
 No leaks evident at time of inspection  
 No hail damage evident at time of inspection  
 All electrics working at time of inspection  
 Brakes, transmission and suspension, final drive systems operating as intended at the time of inspection  
 All engine systems operating as intended at the time of inspection

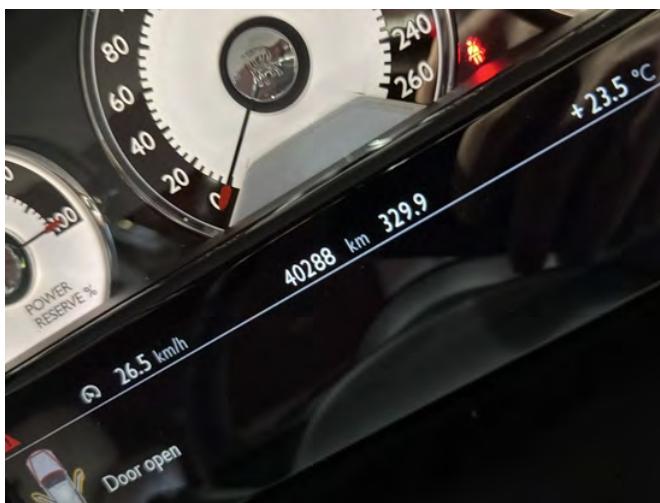
Test Drive

Vehicle drives well with no foreign noises, knocks nor rattles detected during road test
