Pre-Purchase Inspection

Hattarass, 64 Pilothouse, 1984

PPS230510

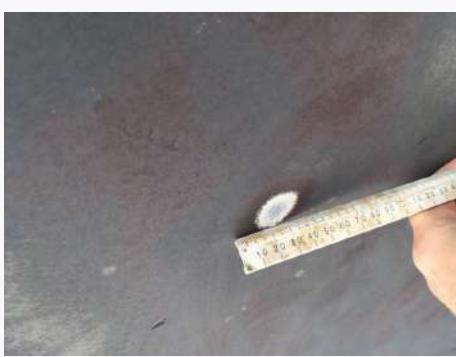
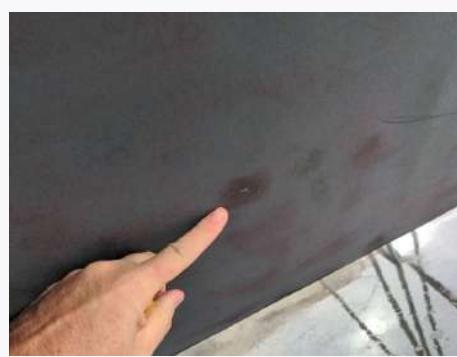
Ref	Item	Material / Construction	Condition	Comments
2.1	Hull Bottom	FRP Composite	Sound	<p>Semi displacement hull, no signs of previous repair, stress or defect was sighted.</p> <p>The antifouling had just been sanded back giving us a good chance to inspect the hull substrate.</p> <p>We did notice some sporadic hull blisters most being around 3-5cm in size, we estimate approximately 20 or so across the hull bottom were sighted.;</p> <p>These blisters appear minor and considered cosmetic shallow blisters only.</p>
2.2	Hard chine	FRP Composite	Sound	Clean and fair edge running along hull, no damage or defects sighted.

Ref # 2.1 - Hull blister

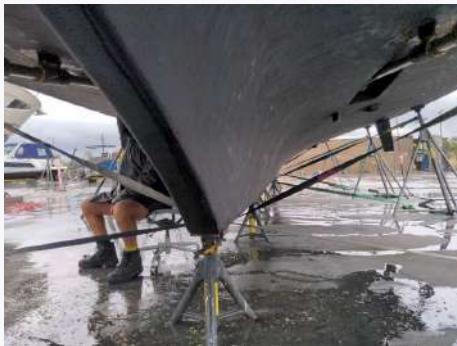
Ref # 2.3

2.3	Keel	FRP Composite	Sound	3/4 box keel running along centreline. Percussion sounded, no defect sighted.
2.4	Transom	FRP /Composite	Sound	The transom was percussion sounded in areas with no notable anomalies detected.
2.5	Antifouling	Black Ablative Application	Good	Suitable coverage and adhesion found to application. Hull was being prepared for new antifouling.
2.6	Thruster Tubes	FRP Composite	Sound	Bow and Stern thruster tubes appear to be installed to a professional standard.
2.7	Underwater Lights	12-volt	Sound	There appears to be two different sets of lights. Four older lights which did not appear functional, and two smaller lights which powered-up.

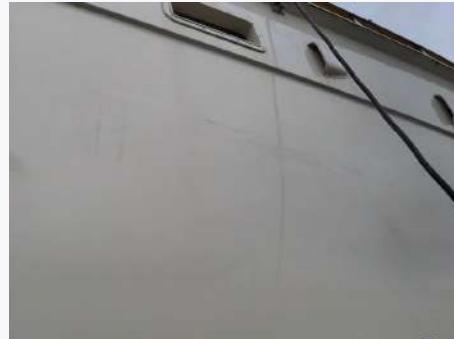
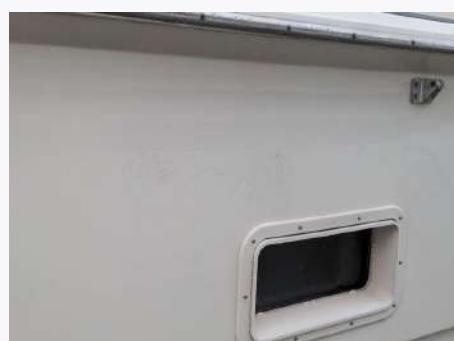
Ref	Item	Material / Construction	Condition	Comments
3.1	Hull side / Topsides	Two Part Polyurethane	Sound	<p>The entire hull topsides appear to have been painted with cream two Part Polyurethane paint or similar.</p> <p>The hull sides displayed a reasonably good gloss and shine, there are some scuffing marks and minor wear and tear in areas to commensurate with age.</p>
3.2	Gunnel	FRP Molding with Stainless Insert	Fair	<p>Hull integral gunnel moulding with stainless steel belting strip, there is a small section missing on the port side midships.</p> <p>C: Low Priority (Cosmetic or Superficial)</p>
3.3	Bow Stem	FRP Composite	Sound	No damage

Ref # 3.1 - Cosmetic hull scuff marks

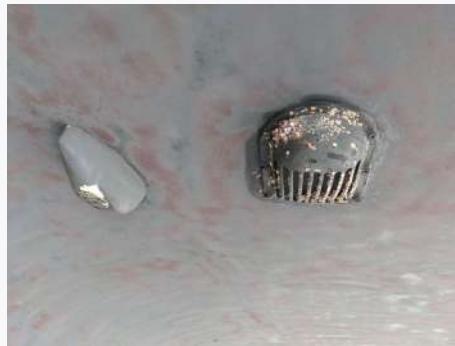
Ref # 4.2

Ref	Item	Material / Construction	Condition	Comments
4.1	Seacocks	Bronze or similar	Sound	<p>All were exercised, however some were quite stiff.;</p> <p>Most display signs of minor surface patina to some valves, however due to the dirty condition of the bilge and most valves and fittings were partially covered in debris.;</p> <p>It is recommended all seacocks be regularly inspected and excised monthly.</p>
4.2	Intake Grills	Bronze or similar on	Sound	Appeared clear and unobstructed.

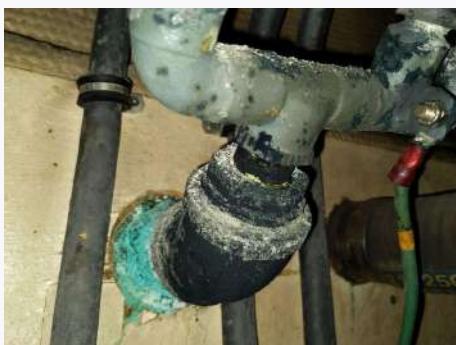
Ref # 4.3

4.3	Skin Fittings	Bronze or similar	Fair	Some skin fittings, particularly above the waterline shows signs of Patina corrosion. Any skin fittings displaying signs of corrosion should be scheduled for replacement. B: Medium Priority (Service or Maintenance Item)
4.4	Transducers / Speed Logs	Thru-Hull Type	Sound	Appeared to be suitably installed.
4.5	Sea Strainers	Perko Type	Poor	The sea strainers under the floor just aft of the utility space (laundry) display signs of build-up, all sea strainers aboard appear due for service. The hoses running's from these strainers are also in poor condition and due for replacement A: High Priority (Rectification Required)

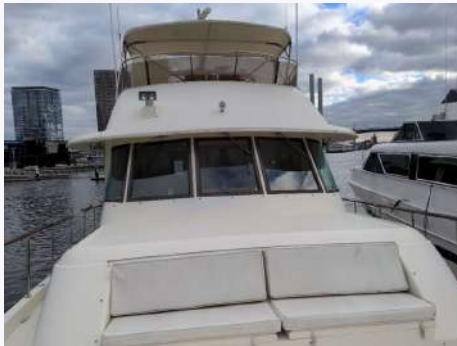
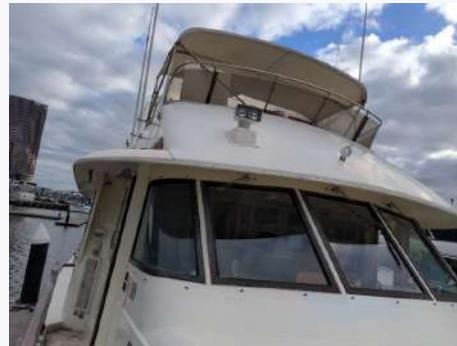
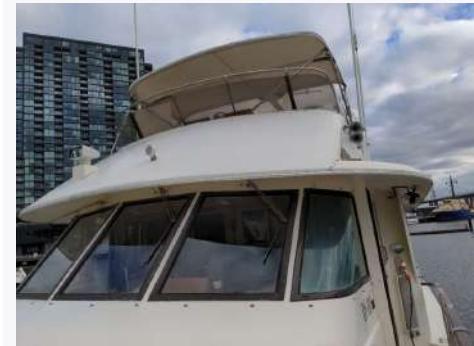
Ref	Item	Material / Construction	Condition	Comments
5.1	Superstructure	FRP Composite	Sound	Enclosed cabin pilothouse appearing structurally sound.; There is some stress cracking on the coach house below the starboard side window.

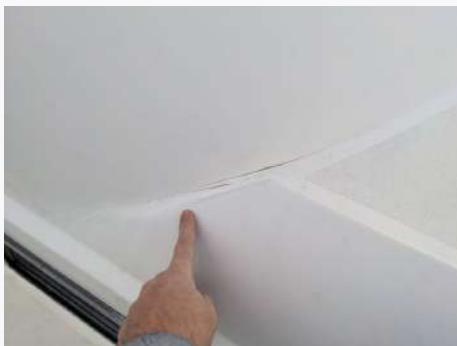
Ref # 5.1 - Hairline stress, starboard side
coach-hoist appears cosmetic only

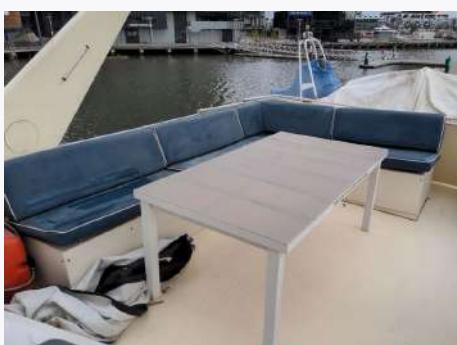
Ref # 5.3 - L-shaped pilot house lounge
condition

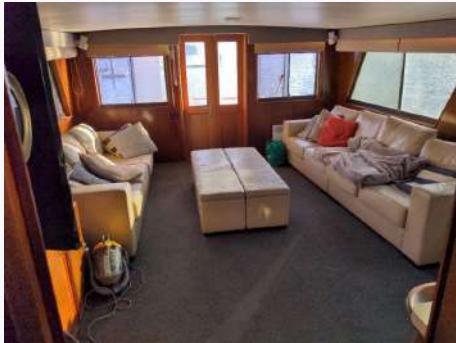
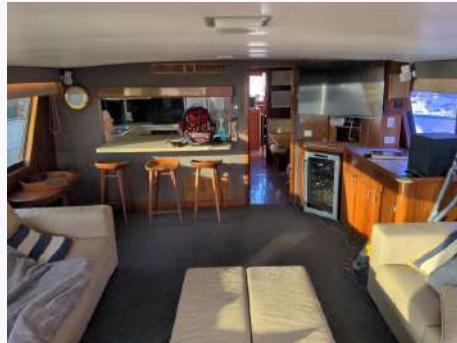
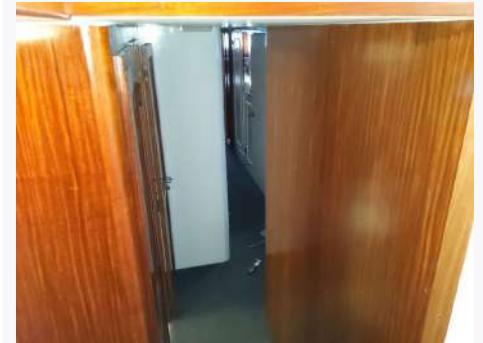
Ref #6

6.7	Cabin Sole	Career / Parquetry	Sound	Parquetry flooring in galley and helm, appear reasonably solid and sound with some wear and tear. A section appears to be sanded back as test piece.
6.8	Doors & Handles	Stainless Steel	Sound	Blue carpet in cabins and saloon, mostly clean with some stains and wear present in some areas, particularly the rear cabin which would benefit from a clean.
6.9	Galley Fitout	Laminated Veneer	Good	In good usable condition, appears to have been upgraded at some stage.
6.10	Benchtops	Stone or similar	Good	No notable wear.
6.11	Seating & Upholstery	Leather	Sound	Cream leather U-shaped dinette with two cream lounges in saloon, no notable wear sighted.
6.12	Bedding	Foam Base	Sound	Appear in reasonable condition.; Port side cabin is used for storage, we inspected this cabin as best of possible without removing all contents.

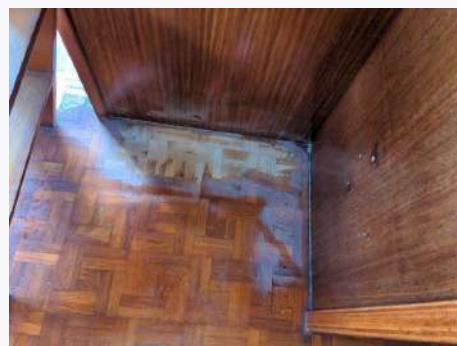
Ref # 6.7 - helm flooring sanded back in area.

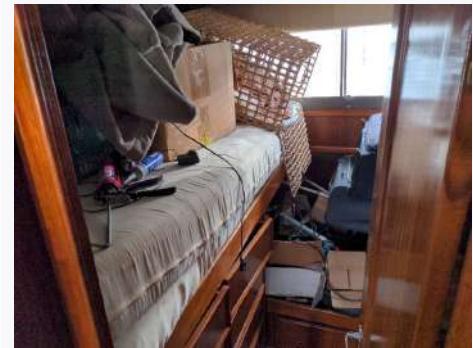
Ref # 6.12 - Port side cabin used for storage.

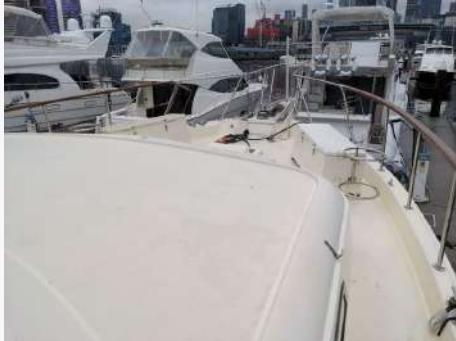
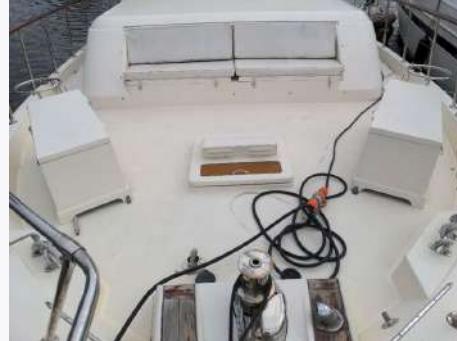
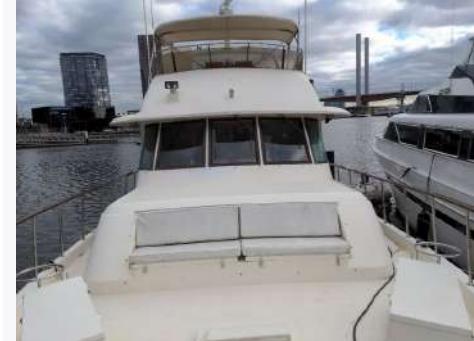
Ref # 7.1

Ref	Item	Material / Construction	Condition	Comments
7.1	Foredeck Structure	FRP Composite	Sound	<p>Percussion sounded and moisture tested appearing rigid and structurally sound.</p> <p>The deck is finished with non-skid tread.</p> <p>There is a stain on the port side of the coach house, appears consistent with something being spilled from the forward lounge storage lockers, spilling from the drain hole.</p> <p>C: Low Priority (Cosmetic or Superficial)</p>

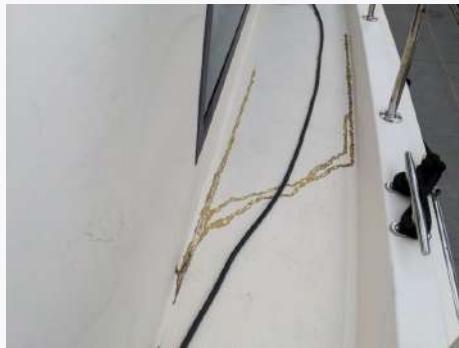
Ref # 7.1 - Deck spillage

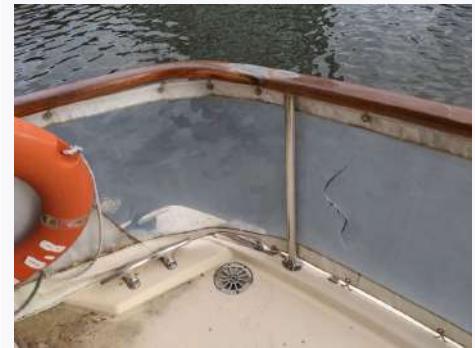
Ref # 7.2 - Clears on rear deck torn.

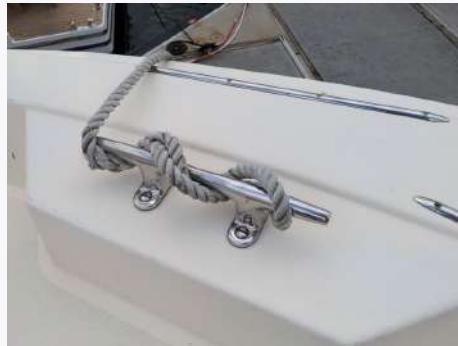
Ref # 7.5

7.4	Stanchions	Stainless Steel	Sound	No signs of crazing or compression found around the bowrail stanchion bases on the deck.
7.5	Cleats	Stainless Steel	Good	Eight deck cleats appeared secure providing multiple mooring configurations.

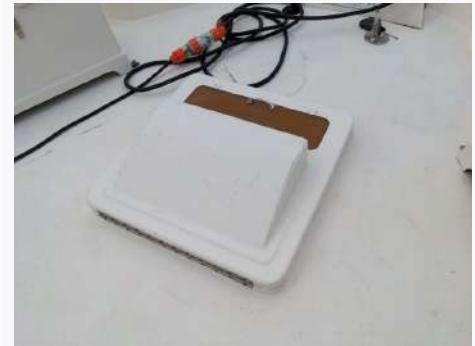
Ref # 7.6

7.6	Hatches	FRP composite	Sound	Composite deck hatch appeared free from leak, minimal wear to lenses.
7.7	Windows	Acrylic or similar	Fair	<p>Multiple sectional tempered glass helm windows surround the helm with acrylic curved side panels which have some crazing present.</p> <p>The sealant around the helm windows are showing signs of deterioration with signs of slight weeping in some areas.</p> <p>Window wipers powered-up, blades appear worn.</p> <p>Small corrosive hole to window frame in port forward cabin.;</p> <p>There is a crack to one window pane on the port side saloon.;</p> <p>The windows do appear to require sealing in some areas and maintenance.</p> <div style="background-color: #ffcc00; border: 1px solid black; padding: 2px; display: inline-block;"> B: Medium Priority (Service or Maintenance Item) </div>

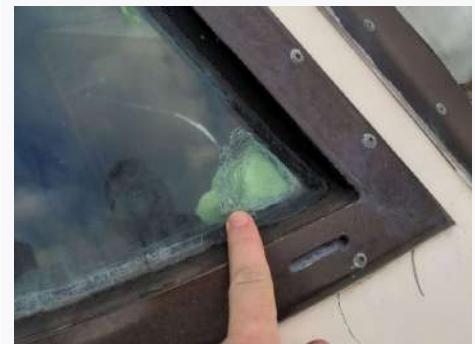
Ref # 7.7 - Crazing to side curved helm window.

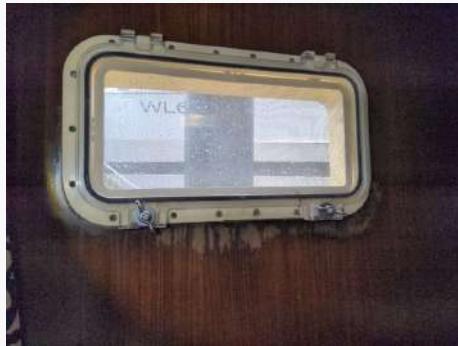
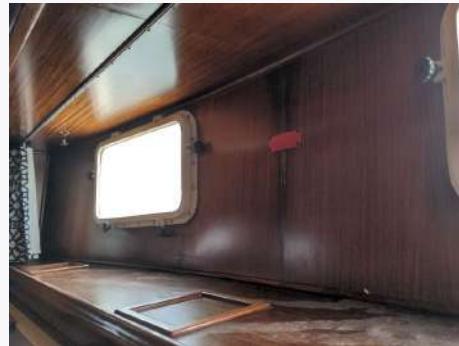
Ref # 7.8

7.8	Portholes	Acrylic or similar	Sound	Porthole windows are installed around hulls sides, no notables leaks sighted, however there are water stains around some port holes to the veneer board

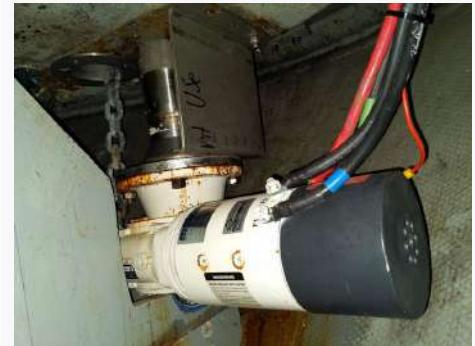
Ref # 7.9

7.9	Anchor Winch	24-Volt Electric	Sound	Muir anchor winch fitted to bow, no notable corrosion to under deck mounted motor. The anchor was raised and lower using helm controls. There is some localised core deterioration the deck around the anchor mount location with corrosion to galvinsed backing washer.
7.10	Anchor	Plough (Galvanised)	Sound	Suitably sized plough type anchor mounted at the bow.
7.11	Anchor chain, warp and fittings	Galvanised	Sound	Galvanised chain sighted in anchor locker; length unknown.
7.12	Bow roller / Stem head	FRP Moulding	Sound	Securely mounted, integral with deck molding creating a small bow spirit with teak inlay.
7.13	Davit Crane	Daveco	Sound	DavCo 500kg Davit crane mounted on bridge deck to launch and retrieve tender. Appeared in sound visual condition. (Not tested)

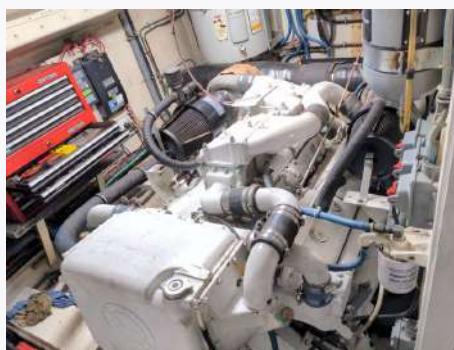
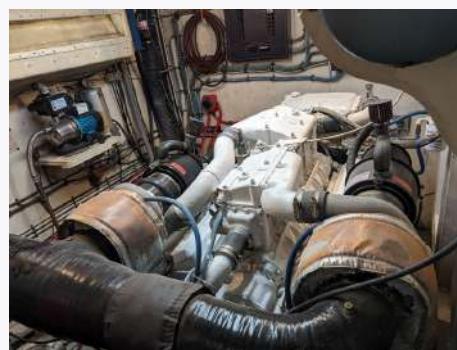
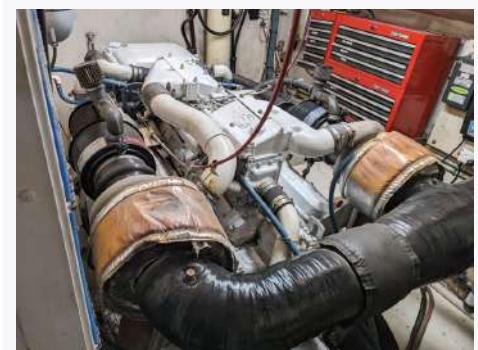
Ref # 8.1

Ref	Item	Type / Make	Condition	Comments
8.1	Engine Block	Detroit Diesel	Sound	V12 V71, 2 Stroke turbo charged 18.6 liter engines.

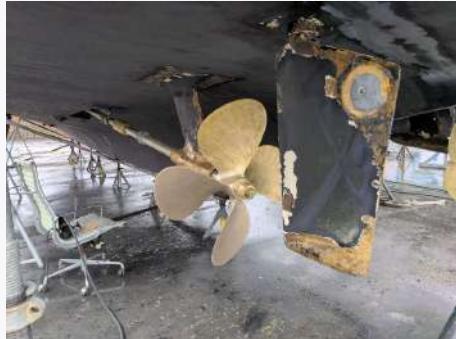
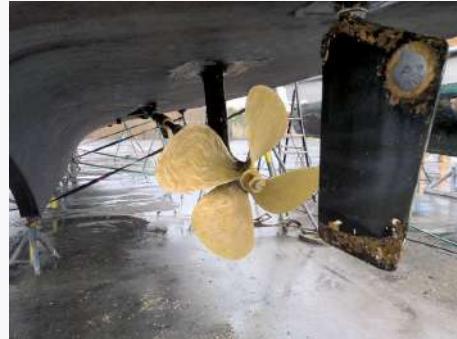
Ref # 9.1

Ref	Item	Type / Make	Condition	Comments
9.1	Type	Shaft Drive	Sound	Twin shaft drives
9.2	Gear Box	Twin Disc	Fair	Said to be Twin Disc transmissions.; Make and specifications of transmissions were not legible due to some surface corrosion and being painted over.
9.3	Propellers	Stainless Steel	Sound	32 x 30 fixed 4 blade bronze propellers, no damaged.
9.4	Shaft	Stainless Steel	Sound	2 1/2 inch shaft, appears to run true.

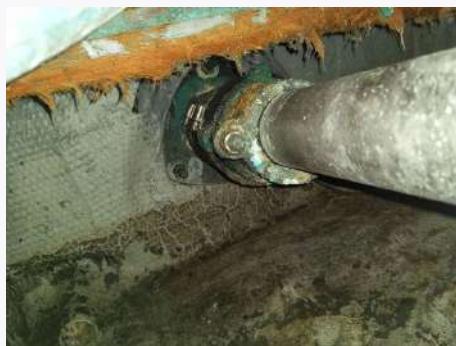
Ref # 9.5

9.5	Shaft Seal	Packing Type Seal	Fair	Packing type lip seal, no leak at rest. Some build-up around seal face and patina on body of gland.
9.6	Coupling	Machined Steel	Sound	Painted shaft coupling, no notable corrosion
9.7	Skegs	Cast Bronze	Sound	Primary and intermediate bronze, securely mounted.
9.8	Skeg Mount (Internal)	Bronze Plate.	N/A	Not accessible
9.9	Bonding	Wire	Sound	Appearing to be connected/bonded where sighted.
9.10	Drive Anodes	Zinc or Aluminium	Sound	Being replaced with new
9.11	Drive Coatings	Prop-spped	Good	Driveline recoated with prop-speed

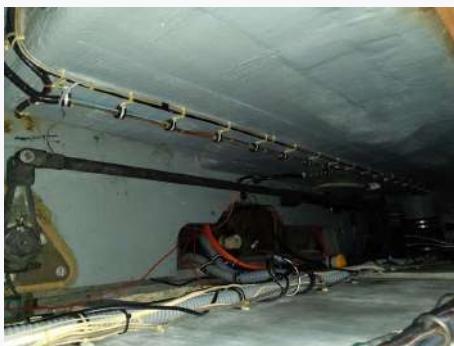
Ref # 10.1

10. Steering & Manoeuvring				
Ref	Item	Type / Make	Condition	Comments
10.1	Type	Hynautic Hydraulic	Sound	Twin rudder connected to rudder shelf with hydraulic assisted steering and tie bar.

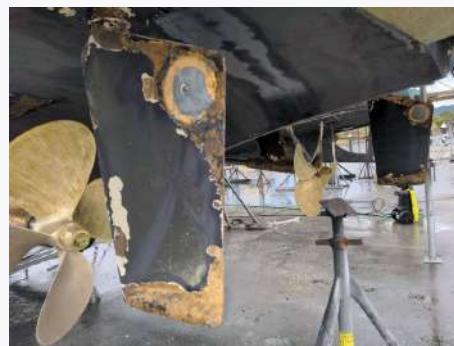
Ref # 10.4

10.4	Rudder	Bronze	Sound	Solid bronze rudder blade, no damage. Rudders were antifouled, being prepared for re-application
10.5	Rudder Glands	Packing Type	Fair	There are signs of rudder bearing movement, more notably on the port side. Rudder glands were repacked and serviced in 2021 by Miller Marine. The starboard side exhibits signs of corrosion around studs and the stock. Consideration to removing and inspecting rudder posts and bolts/studs along with full service would be recommended at next haul-out.

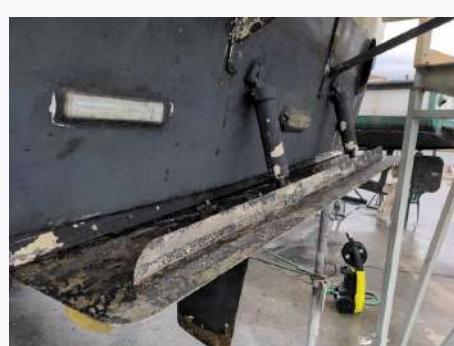
Ref # 10.7

10.6	Rudder Head/Shelf	Timber Veneer	Sound	Rudder head secured to FRP composite rudder shelf.
10.7	Trim Tabs Plate	Stainless Steel	Sound	Anodes being reapplied., no damage.

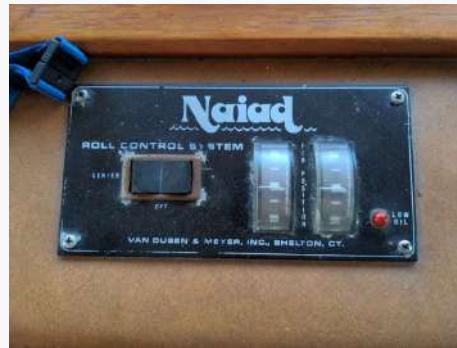
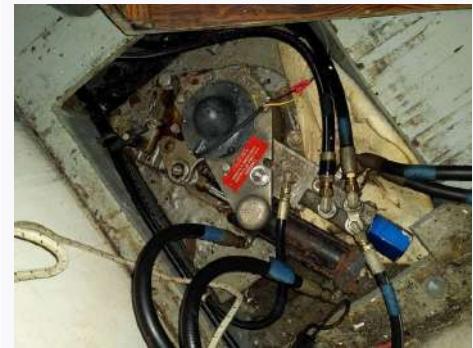
Ref # 10.11

10.10	Stern Thruster	Craftsman Marine	Poor	Thrusters did not power-up, bow thruster power head removed.; Corrosion to stern thruster motor. C: Low Priority (Cosmetic or Superficial)
10.11	Stabilizers	Naiad	Sound	Not tested, visually appear sound

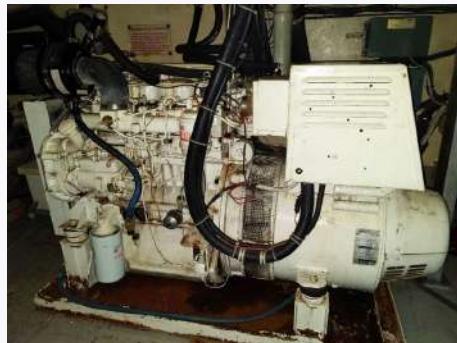
Ref	Item	Type / Make	Condition	Comments
12.1	Type	Onan 4KVA	Sound	<p>There are two Gensets aboard, however only one is said to be operational.</p> <p>We did not test the older 20kw Kohler Genset as it has not been started in sometime and not required for ships supply.</p> <p>The tested Genset was a Kohler 21kw fresh water cooled diesel genset.</p>
12.1.1	- Genset Hours	Analogue Gauge	Sound	Genset gauge is reading 2436 hours
12.2	External Case / Bottom Tray	Steel	Sound	No external case, only minor corrosion to bottom tray.
12.3	Cooling System	Closed / Fresh water	Fair	Some hoses showing signs of wear, the raw water intake feed hose was unconventional but functional.
12.4	Heat Exchanger	Metal	Sound	Some minor build-up around end caps.
12.5	Hoses and Fittings	Reinforced Marine Hose	Fair	Appeared sound.
12.6	Exhaust	Reinforced Marine Hose	Sound	Exits hull on port side.

Ref # 12.1 - Older Genset not tested

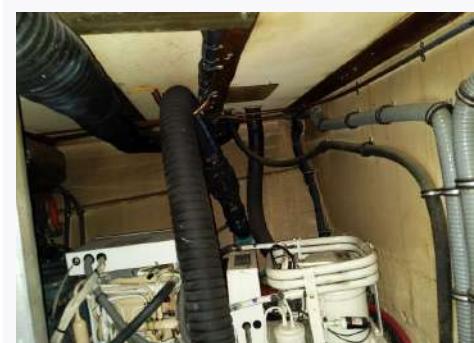
Ref # 12.7

12.7	Muffler / Wet lock	FRP Composite	Sound	Appears suitably installed.
12.8	Engine Oil	Oil	Sound	Appears at normal levels.
12.9	Cooling water flow	Port Side	Sound	Appeared normal.
12.10	Load Tested	Ships Power	Sound	Load tested, power up all ships systems with output of 240-volts
12.11	Notice			The findings reported are from a visual inspection only, no assessment has been made of the internal condition of the engine.

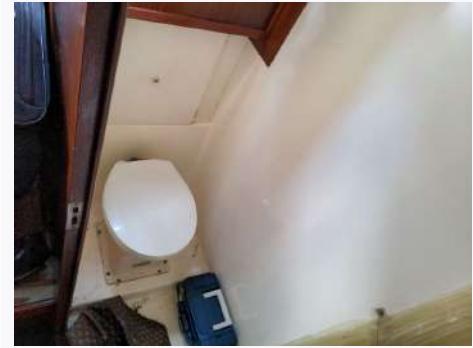
Ref # 13.11 - Forward port cabin head did not powers-up.

13.11 Plumbing Systems » Toilet / Head	N/A	Four electric flush toilets fitted in head, however the two forward TMC toilets did not power-up.
13.12 Plumbing Systems » Toilet Plumbing	N/A	Hose with hose clamps draining into holding tank. Hoses, pumps and hose clamps all showing signs of wear.; Head plumbing and pumps require service.;
15.5 Heating & Cooling » Heating Mode	N/A	From our testing, we did not get any warm air from the air con units. May require service,
15.6 Heating & Cooling » Cooling Water Flow	N/A	No water flow sighted, there appears to be 2 x 240-volt raw water cooling pumps forward of the port engine. Both trip the circuit breakers when powered-up. Plumbing hose on pumps are in poor condition and should be replaced. Pumps are mounted low in the bilge, possibly water affected. ; Further investigation and repair required by technician.

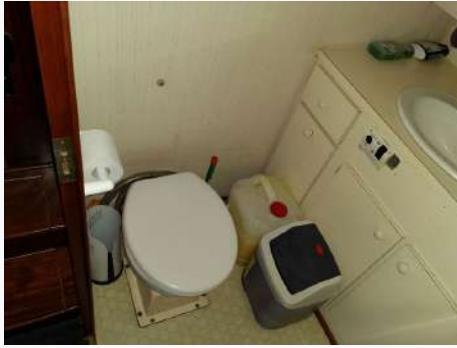
Ref # 13.11 - Forward head did not power-up

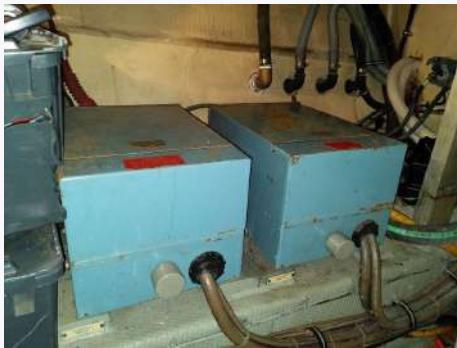
Ref # 14.5

14.4	Interior Lighting	110-volt and 32-volt lighting	Fair	Most powered-up. Rear cabin port side reading light broken.
14.5	Transformers	240 to 120 Transformers	Sound	2 X Step down transformer fitted.

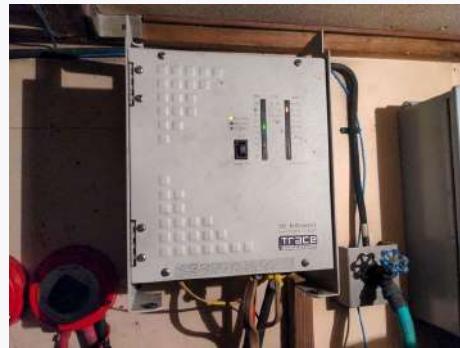
Ref # 14.6

14.6	Invertors	Trace Engineering	Sound	1.5kw Invertor charger, powered up. Not load tested.
14.7	Wiring & Cables	Insulated Wire	Fair	Visually inspected, no defects sighted.

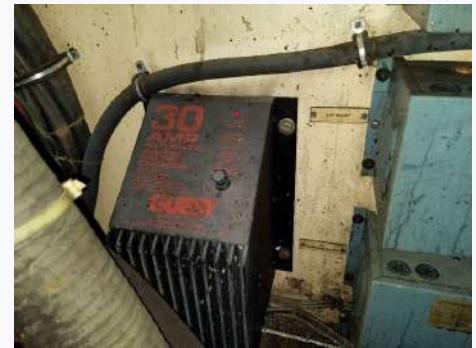
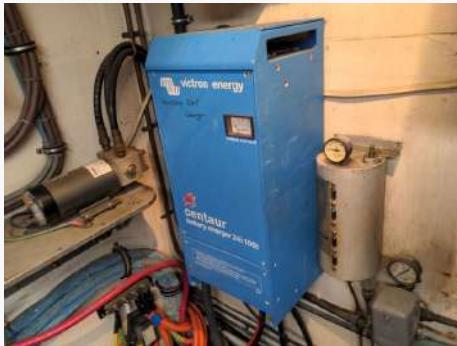
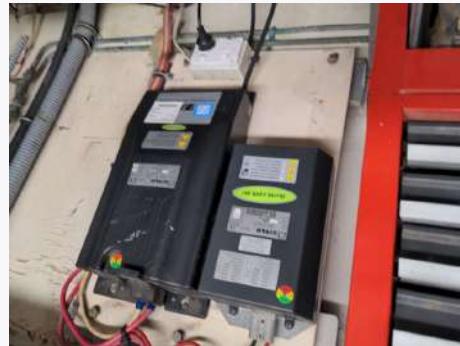
Ref # 14.9

14.9	Battery Charger	Various	Sound	Older style Guest 30 amp charger and and older style Powered-up. Victron blue charger in port engine bay.
14.10	Batteries (House)	12-volt		4 x 8-volt batteries = 32 volts

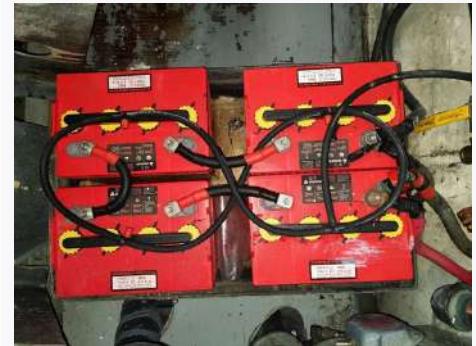
Ref # 14.11

14.11	Batteries (Start)	8-volt / 32-volt		4 X 8-volt batteries = 32 volts
14.12	Batteries (Genset)	12-volt		2 x 12-batteries - 24-volts ; Some batteries not secured.

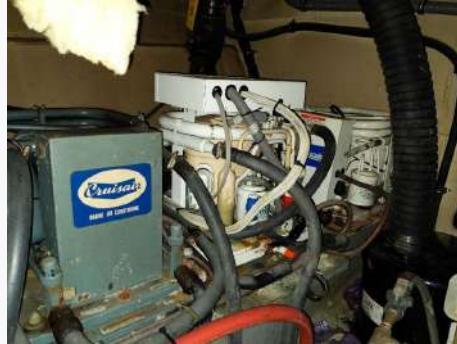
Ref # 15.1

Ref	Item	Type / Make	Condition	Comments
15.1	Type	Cruise Air	Sound	<p>There are seven Air Conditioner condensers fitted, there are 3 Cruiser Air units which appear original and did not power up.</p> <p>There are also two newer Cruise Air units which also did not power up.</p> <p>There is a Dometic and a Marine Air unit, which both powered up and appeared connected to the 2 Dometic digital touch screen displays</p> <p>One services the main saloon and the other serving the rear master cabin.</p>

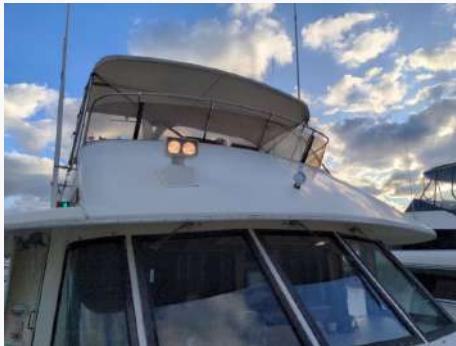
Ref # 17.9

17.9	Spotlight	32-volt	Powered-up:	Yes	Search light functional the smaller deck light was not tested as unable to locate the switch for it.
17.10	Horn	32-volt	Powered-up:	Yes	Tested
17.11	Trim Tab Gauge	Bennett	Powered-up:N/A		Bennett gauges on helm (not tested)
17.12	Analogue Gauges	Digital & Analogue	Powered-up:	Yes	There are two floscan digital gauges on the helm which appear functional, some analogue gauges on the helm did not appear to be functional may not be working correctly being the voltage and temperature gauges. There are temperature gauges in the engine bay which did appear functional.

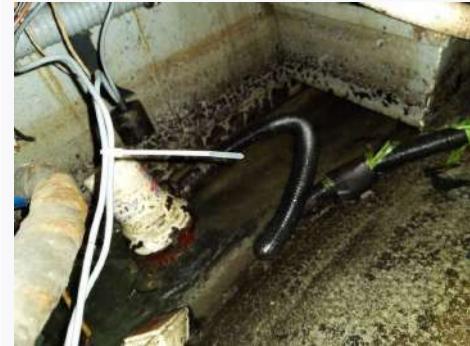
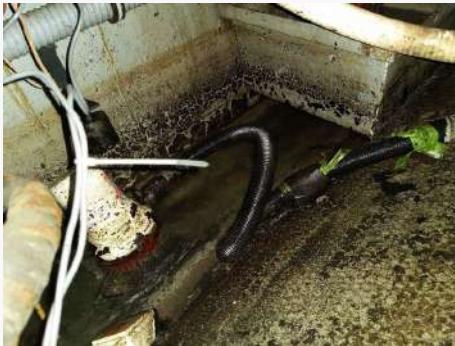
Ref # 18.2

Ref	Location	Number / Type	Comments
18.1	Forward Pump/s	2 x 32-Volt	Rule pump with float switch, powered up
18.2	Midships Pump/s	1 x 32-Volt	Rule pump with float switch, powered up. There are joins in the outlet hoses which is not ideal.
18.3	Aft Pump/s	2 x 32-Volt	Rule pump no float switch, powered up
18.4	Manual Hand Pump	Whale	2 x Manual Bilge pumps aboard
