# INSURANCE SURVEY FOR GRAHAM ROSE

26/3/2021

**VESSEL:** Halcyon Quest **DESIGN:** Roberts 38 **REGISTRATION:** WE562Q

**LOA:** 11.66 meters **BEAM:** 3.43 meters **DRAFT:** 1.7 meters **BUILT:** 1978

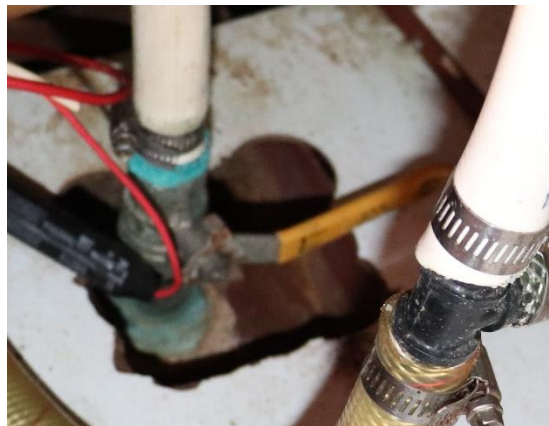
There is a 400-litre aluminium diesel tank.

There are 400-litres of water in bladders.

The seacocks all opened and closed easily.
