## Pre-Purchase Inspection

Angelone, 490, 2018 Model

### Survey Details

Survey type:	Pre-Purchase Inspection
Survey No#:	PPS210913
Client:	[REDACTED]
Email:	spayne@dalboramarine.com.au
Inspection date:	12th September 2021
In-Water location:	The Boatyard, Mount Martha, Victoria
Out-Water location:	Martha Cove Marina, Mount Martha, Victoria

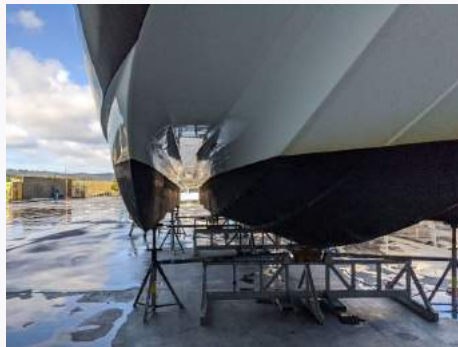
Ref # 2.1

Ref	Item	Material / Construction	Condition	Comments
2.1	Hull Bottom	FRP Composite	Sound	<p>Trimaran semi-planning hull, hulls are stepped. No signs of previous repair, stress or defect was sighted.</p> <p>The hull bottom was moisture tested using a moisture meter (Tramex Skipper +) the hulls were mostly found to be within normal ranges, however we did detect slightly elevated reading on each bow around the waterline. We did notice some minor cosmetic blisters in these areas.</p> <p><b>C: Low Priority (Cosmetic or Superficial)</b></p>

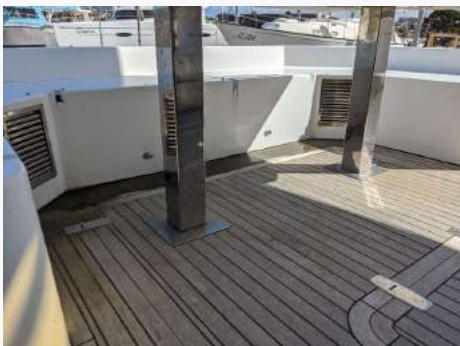
Ref # 5.8

5.7	Lockers and storage	FRP Composite	Sound	Storage lockers are clean and free from water and moisture.
5.8	Cockpit Drainage	Self draining	Fair	<p>Cockpit is somewhat self draining, however water can collect around seating area and run-off from side decks leads into side deck hatches. Drainage could be improved in these areas.</p> <p><b>B: Medium Priority (Service or Maintenance Item)</b></p>
5.9	Cockpit lighting	12-volt	Fair	<p>Cockpit lighted powered-up.;</p> <p>Courtesy and underwater lighting did not power-up. Kept tripping breaker.</p> <p><b>B: Medium Priority (Service or Maintenance Item)</b></p>

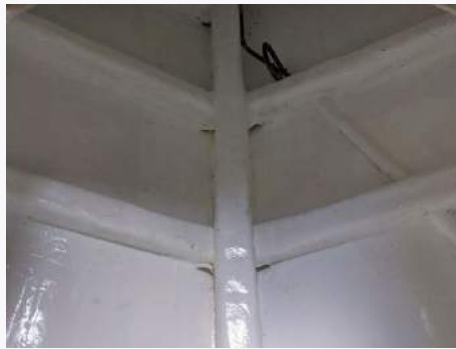
Ref # 6.2

Ref	Item	Material / Construction	Condition	Comments
6.1	Interior Frames & Bulkheads	FRP Composite	Sound	Timber veneer plywood panels bonded to hull.
6.2	Hull stringers	FRP Composite	Sound	FRP longitudinal and transverse frames all found in sound structural condition. Not all hull frames could be inspected due to permanently fitted panels.;  Please note, the internal areas of both side hulls were not inspected. Access was restricted by fixed panels.

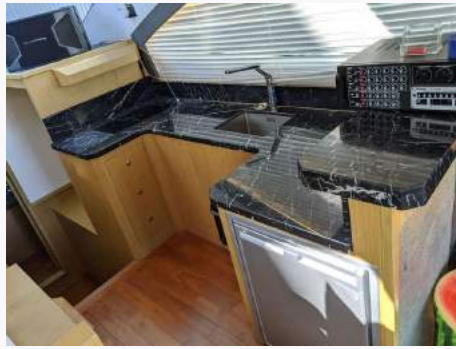
Ref # 6.9

6.7	Cabin Sole	Timber	Sound	Laid timber 10mm, some minor wear.
6.8	Doors & Handles	Aluminium	Good	All found functional
6.9	Galley Fitout	Timber Veneer	Good	In good usable condition.

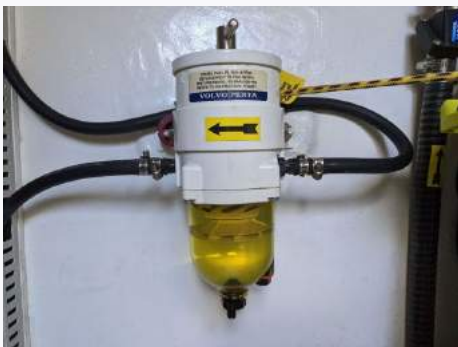
Ref # 10.3

Ref	Item	Type / Make	Condition	Comments
10.1	Fuel Lines	Marine Fuel Hose	Good	No deterioration sighted.
10.2	Fuel Fittings	Hose and clamps	Good	No leaks sighted.
10.3	Fuel Filters	Volvo Penta	Good	no corrosion externally.
10.4	Fuel Shut-Off	Bronze Valve	Sound	Fitted on fuel tank.
10.5	Fuel Filler Line	Fuel Hose	Sound	Appeared serviceable where accessible.
10.6	Fuel Breather	Fuel Hose	Sound	Appeared serviceable where accessible.

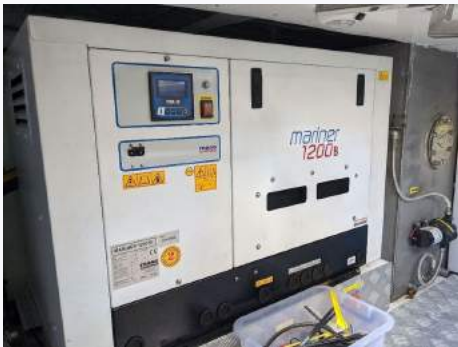
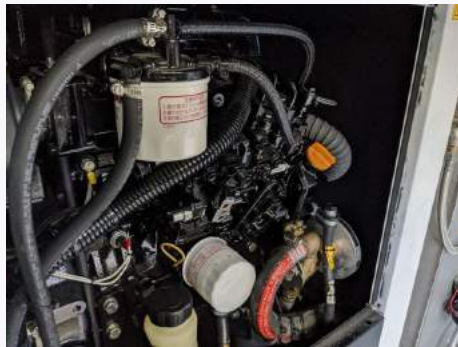
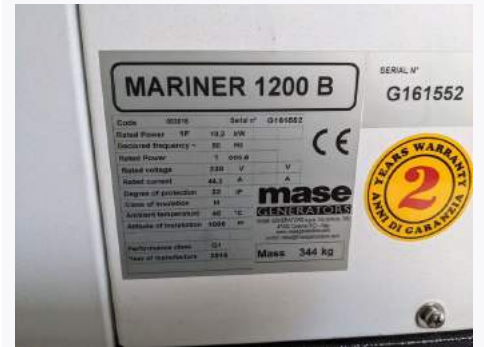
Ref # 11.1

Ref	Item	Type / Make	Condition	Comments
11.1	Type	Made 10.2 kw	Good	Fresh water cooled diesel genset.
11.2	External Case / Bottom Tray	Steel	Good	No corrosion.
11.3	Cooling System	Closed / Fresh water	Good	No leaks sighted.
11.4	Heat Exchanger	Metal	N/A	Not accessible, not inspected.
11.5	Hoses and Fittings	Reinforced Marine Hose	Good	Fitted on fuel tank.
11.6	Exhaust	Reinforced Marine Hose	Good	Exits hull on port side.
11.7	Muffler / Wet lock	FRP Composite	Good	Appears suitably installed.
11.8	Engine Oil	Oil	Good	Appears at normal levels.
11.9	Cooling water flow	Port Side	Good	Appeared normal.
11.10	Load Tested	Ships Power	Good	Load tested to 22 AMPS

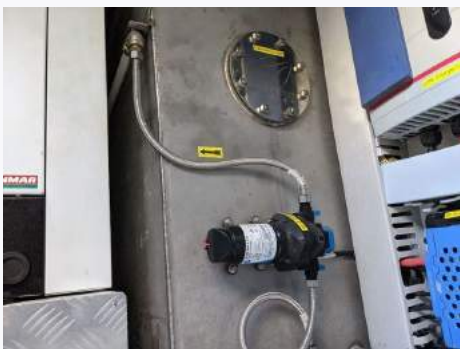
Ref # 12.1

Ref	Item	Type / Make	Condition	Comments
12.1	Fresh Water Pump	12-Volt Jabsco	Good	Functional
12.2	Plumbing / Hose	PEX type	Sound	Potable water is serviced with PEX type piping and brass fittings. No leak or deterioration sighted where accessible.
12.3	Water Heater	Nautic Marine	Good	240-volt electric element type.
12.4	Relief Valve	Pressure Relief Valve	Good	Tested
12.5	Hot Water Supply	Hot Water Test	Good	Hot water produced, using electric element,
12.6	Sinks	Stainless Steel	Good	All drain overboard.
12.7	Showers	Head Shower	Good	Showers fitted in head, functional
12.8	Shower Drainage	12-volt	Good	Shower drains into sump box, discharging overboard via 12-volt pump.
12.9	Toilet / Head	Dometic Vacuum flush	Good	Fresh water flush toilet fitted in head, functional.
12.10	Toilet Plumbing	Sanitation Hose	Good	Hose with hose clamps draining into holding tank.

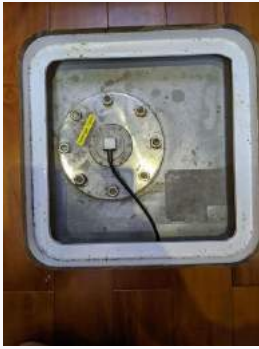
Ref # 15.3

Ref	Type	Material / Construction	Condition	Capacity
15.1	Water Tank	Aluminium	Good	Said to be 300 litres
15.2	Fuel Tanks	Aluminium	Sound	Said to be 1100 litres total
15.3	Blackwater Tanks	Stainless Steel	Good	Approximately 200 litres.

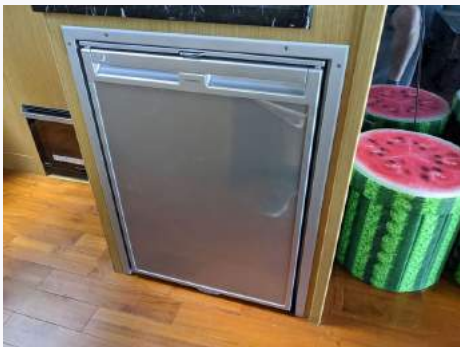
Ref # 16.1

Ref	Appliance	Type	Test	Comments
16.1	Refrigeration Systems	Dometic	Powered-up: <span style="color: green;">Yes</span>	12 volt fridge in galley.
16.2	Stove / Oven	Euro Kera	Powered-up: <span style="color: green;">Yes</span>	Two burner induction
16.3	Microwave	Panasonic	Powered-up: <span style="color: green;">Yes</span>	240 volt microwave.
16.4	Televisions	LE tv	Powered-up: <span style="color: green;">Yes</span>	Pop up television in saloon.
16.5	Sound Systems	Fusion	Powered-up: <span style="color: green;">Yes</span>	With speakers throughout.

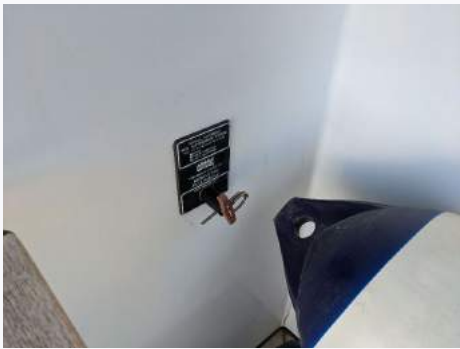
Ref # 19.3

Ref	Safety Gear	Type	Comments
19.1	Life Jackets	Foam PFD type	2 x Inflatable & 20 x Foam sighted.
19.2	Extinguishers	Dry Chemical Type	2 x 9kg
19.3	Fire Suppression	Sea Fire	In engine bay
19.4	EPIRB	N/A	None sighted
19.5	Flares	One set	Dated: September 2023
19.6	Fire Blankets	One Blanket	Found in galley
19.7	Life rings	Plastic Ring	3 onboard

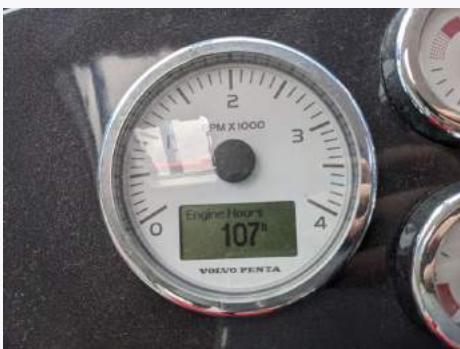
Ref # 20.1

Ref	Gauge	Location / Type	Reading
20.1	Engine Hour (Port)	Helm Analogue Gauge	107 hours
20.2	Engine Hour (Starboard)	Helm Analogue Gauge	111 hours
20.3	Genset	Analogue Gauge on Genset	118 hours
20.4	Batteries (House)	12-volt	13.5 volts
20.5	Batteries (Start)	12-volt	13.4 volts
20.6	Batteries (Genset)	12-volt	13.2 volts
20.7	Shore power (240 volt)	Switch board reading	246 volts
20.8	Gen Set power (240 volt)		232 volts
